**Ashton Coal  
Longwall Panels 1 - 4**

Subsidence Management Plan  
Written Report

# Slope Stability Assessment for Ashton Coal SMP

July, 2006

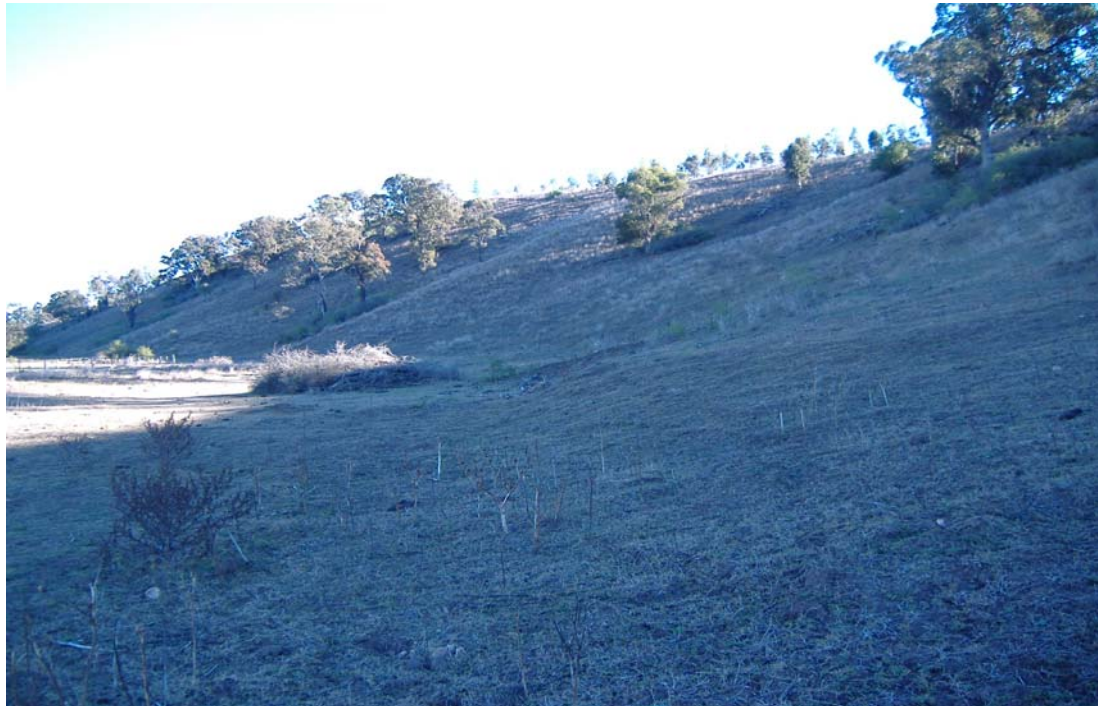
- The slopes down to Glennies Creek were uniform and grass covered. The maximum measured slope angle was about 32 degrees below horizontal.
- The slope has a maximum of height of about 40m
- The slope contained no outcropping bedrock. Some scouring was observed on the slope possibly due to the existence of springs. Material exposed in the scoured areas comprised sandy clay with boulders to about 0.5m diameter. The material was assessed to be colluvium. There was no indication as to the depth of colluvium mantling the slope.
- There was no evidence of past or existing instability on the slope.
- The coal seam to be mined (Pikes Gully Seam) crops out near the toe of the slope. The coal seam was not observed during our inspection.

**Photo 3-1 Natural Slopes adjacent Glennies Creek, looking south**

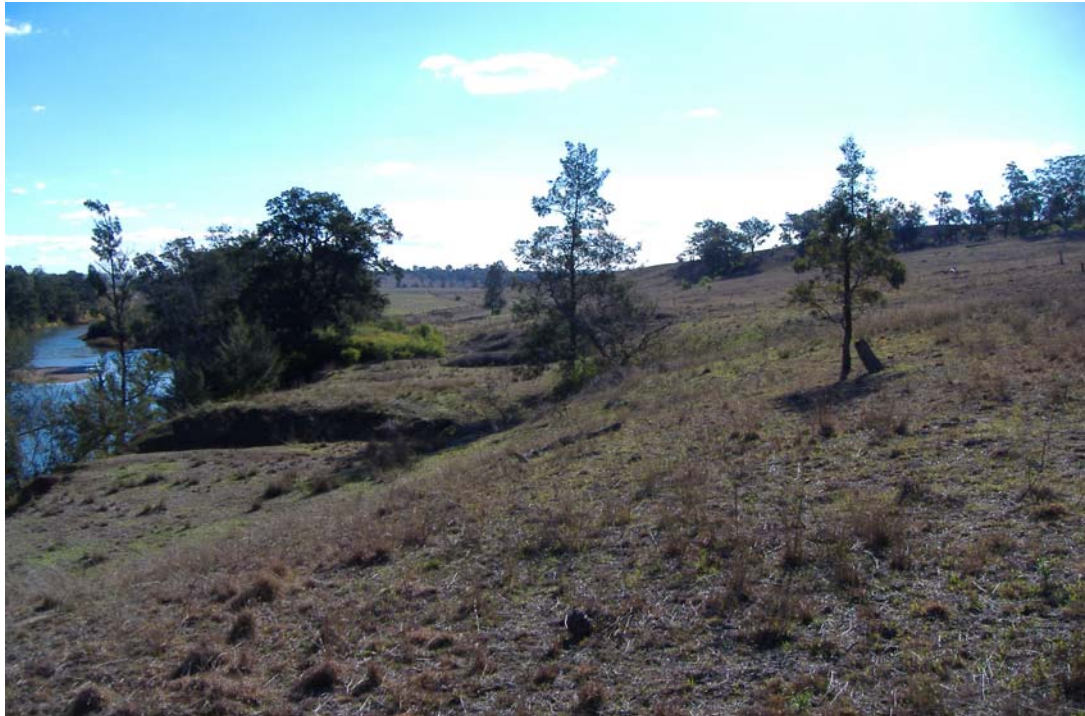
- Slopes down to the Hunter River were uniform and measured to be about 10°-12°.
- The slopes were grassed covered. One portion of the slope was also well wooded.
- The maximum slope height (from hill crest to the Hunter River) was about 30m-40m.
- Outcropping conglomerate bedrock was observed on the slope near the crest and approximately half way down. Partial undermining of the slope has occurred adjacent the Hunter River due to scouring. Material exposed in this area comprised silty sands (presumably slopewash material). Based on surface observations, the slopes are expected to be underlain by a thin veneer (say maximum 2m depth) of silty sand slopewash then bedrock.
- Shallow drainage lines ran down the slope. At the time of the inspection the drainage lines were dry.

**Photo 3-2 Natural Slopes adjacent Hunter River, looking west**

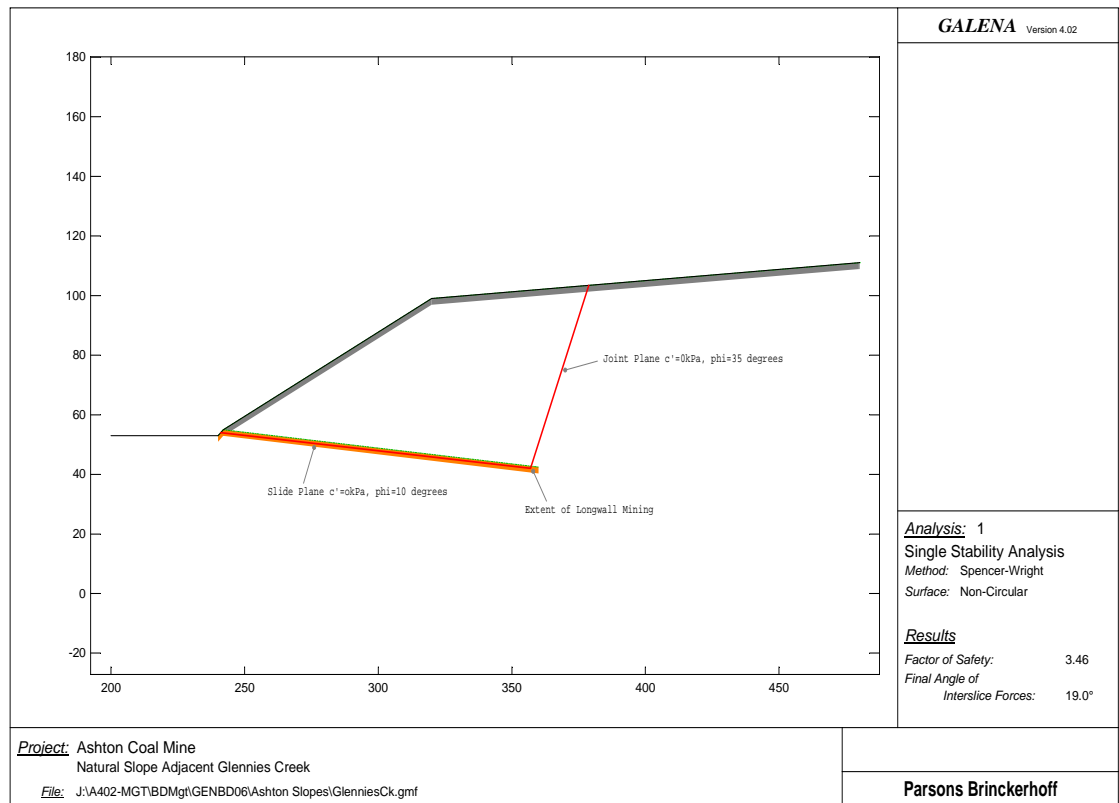
A stability analysis was carried out using Galena slope stability software assessing planar slip for the Glennies Creek site. Absolute lower bound shear strength parameters were adopted as shown below. The analysed Factor of Safety was 3.46.

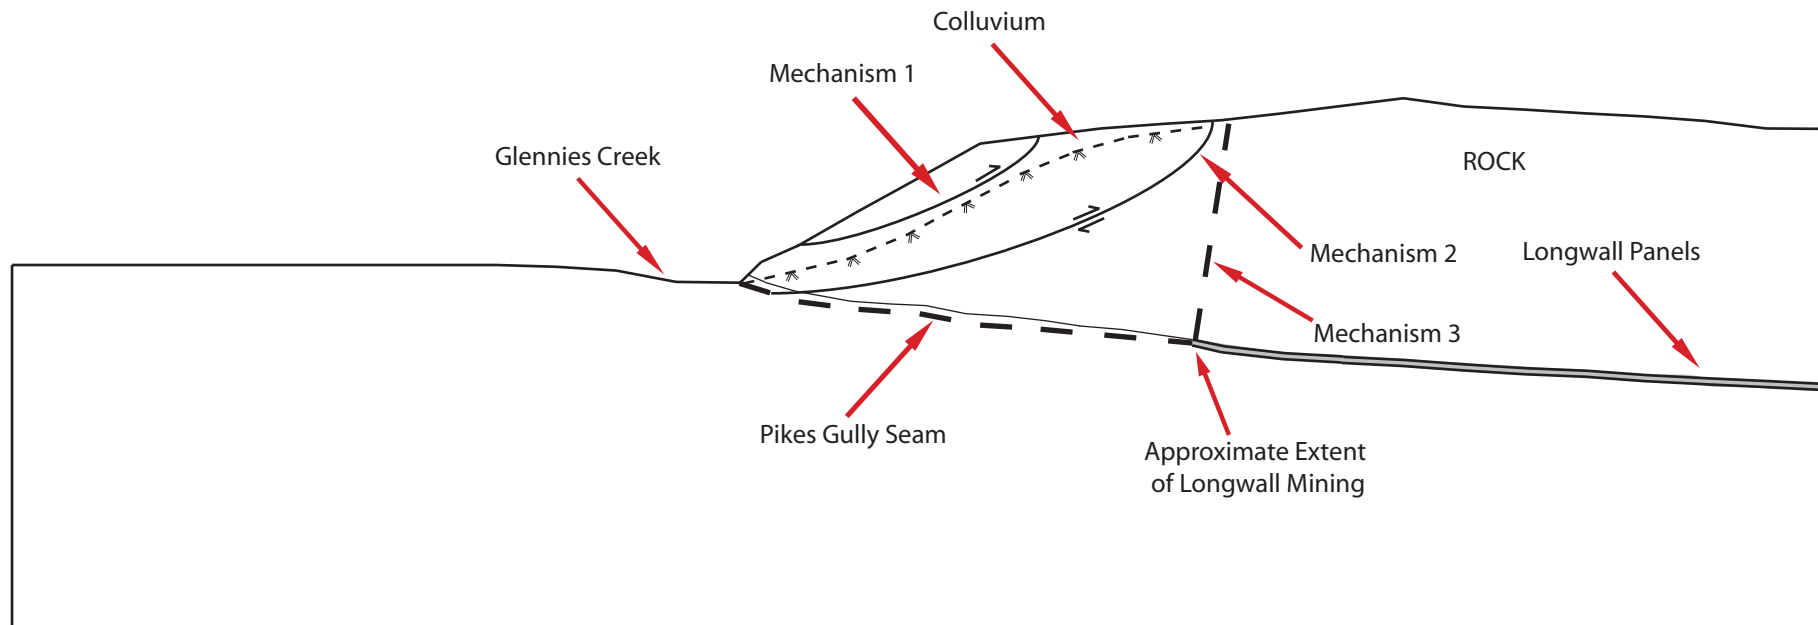
# SECTION 1

The sites were inspected by an experienced engineering geologist on 6 July 2006 with observations summarised below. Slope profiles are shown on the attached Sections 1 and 2. The depth to the Pikes Gully Seam shown on the sections was based on depth of cover contours provided by Ashton.

The failure mechanisms are illustrated on the attached Section 1.
