Ashton Coal  
2017 Annual Review

Figure 1 Overview of operations

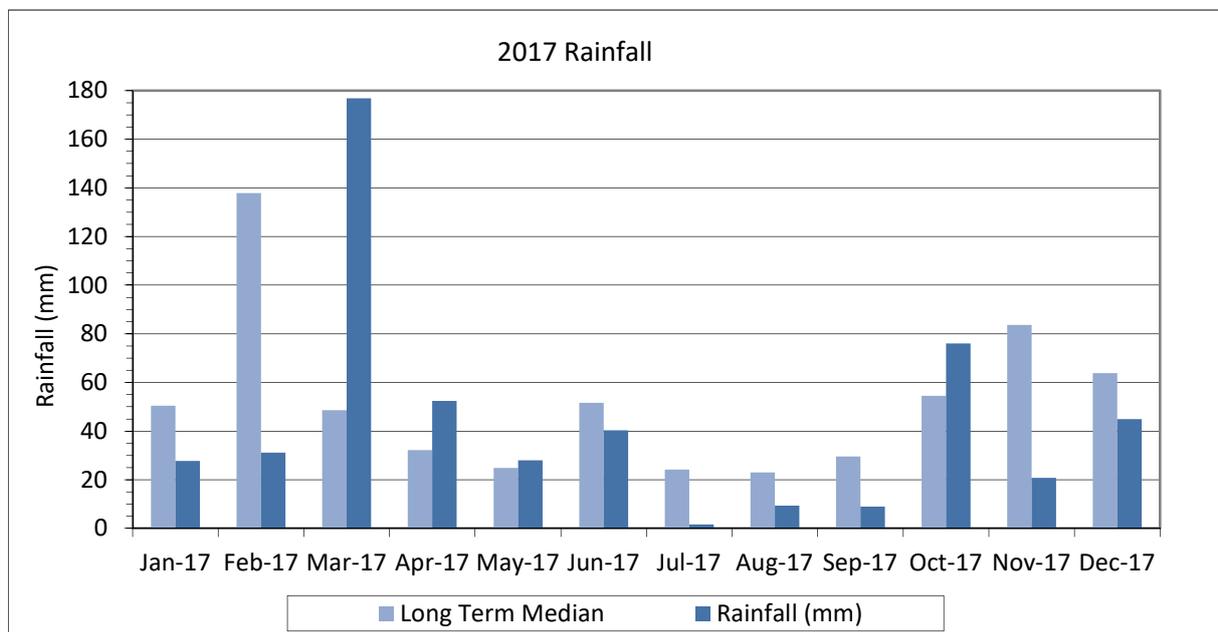
**Figure 2 2017 Rainfall**

Meteorological data is used at Ashton to interpret environmental impacts and to understand rehabilitation and land management outcomes. Ashton has two meteorological monitoring stations: Monitoring Site 1 (predominantly used to monitor for noise and air quality impacts in adverse weather conditions) and the Repeater Station (the main monitoring site). A summary of meteorological data recorded at the Repeater monitoring station during the reporting period is provided in Table 11. Rainfall is included as Figure 2 and seasonal wind roses as Figure 3.

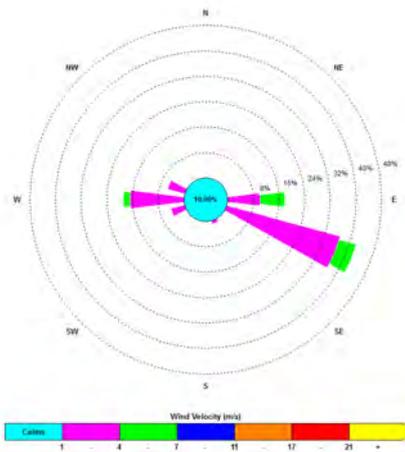
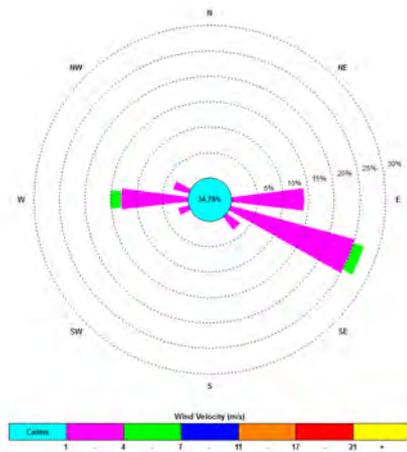
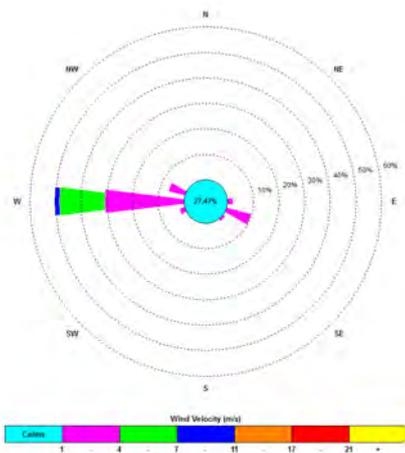
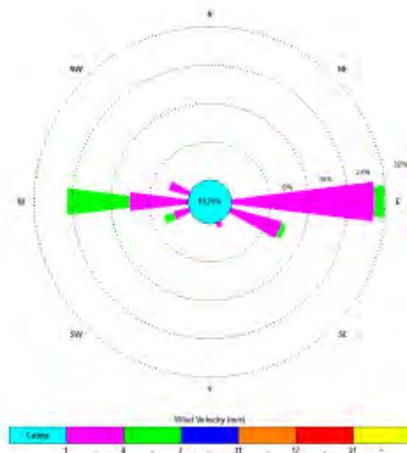
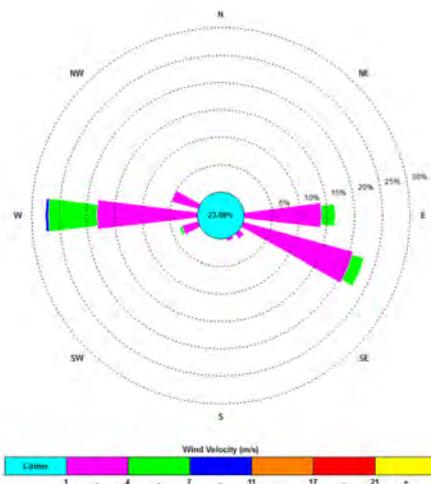
Figure 3 Seasonal and annual wind roses, 2017

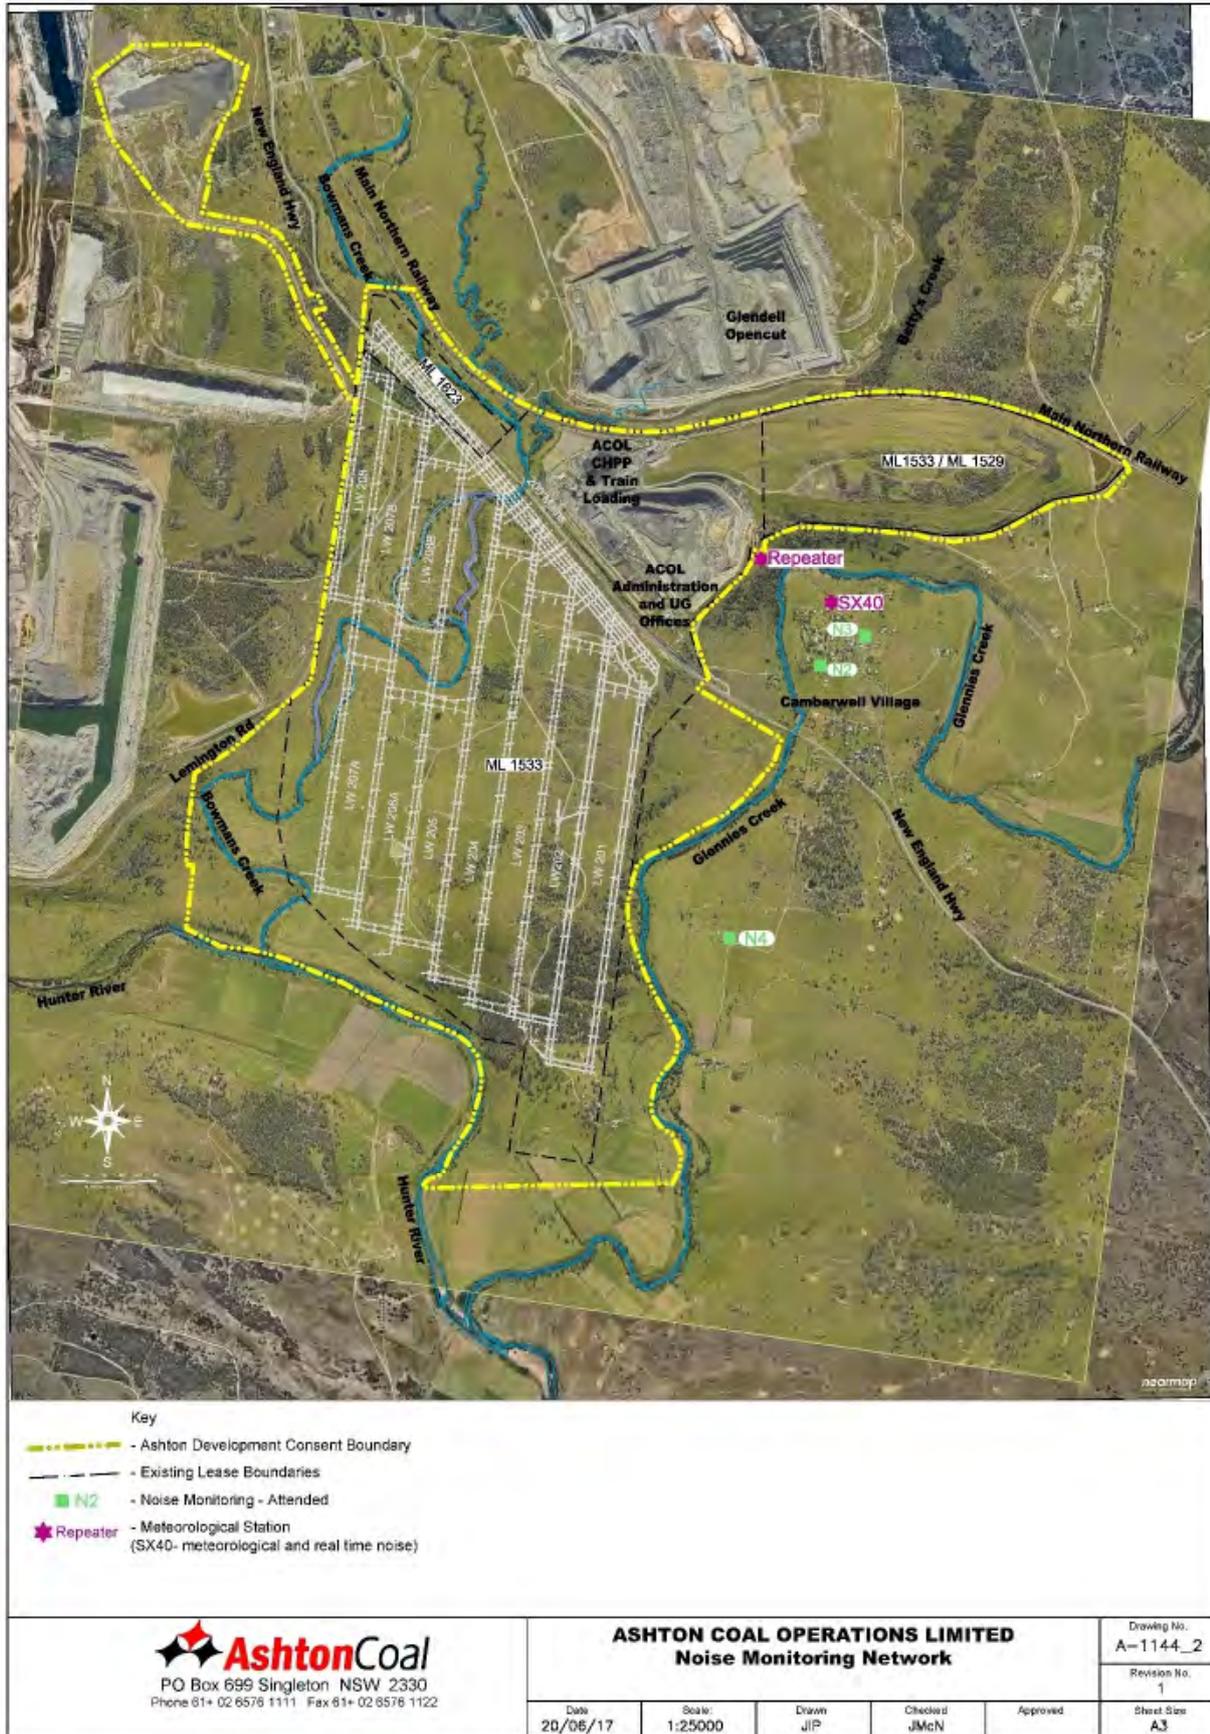
Figure 4 Meteorological and Noise Monitoring Locations

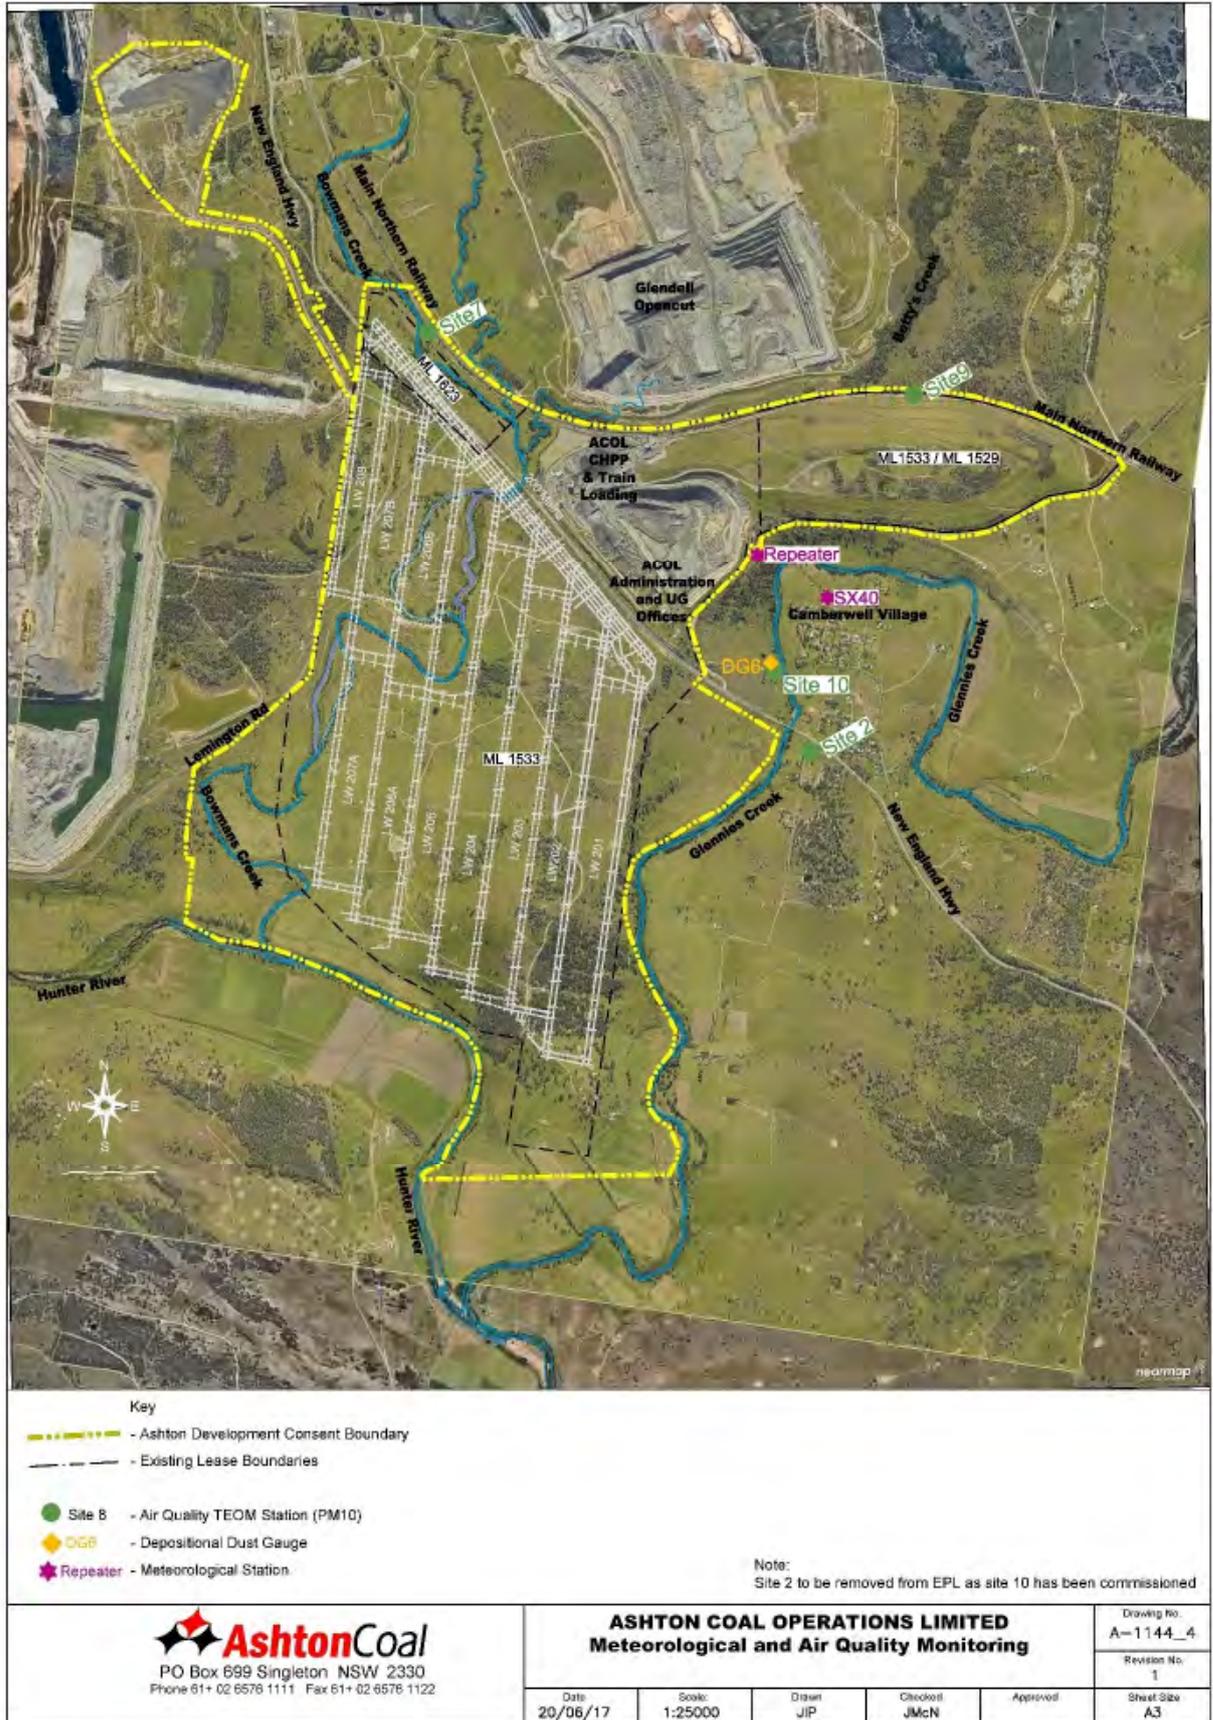
Figure 5 Location of air quality monitoring sites

The locations of air quality monitoring sites at Ashton Coal are shown in Figure 5.

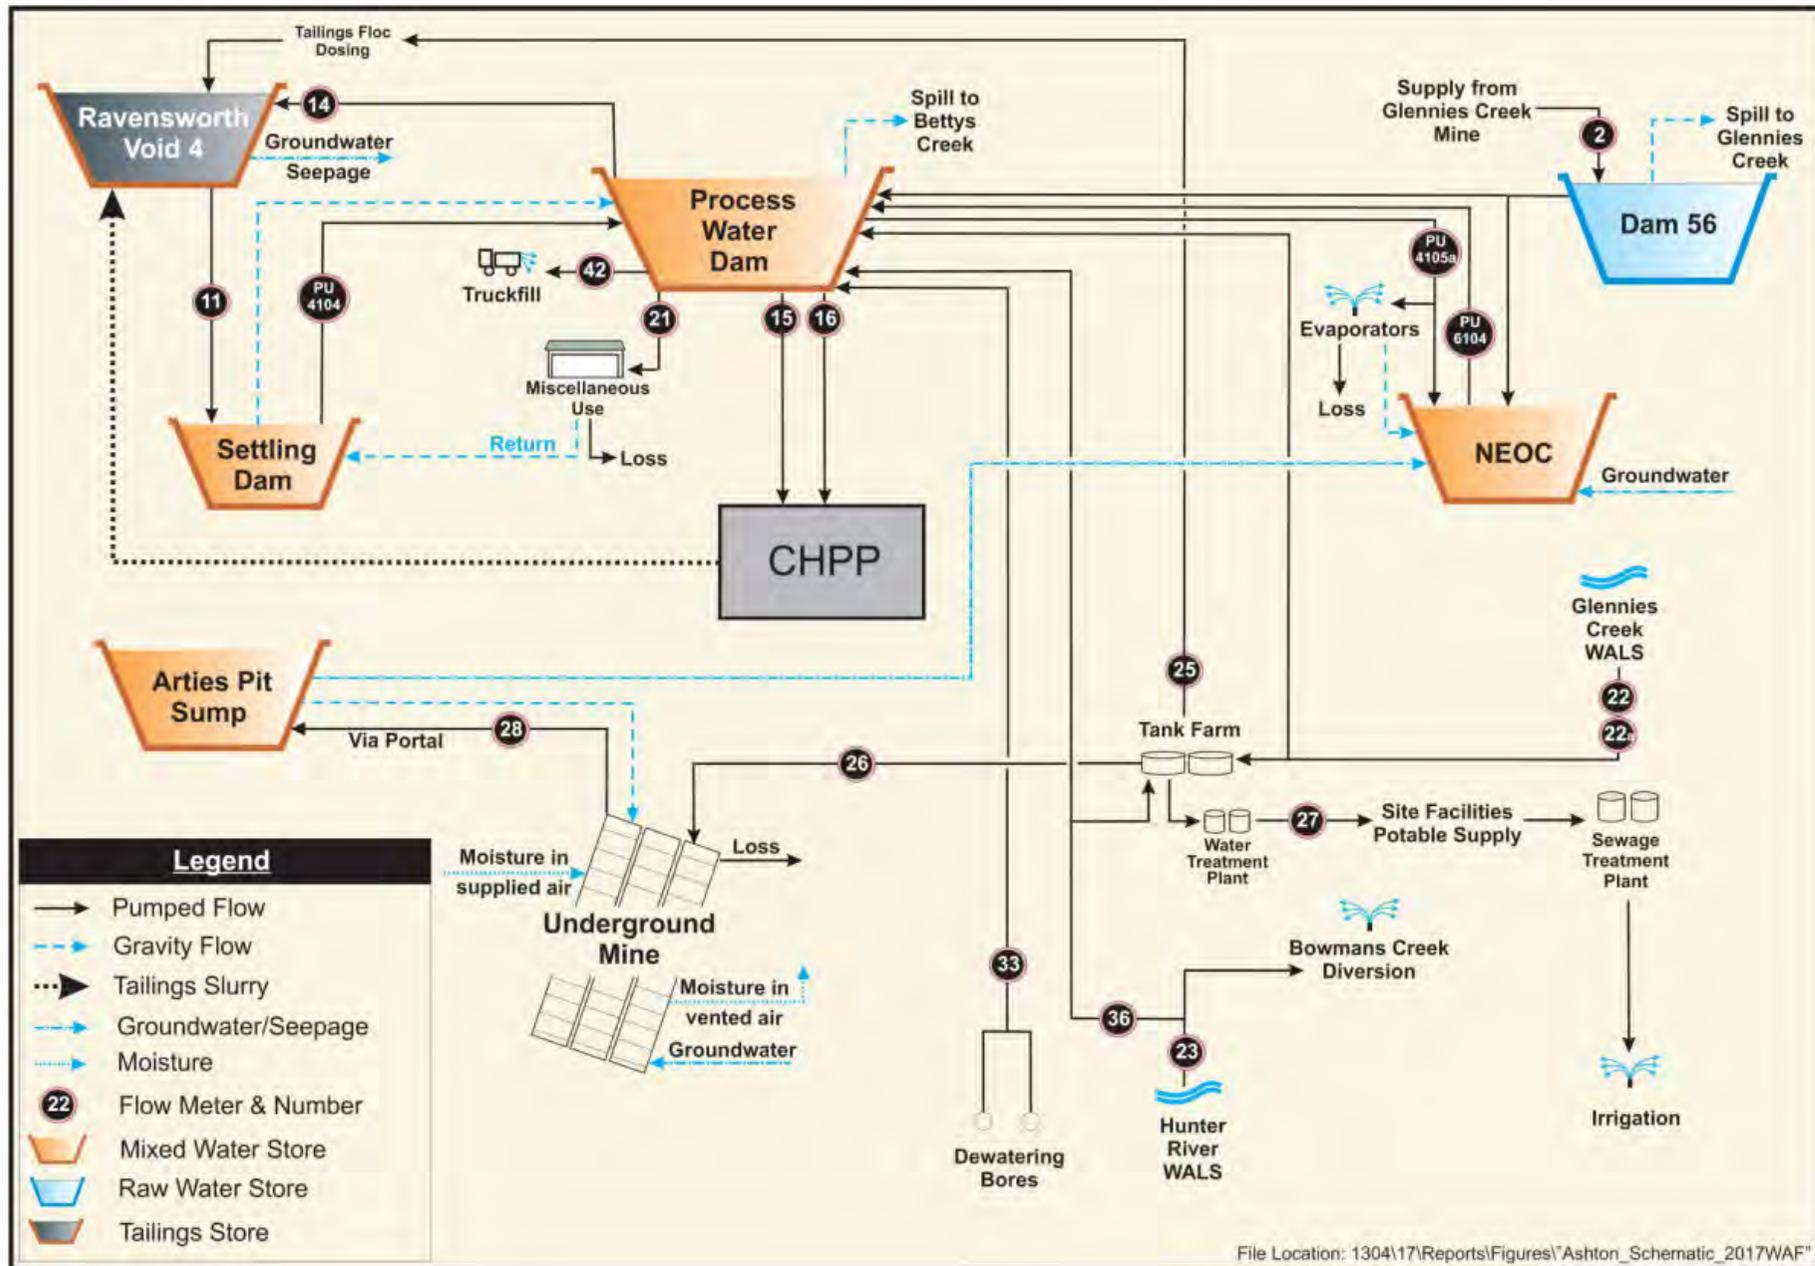
**Figure 8 Ashton Coal Water Schematic** \* All dams must have spillways constructed to ensure dam wall stability. Dams at the ACP are managed to prevent spills occurring.

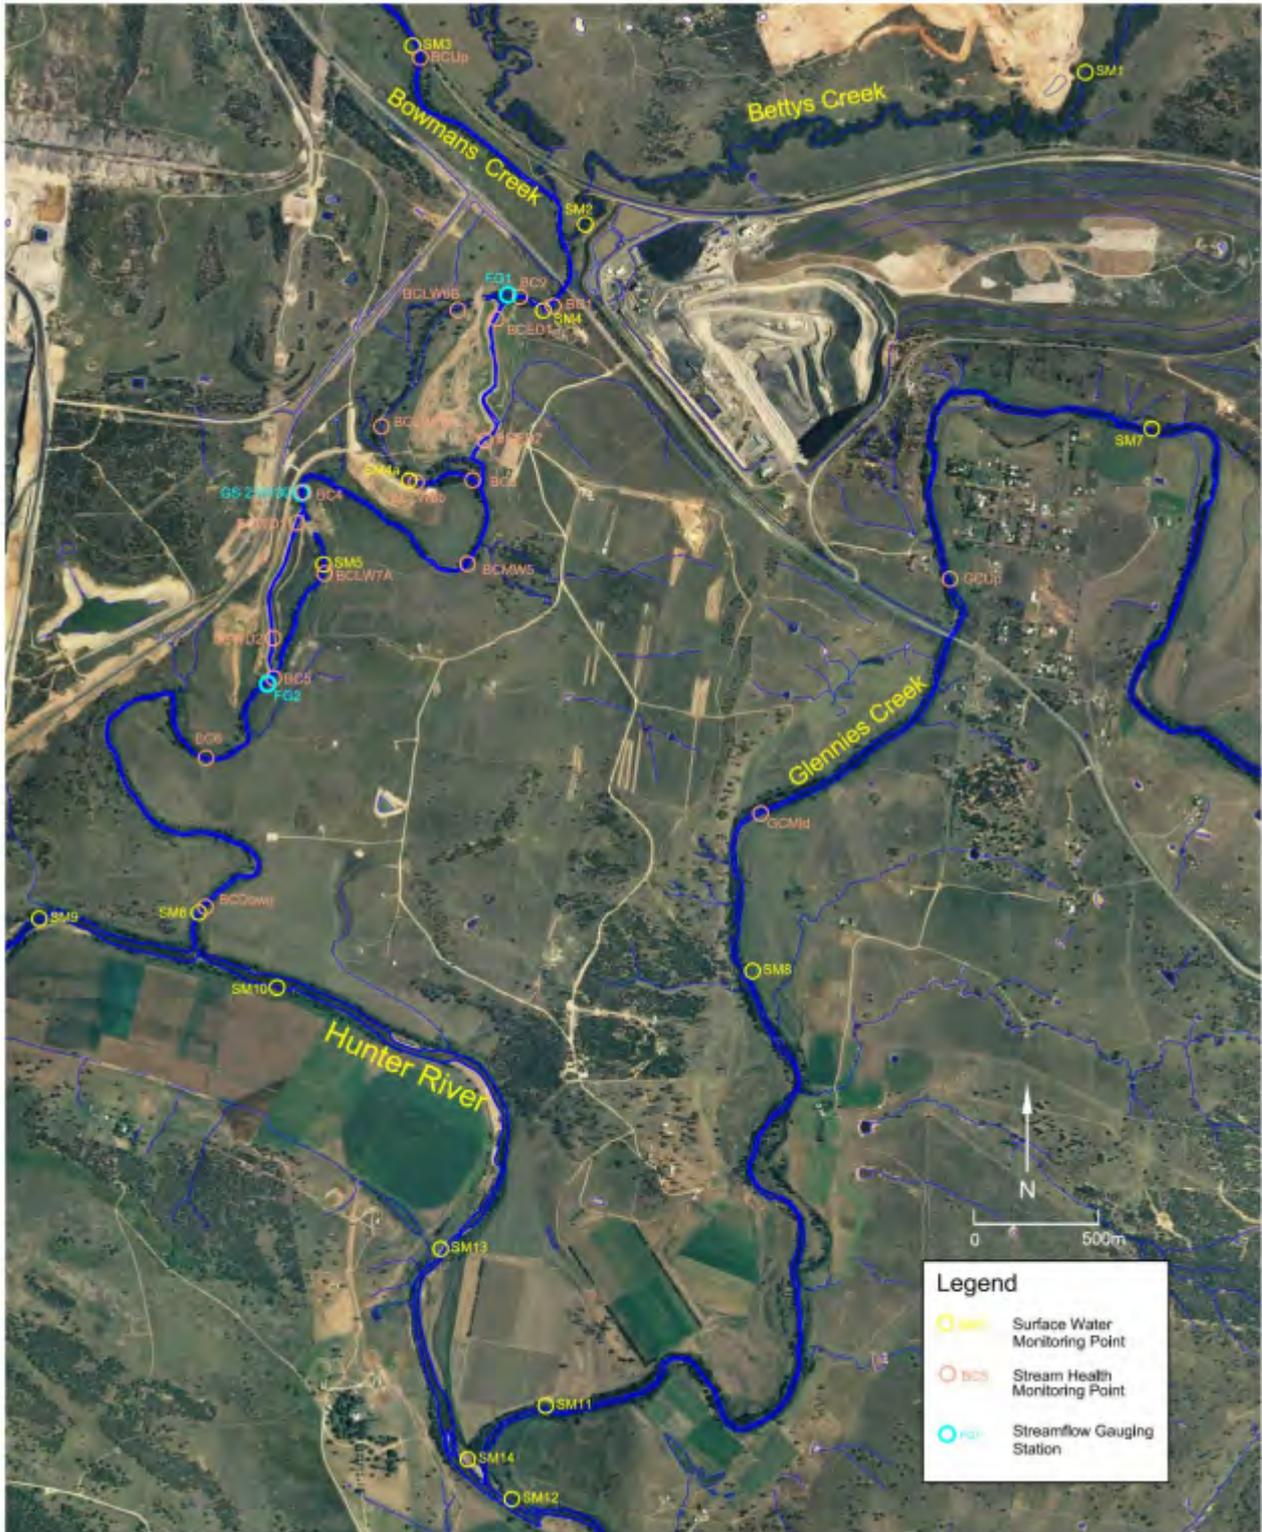
Figure 9 Ashton Coal surface water monitoring locations

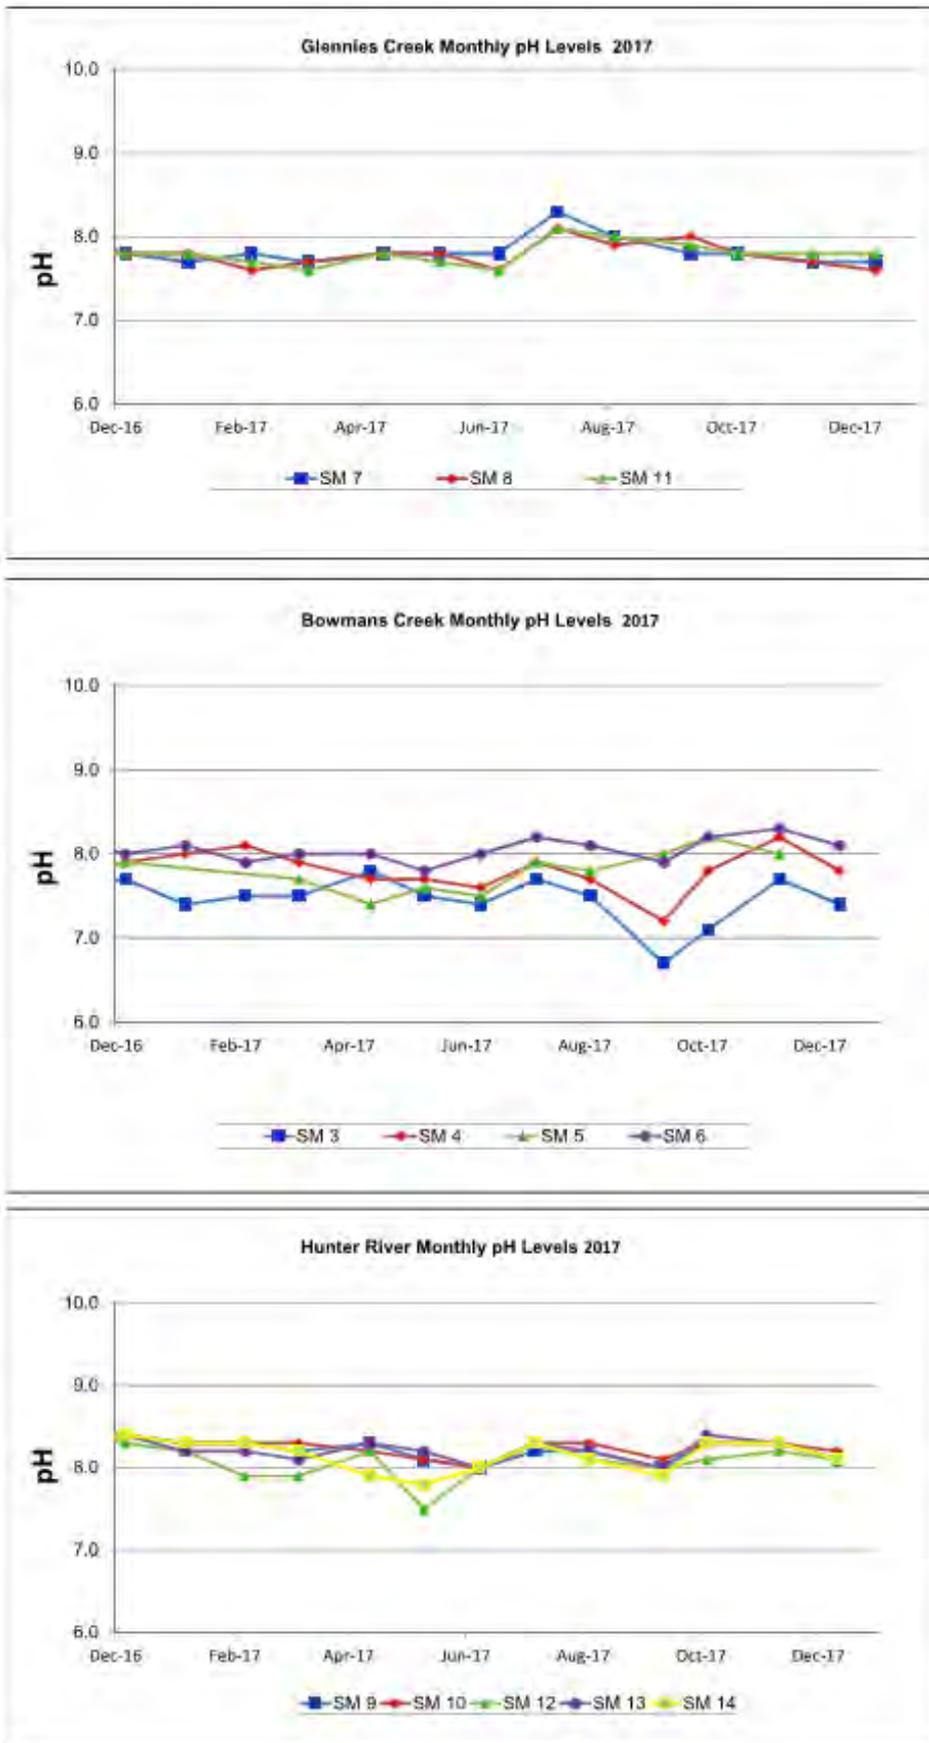
Figure 10 pH, Bowmans and Glennies Creeks and Hunter River

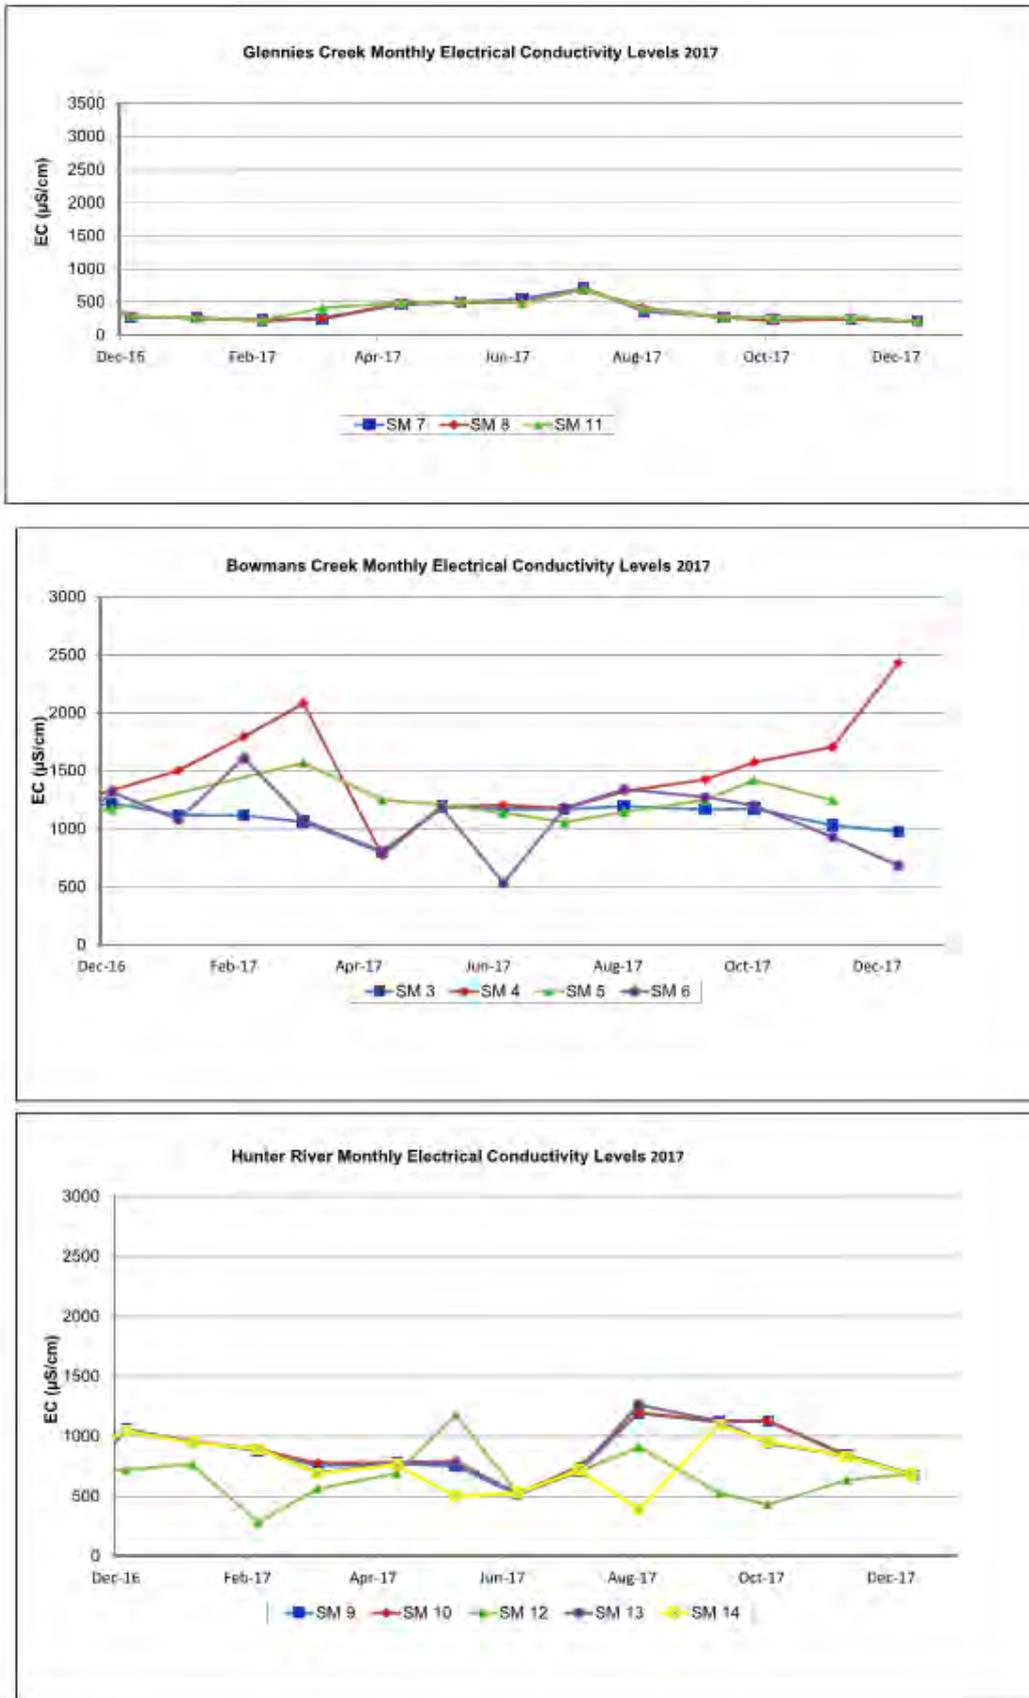
Figure 11 Electrical Conductivity, Bowmans and Glennies Creeks and Hunter River

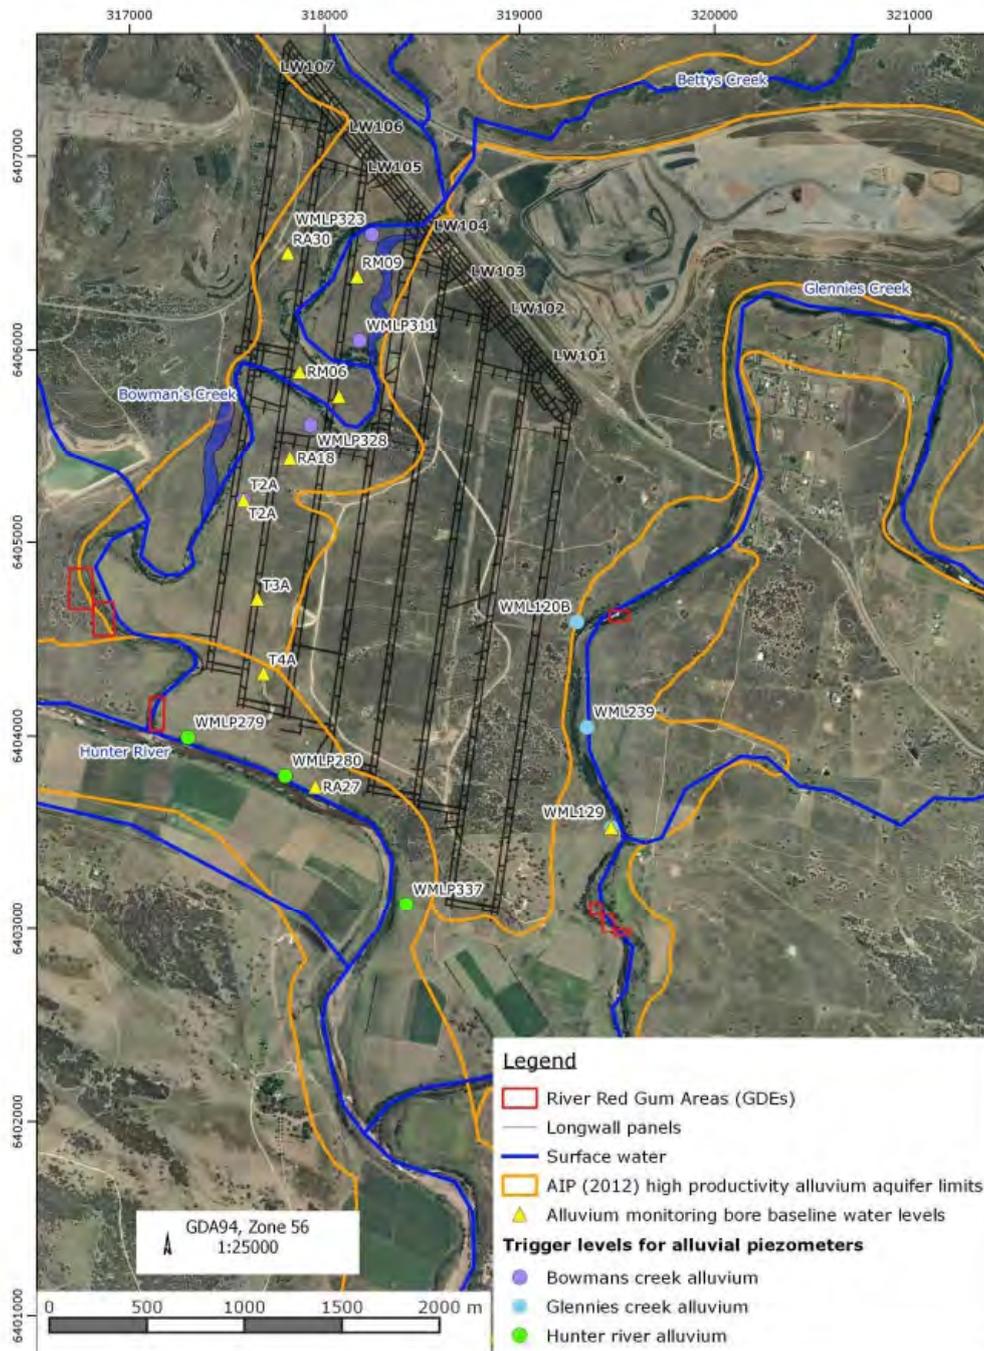
Figure 12 ACOL's groundwater trigger action response plan monitoring locations

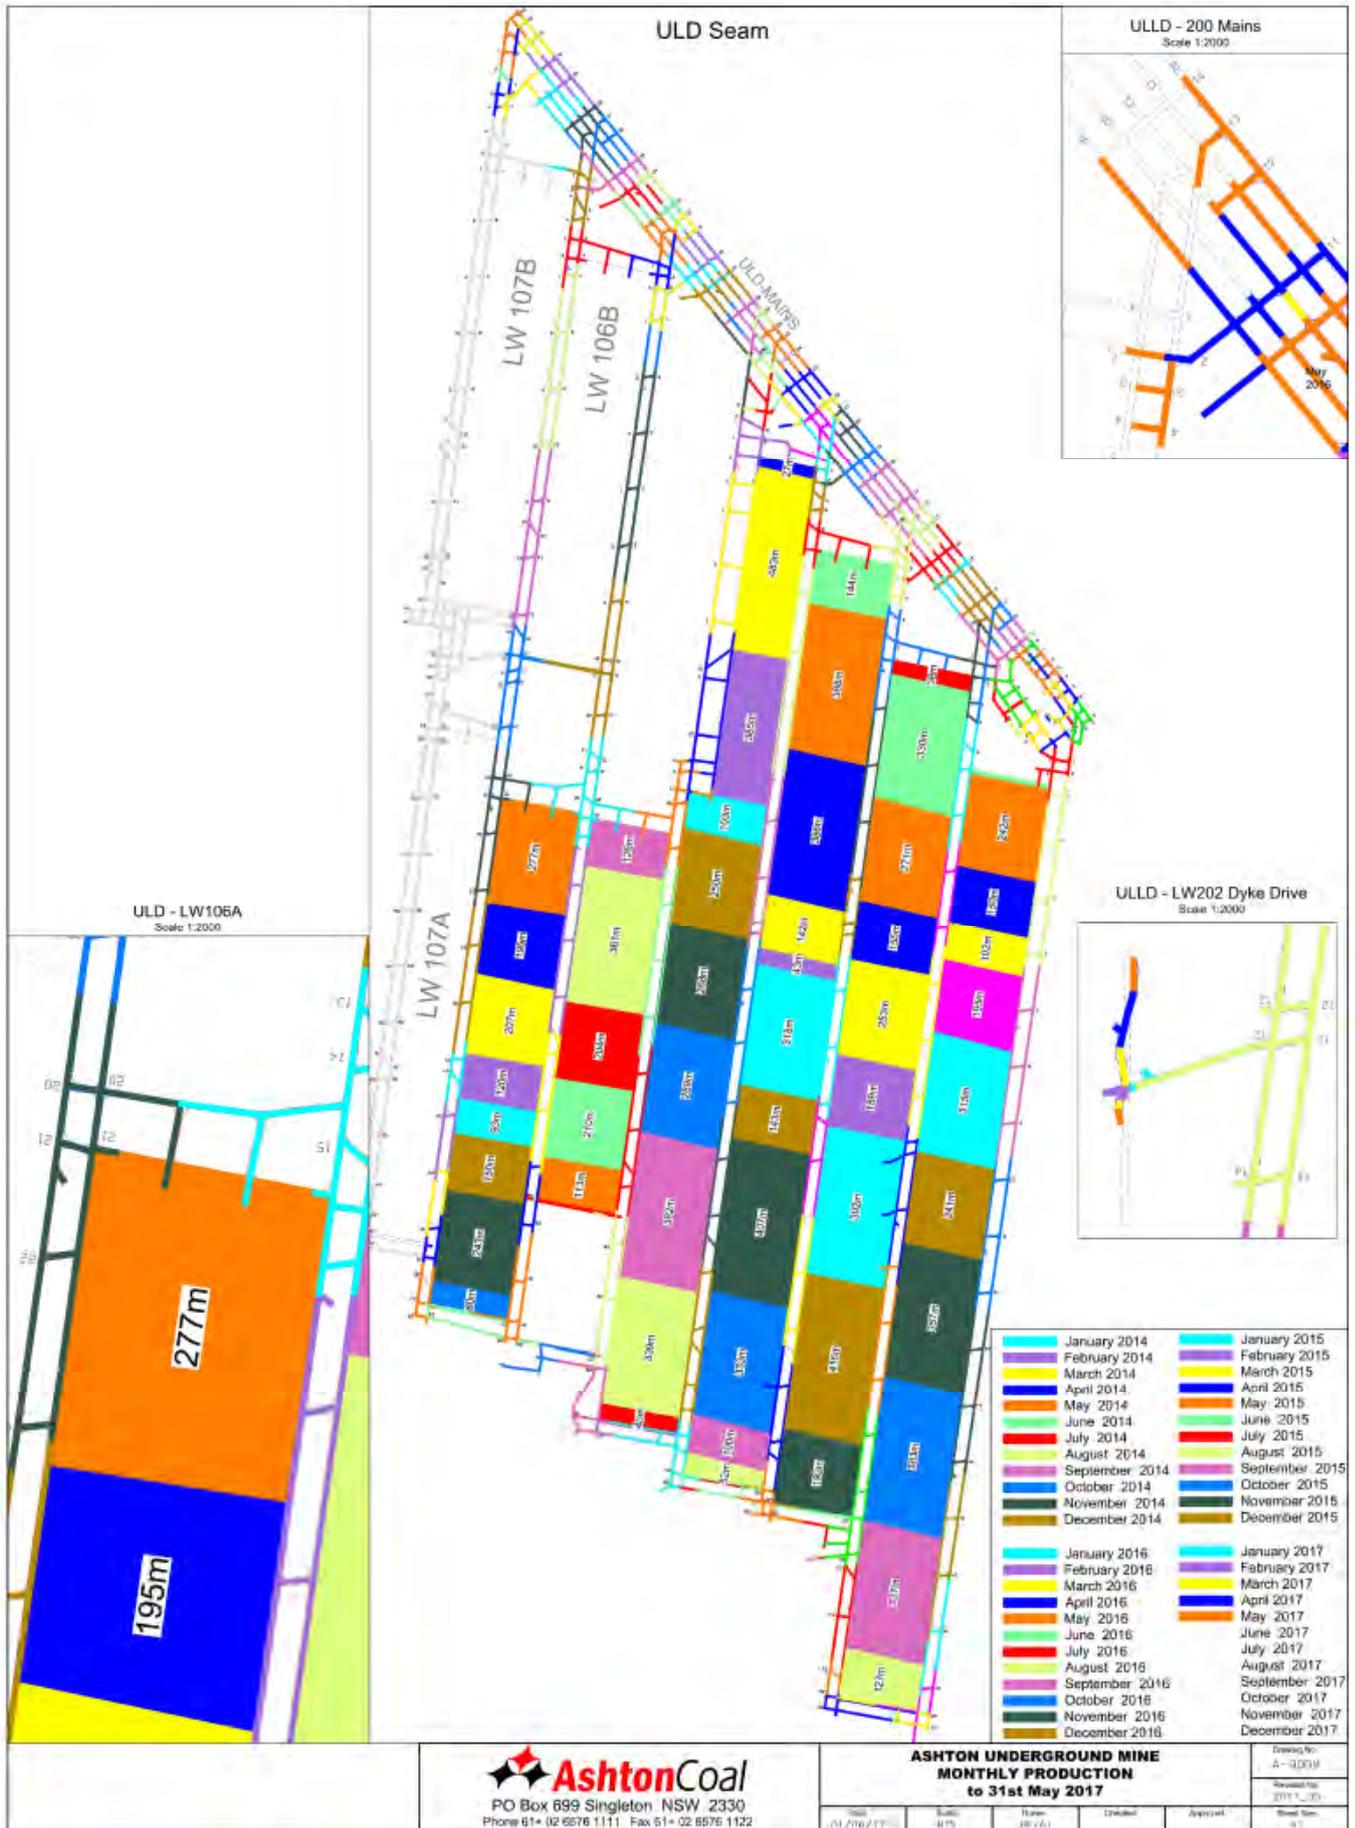
Figure 13 Production in ULD seam to May 2017

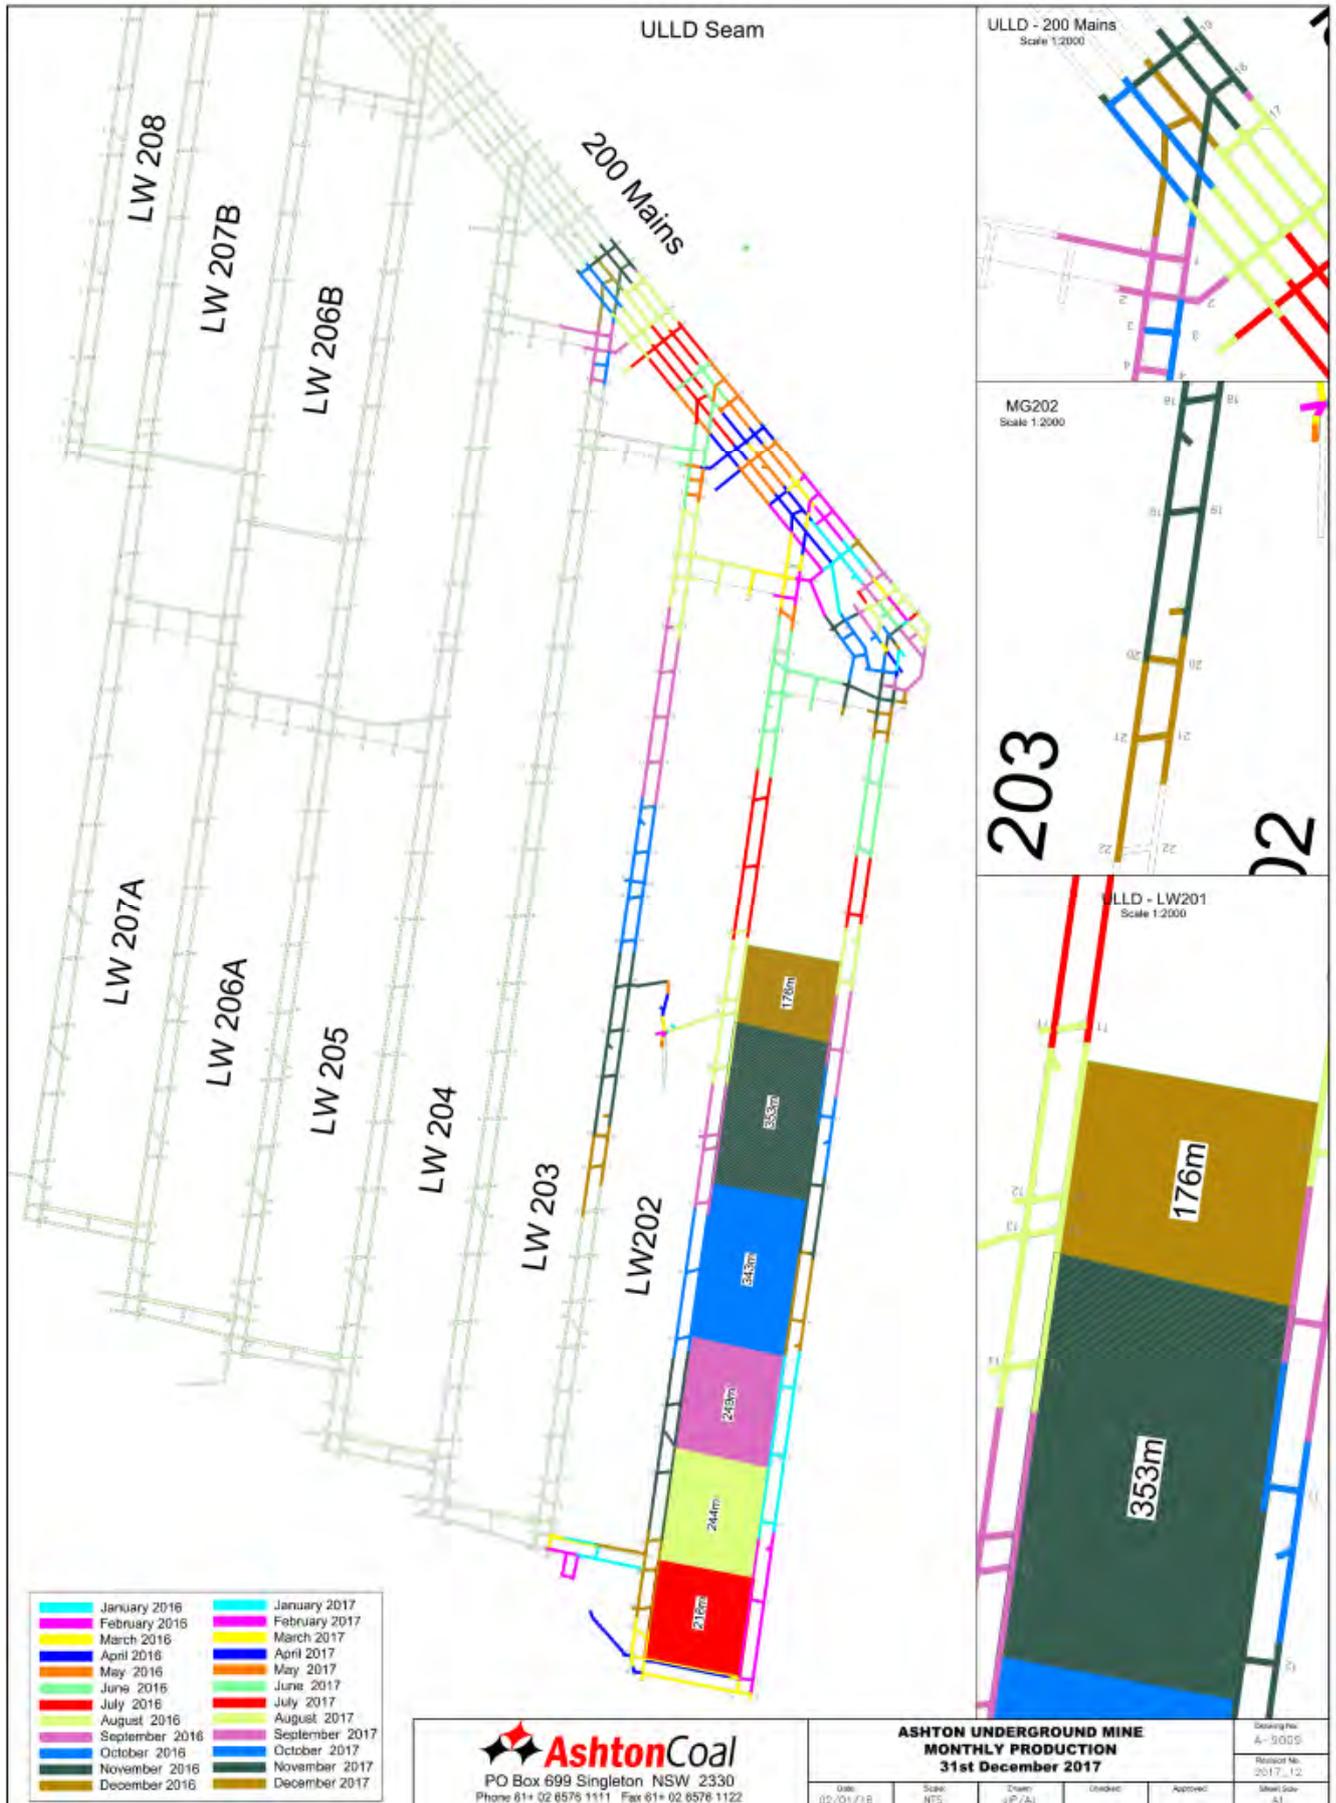
Figure 14 Production in ULLD Seam to December 2017

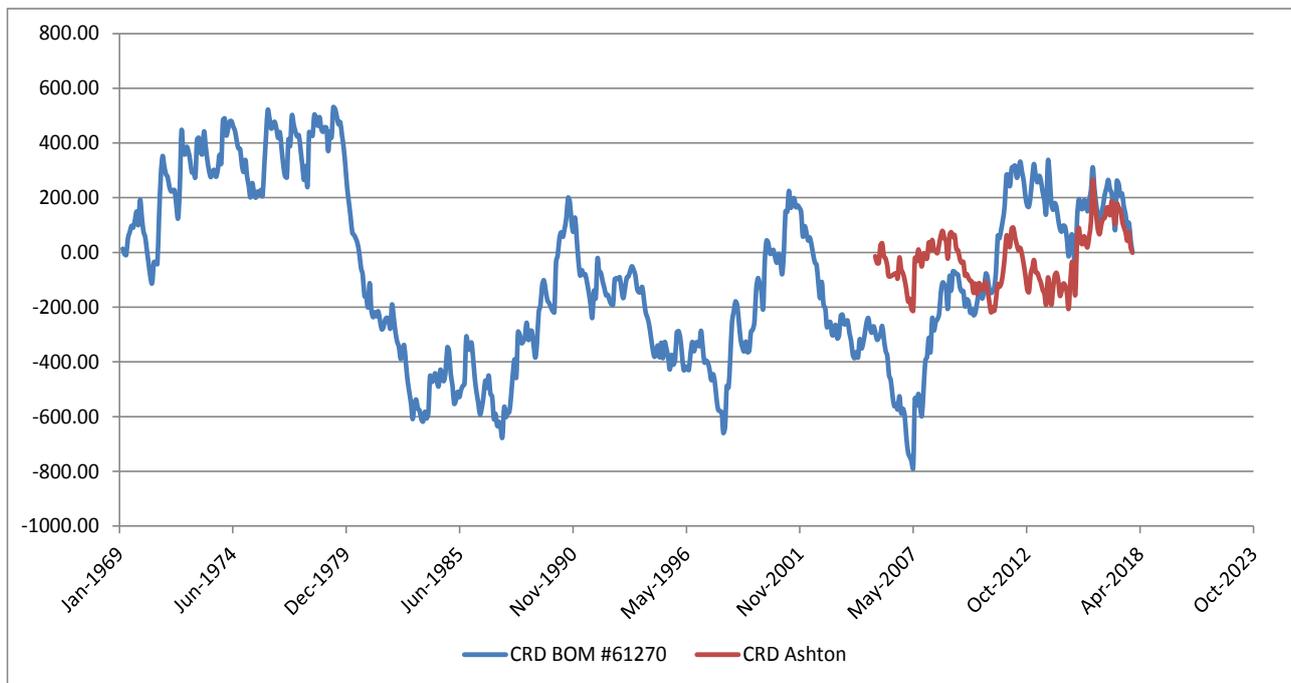
**Figure 2.1 Cumulative Rainfall Departure**

The CRD for Ashton weather station and Bowmans Creek station (#61270) are shown on Figure 2.1. CRD trends for both stations showed below average rainfall for 2017 represented by a declining CRD slope.

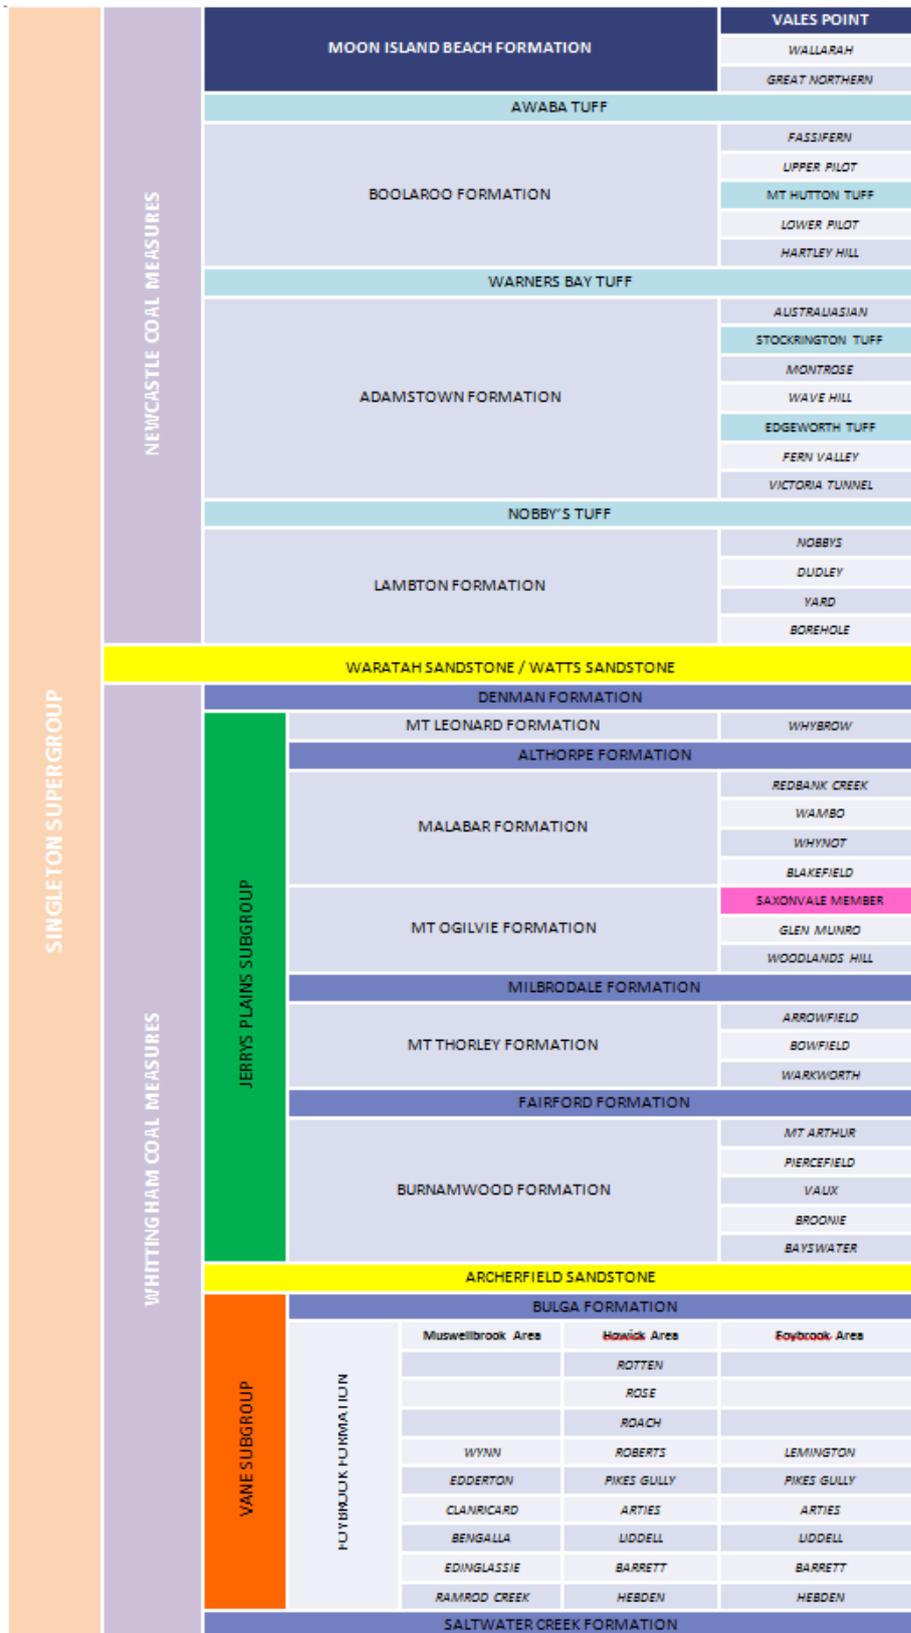
Figure 2.2 Singleton Super Group sequence stratigraphy (after AGE, 2016d)

The stratigraphic sequence in the region comprises two distinct units: Quaternary alluvium and Permian strata. The Permian strata comprise coal seams (typically 2 m to 2.5 m thick) with overburden and interburden (typically 30 m thick between successive seams) consisting of sandstone, siltstone, tuffaceous mudstone, and conglomerate. The Quaternary alluvium consists of unconsolidated silt, sand and gravel in the alluvial floodplains of the Hunter River (HR), Bowmans Creek (BC) and Glennies Creek (GC). The alluvium unconformably overlies the Permian within the floodplains of the HR, BC and GC. Elsewhere, the Permian is overlain by a regolith comprising colluvium, eluvium and completely weathered rock, which interfaces with the floodplain alluvium at the flanks of the valleys.
