Ashton Coal  
2017 Annual Review

Figure 1 Overview of operations

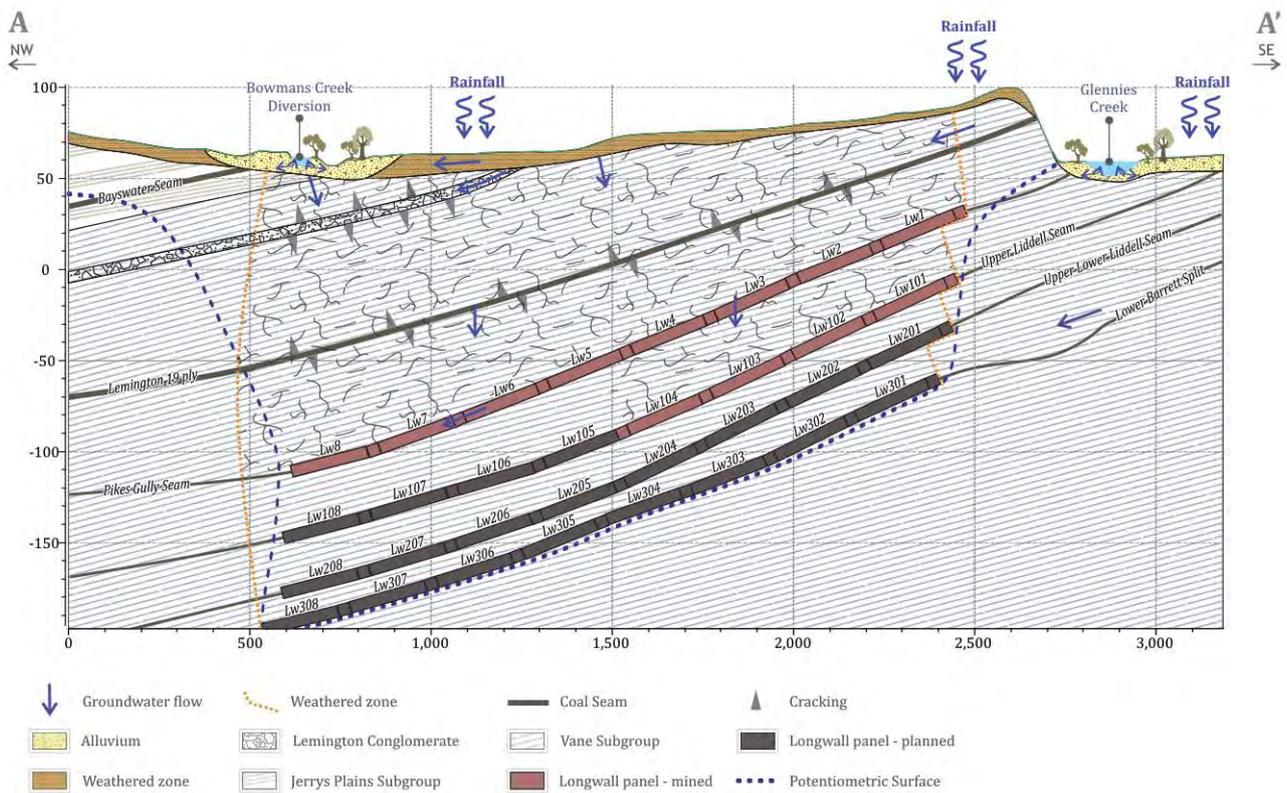
**Figure 2.3 Conceptual hydrogeology - north-west to south-east - not to scale (AGE 2016)**

The presence of subsidence cracking over parts of the underground mine increases the potential connectivity of the mine with the water within the creeks and associated alluvium. Planned LW panels within the underlying ULD, ULLD and LB seams may allow for reactivation of subsidence and subsidence related fracturing within these areas (AGE, 2016). Figure 2.3 shows the conceptual hydrogeology after AGE (2016c).

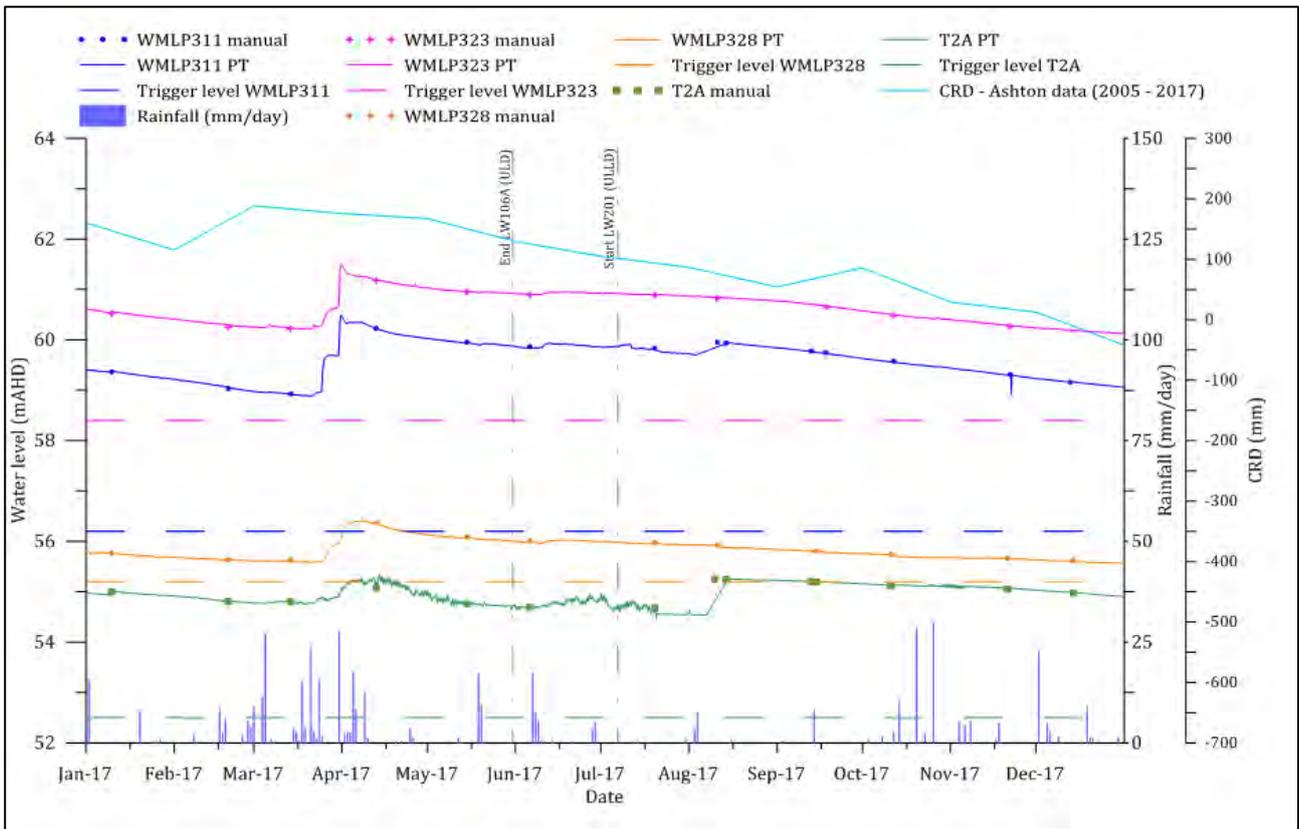
**Figure 4.1 Bowmans Creek alluvium trigger bores hydrograph**

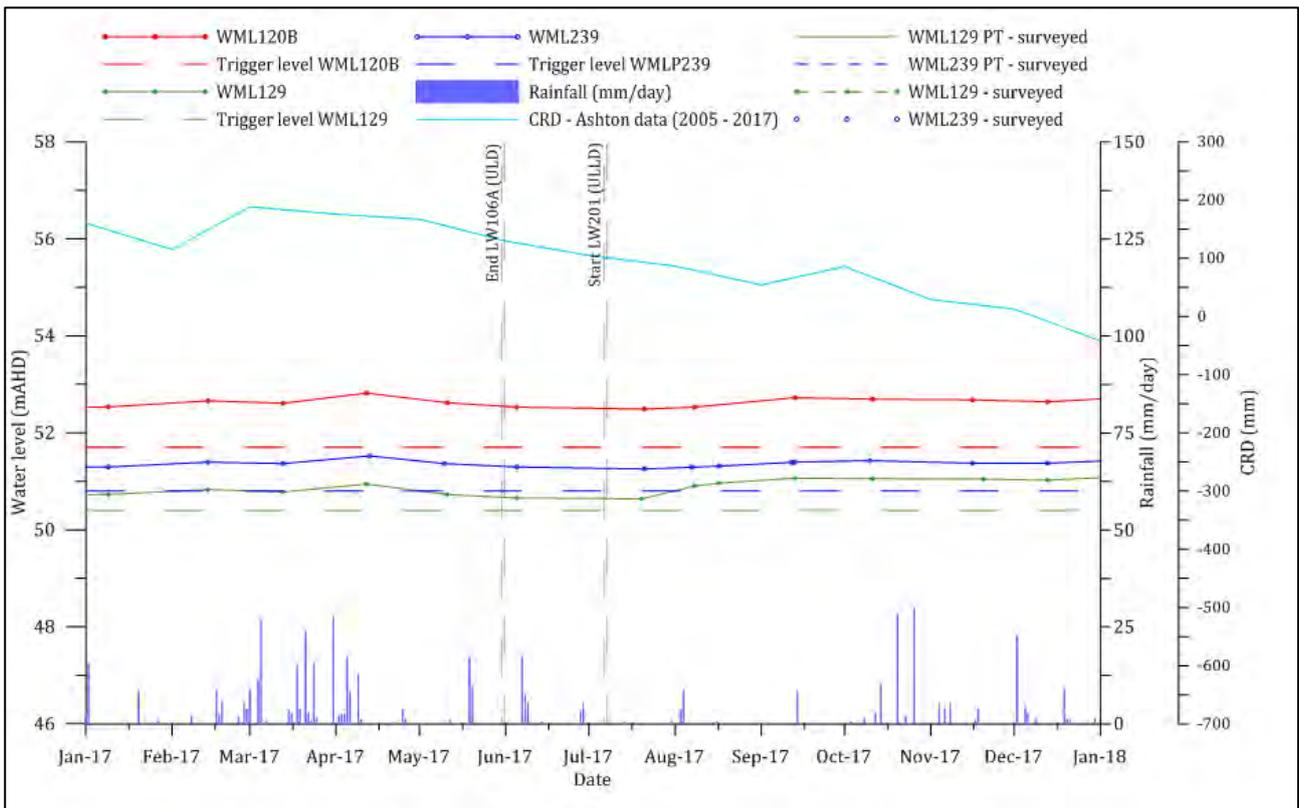
**Figure 4.2 Glennies Creek alluvium trigger bores hydrograph**

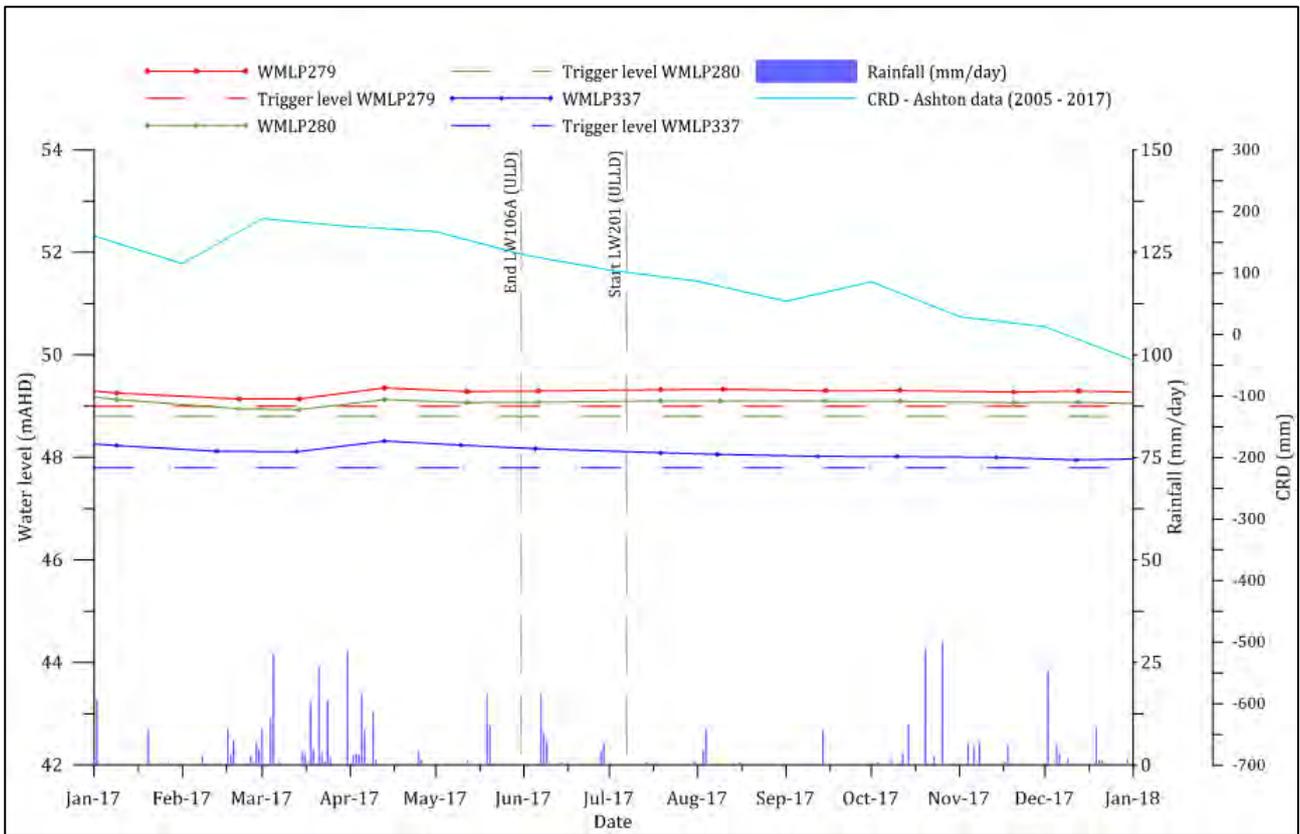
**Figure 4.3 Hunter River alluvium trigger bores hydrograph**

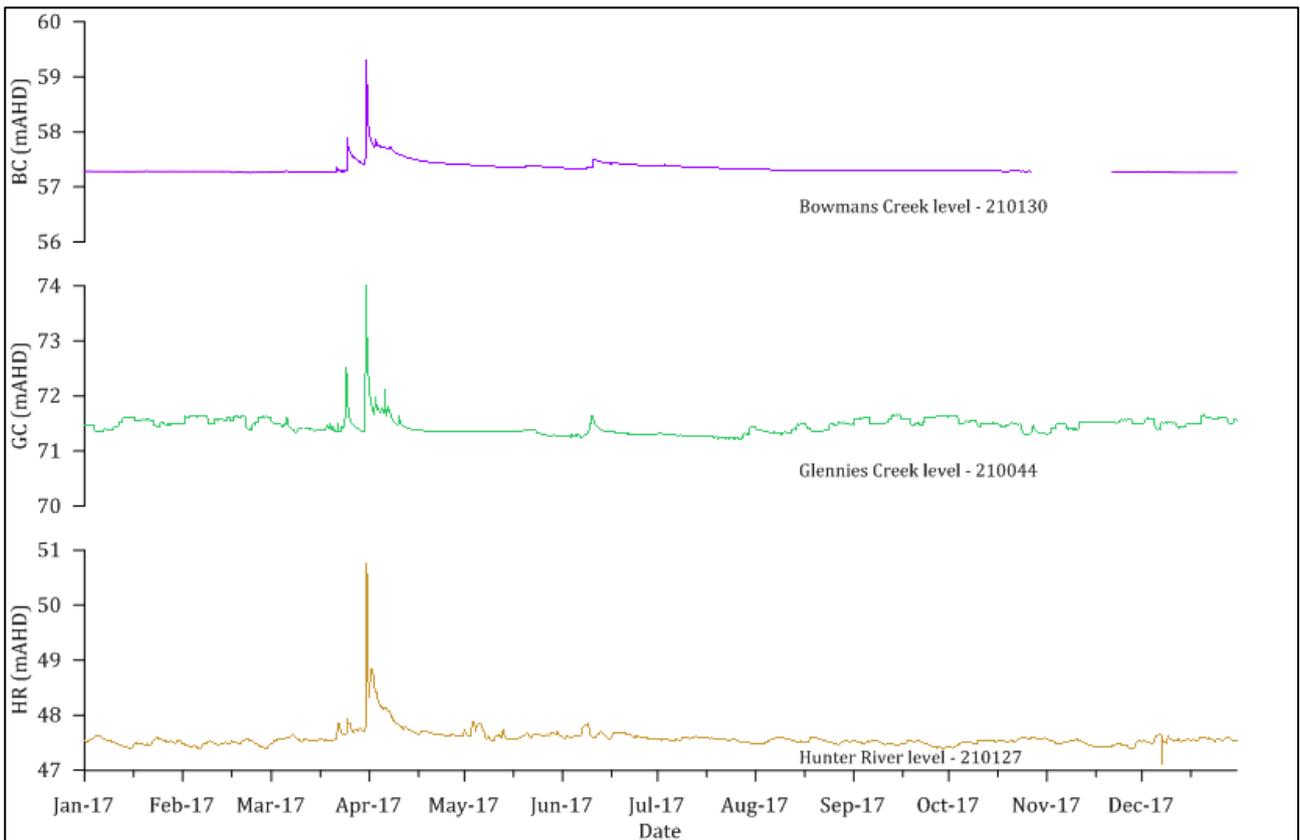
**Figure 4.4 River / creek water level trends**

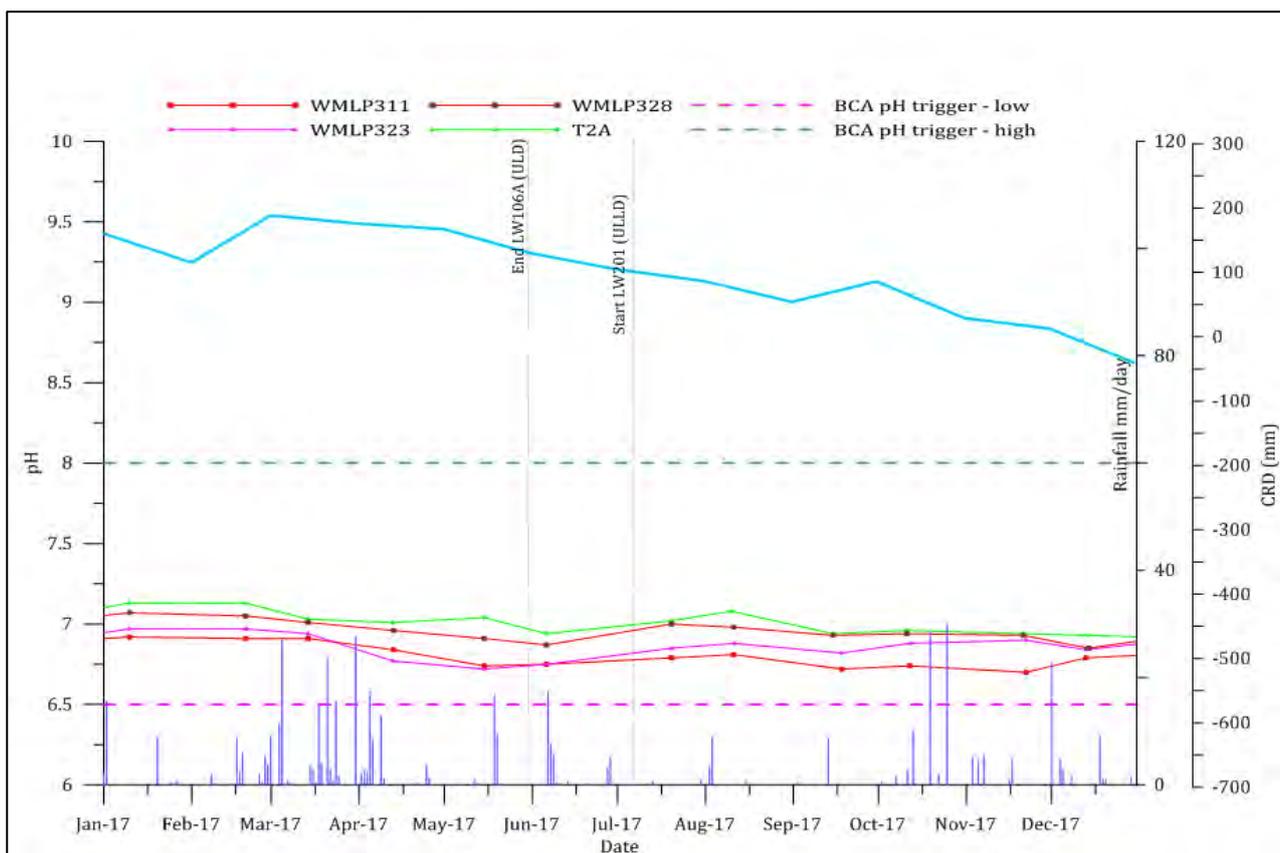
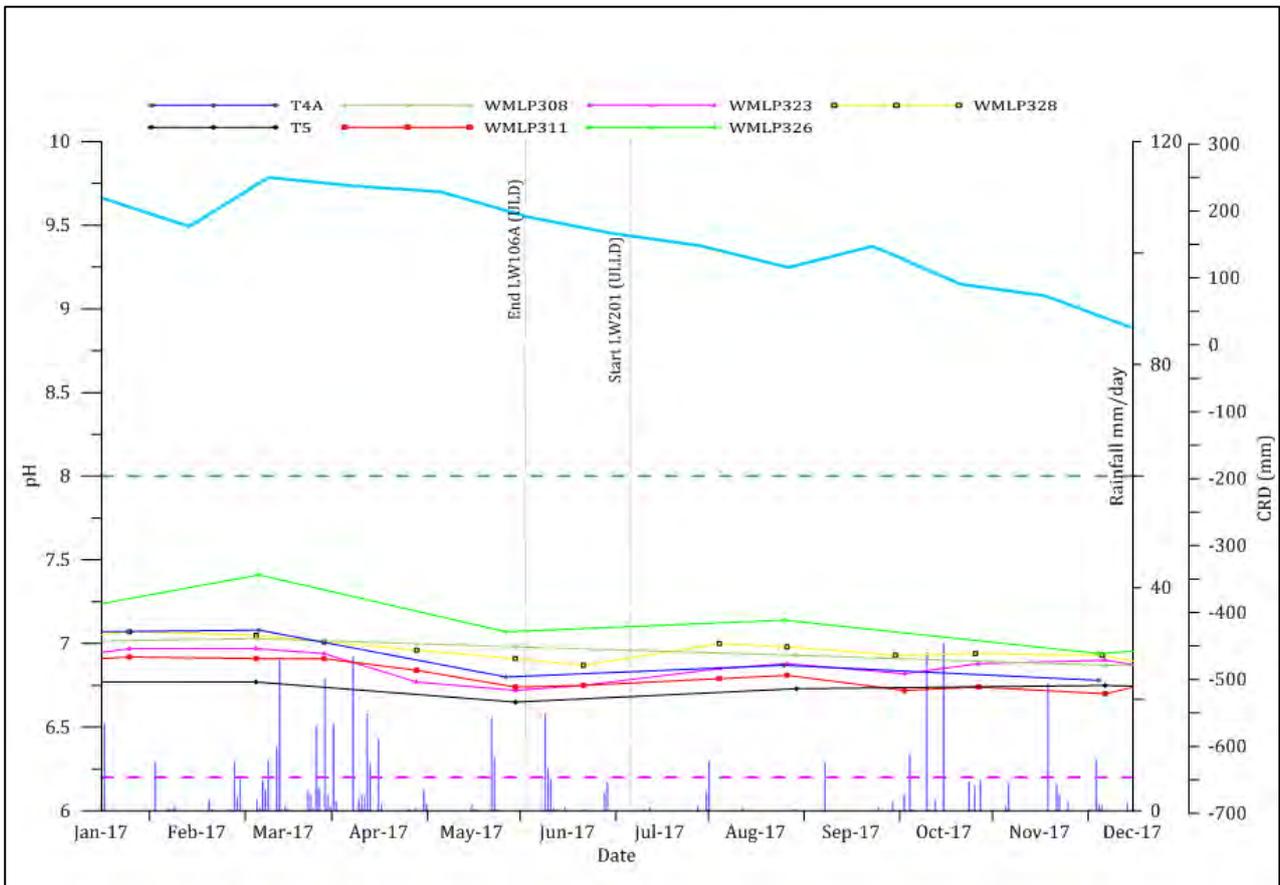
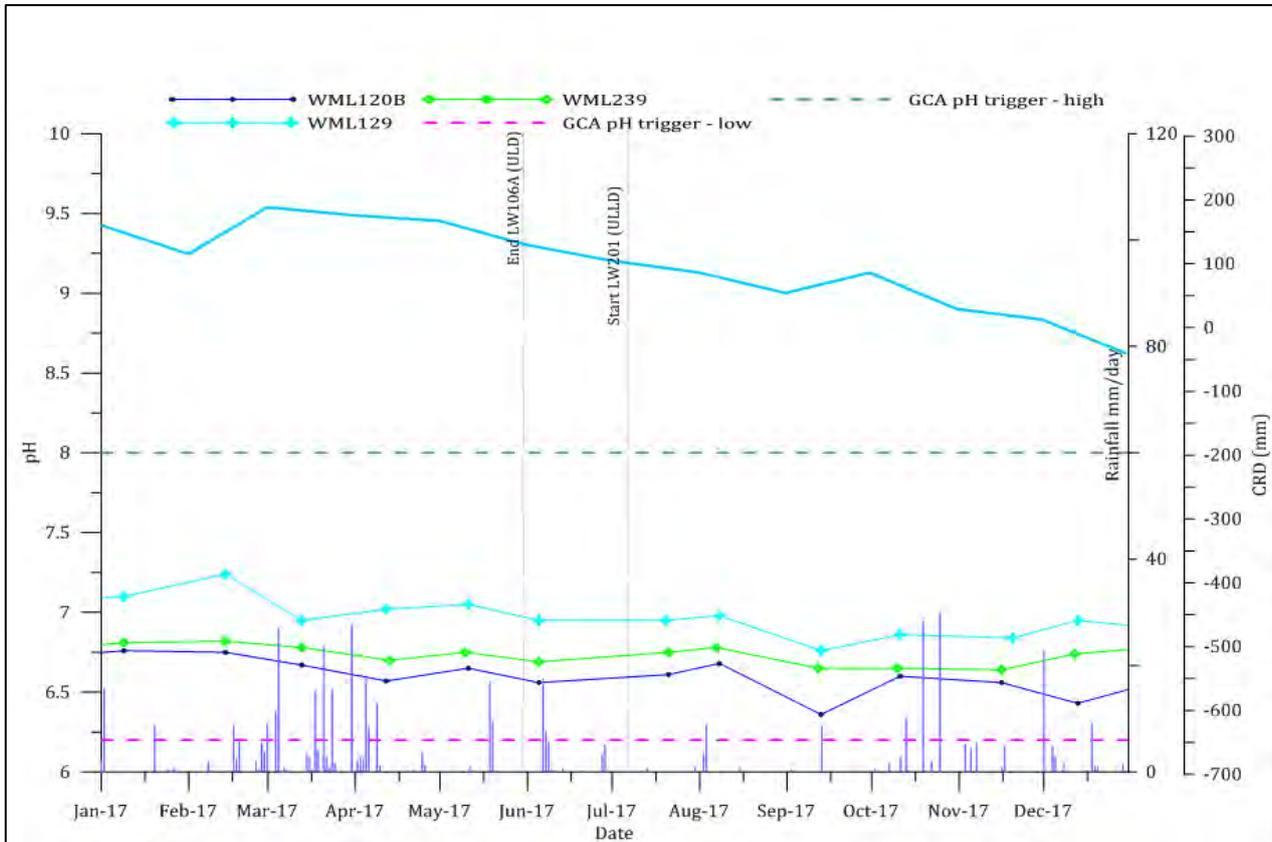
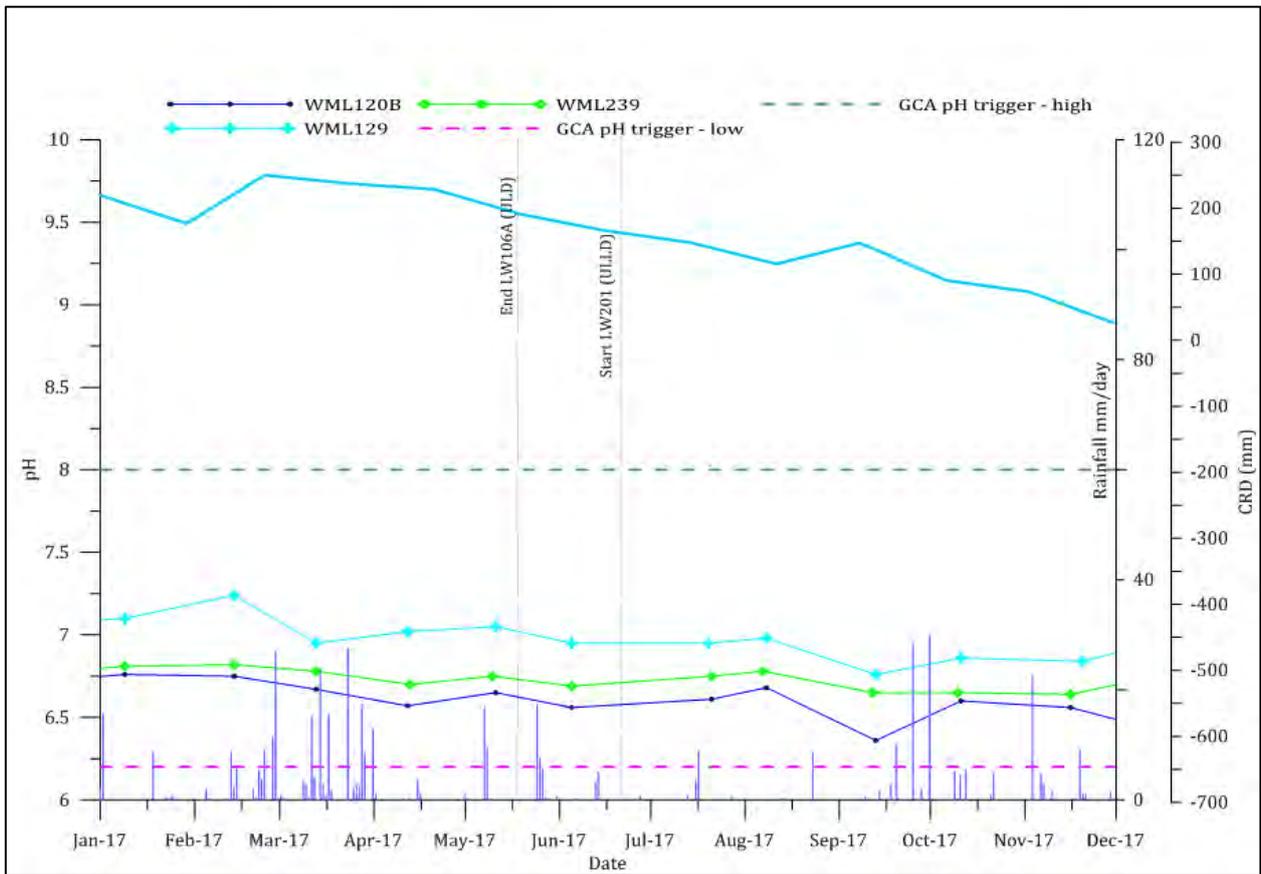
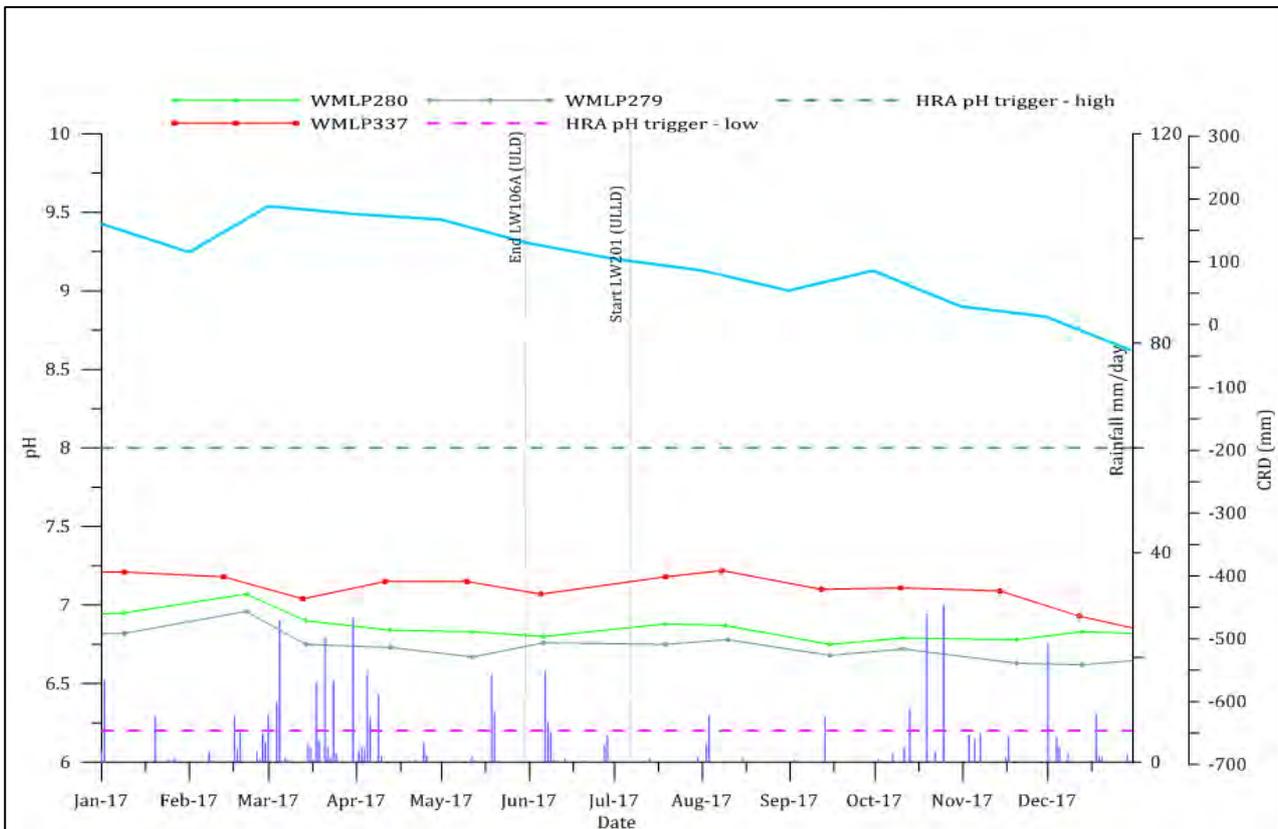
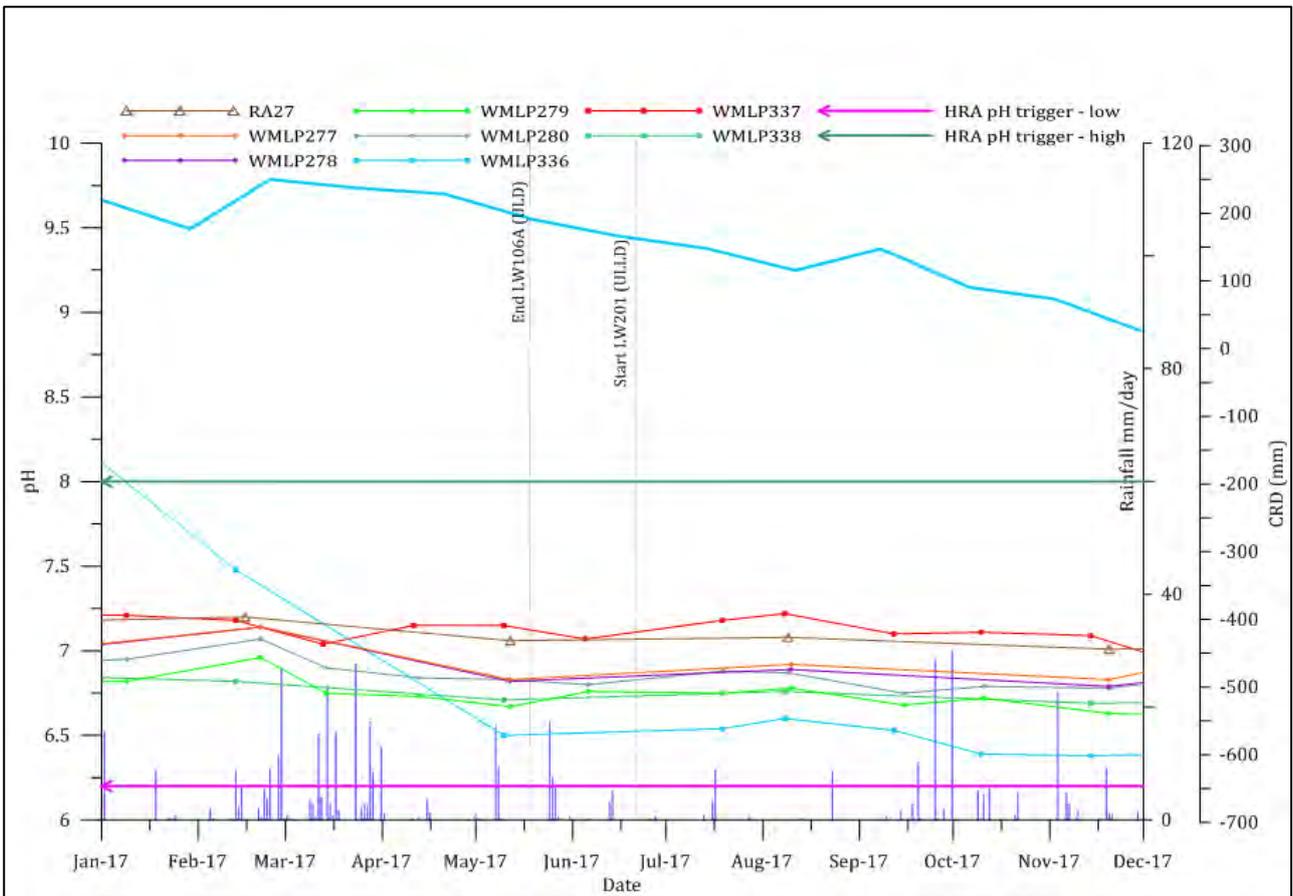
**Figure 4.5 Bowmans Creek alluvium pH trends (water level compliance bores)**

**Figure 4.6 Bowmans Creek alluvium pH trends (other bores)**

**Figure 4.7 Glennies Creek pH trends (water level compliance bores)**

**Figure 4.8** Glenties Creek alluvium pH trends (other bores)

**Figure 4.9** Hunter River alluvium pH trends (water level compliance bores)

**Figure 4.10 Hunter River alluvium pH trends (other bores)**

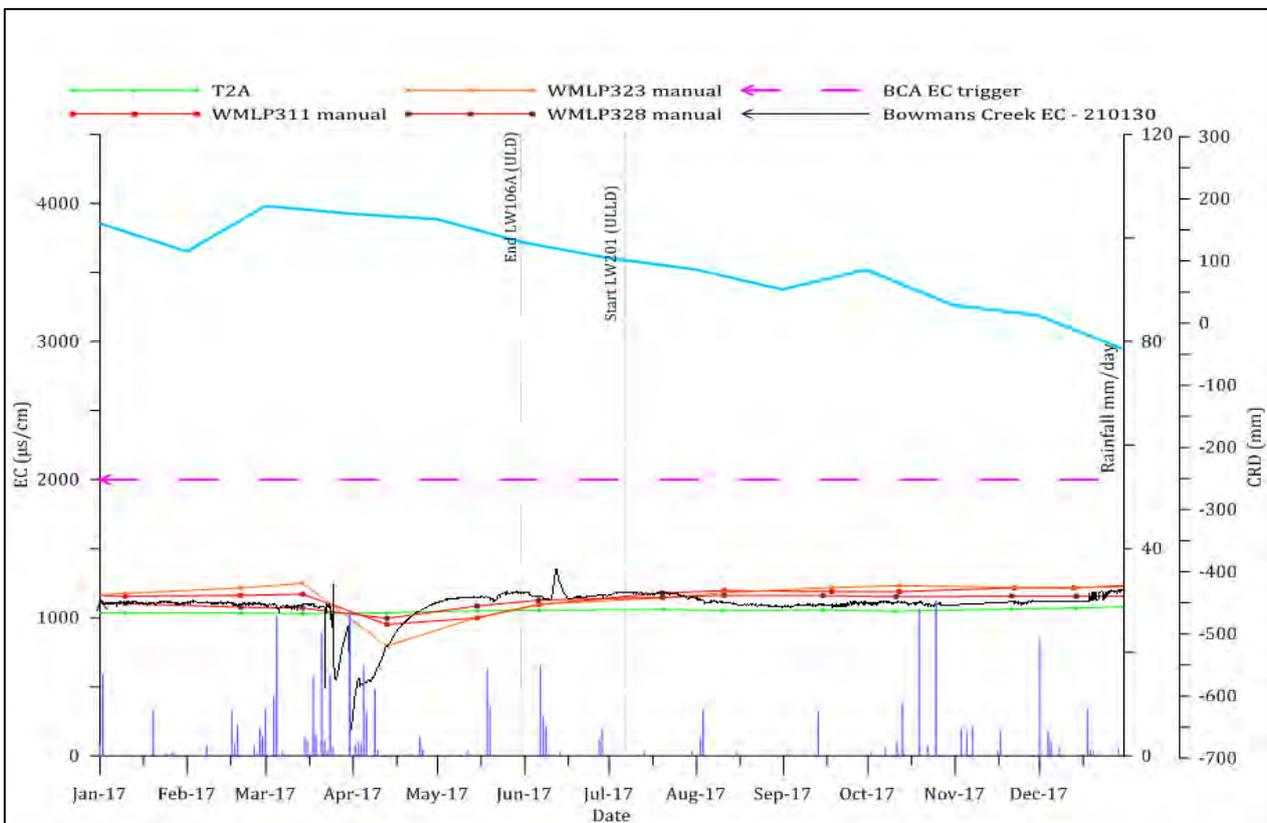
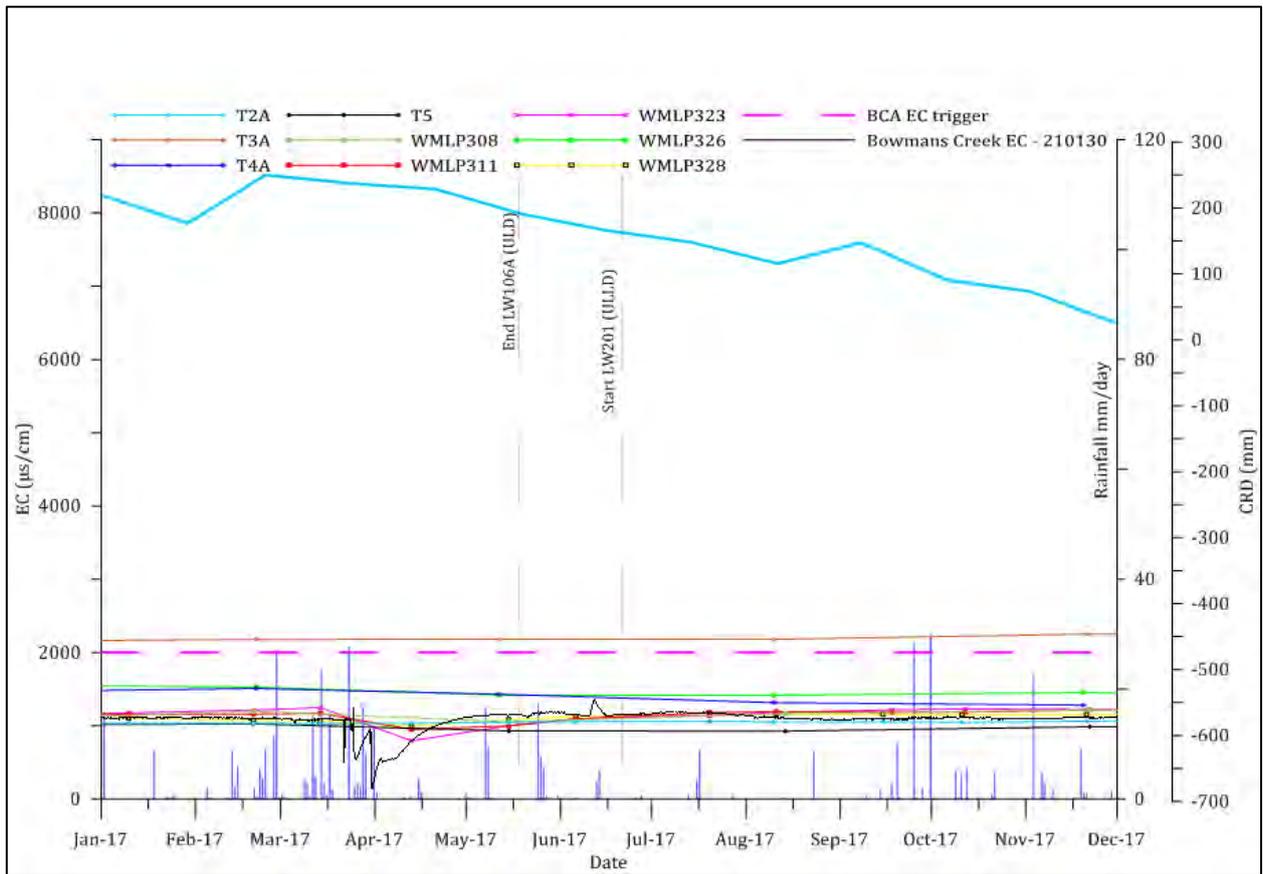
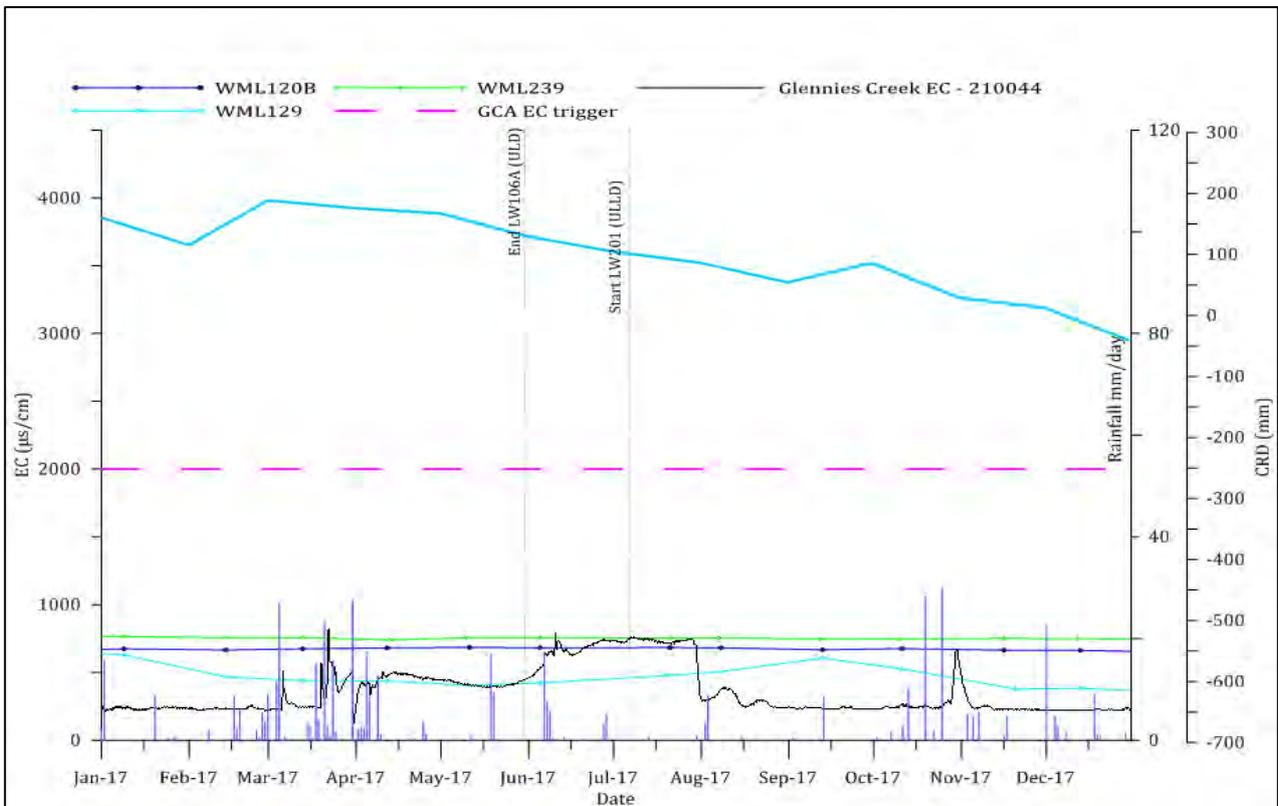
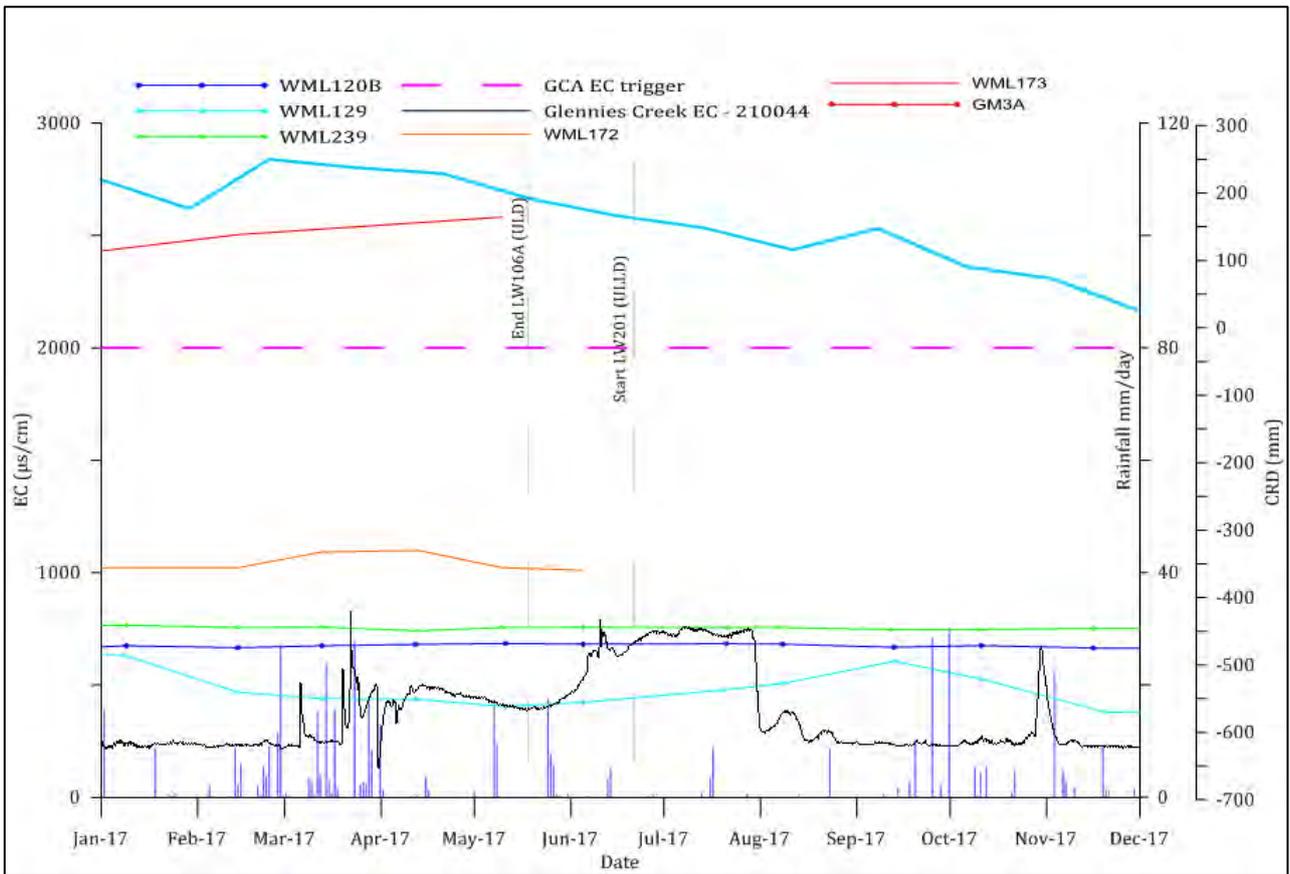
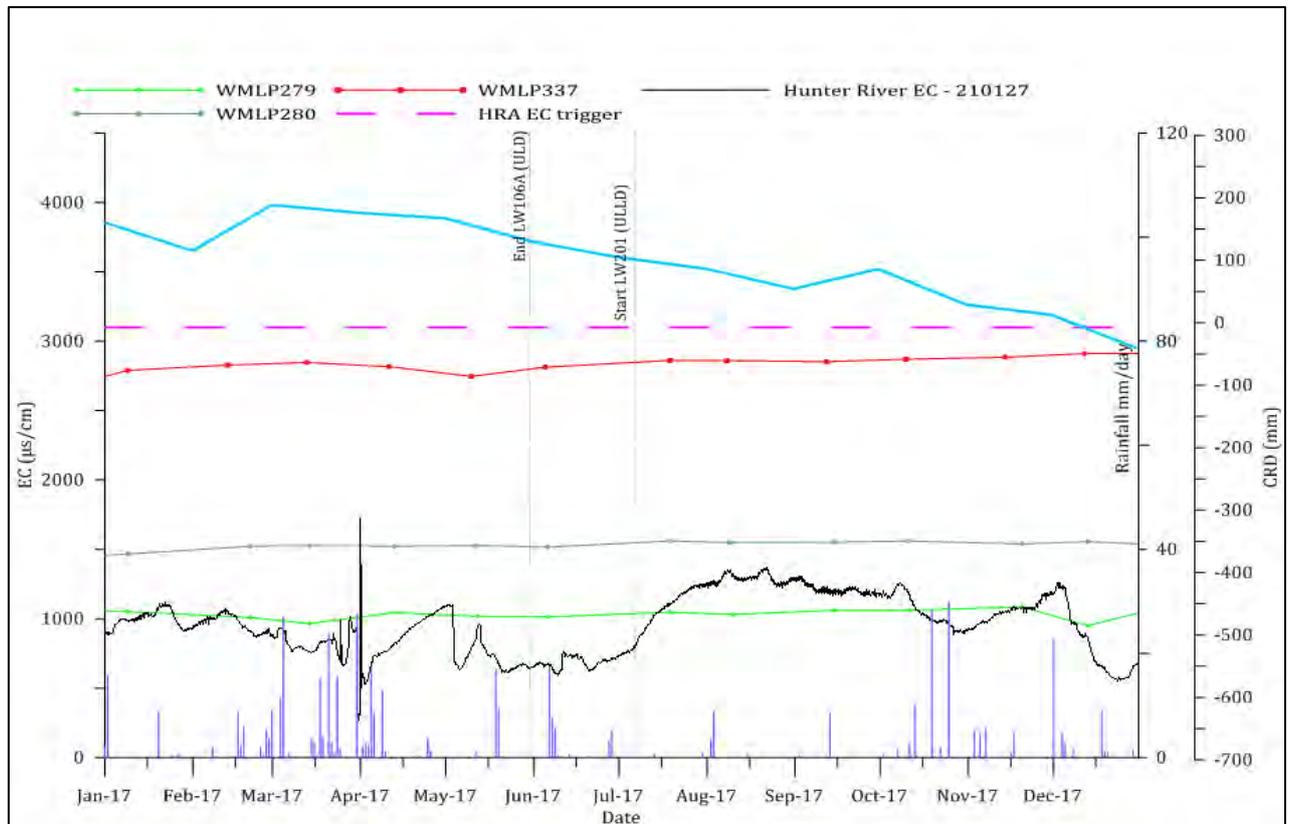
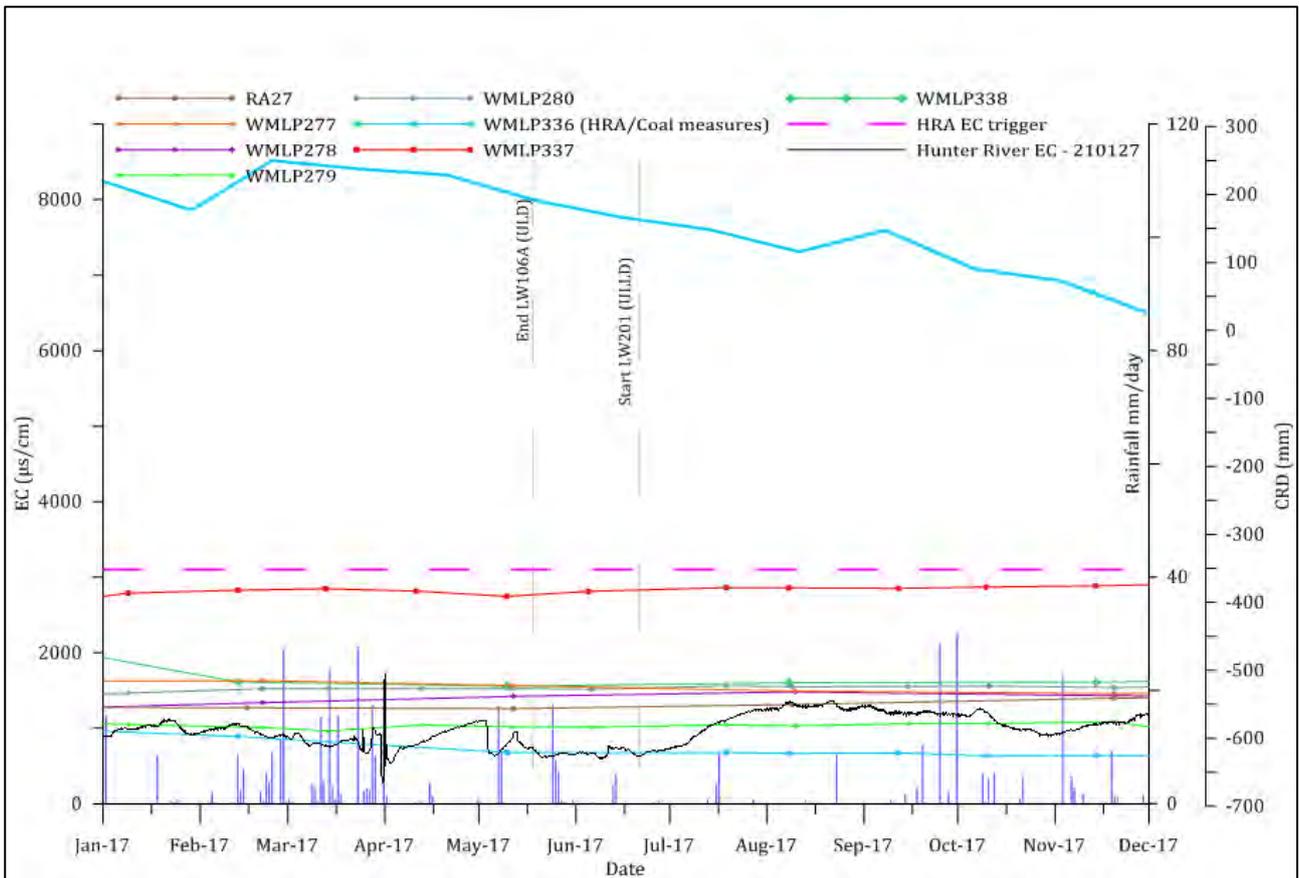
**Figure 4.11 Bowmans Creek alluvium EC trends (water level compliance bores)**

**Figure 4.12 Bowmans Creek alluvium EC trends (other bores)**

**Figure 4.13 Glennies Creek alluvium EC trends (water level compliance bores)**

**Figure 4.14 Glennies Creek alluvium EC trends (other bores)**

**Figure 4.15 Hunter River alluvium EC trends (water level compliance bores)**

**Figure 4.16 Hunter River alluvium EC trends (other bores)**

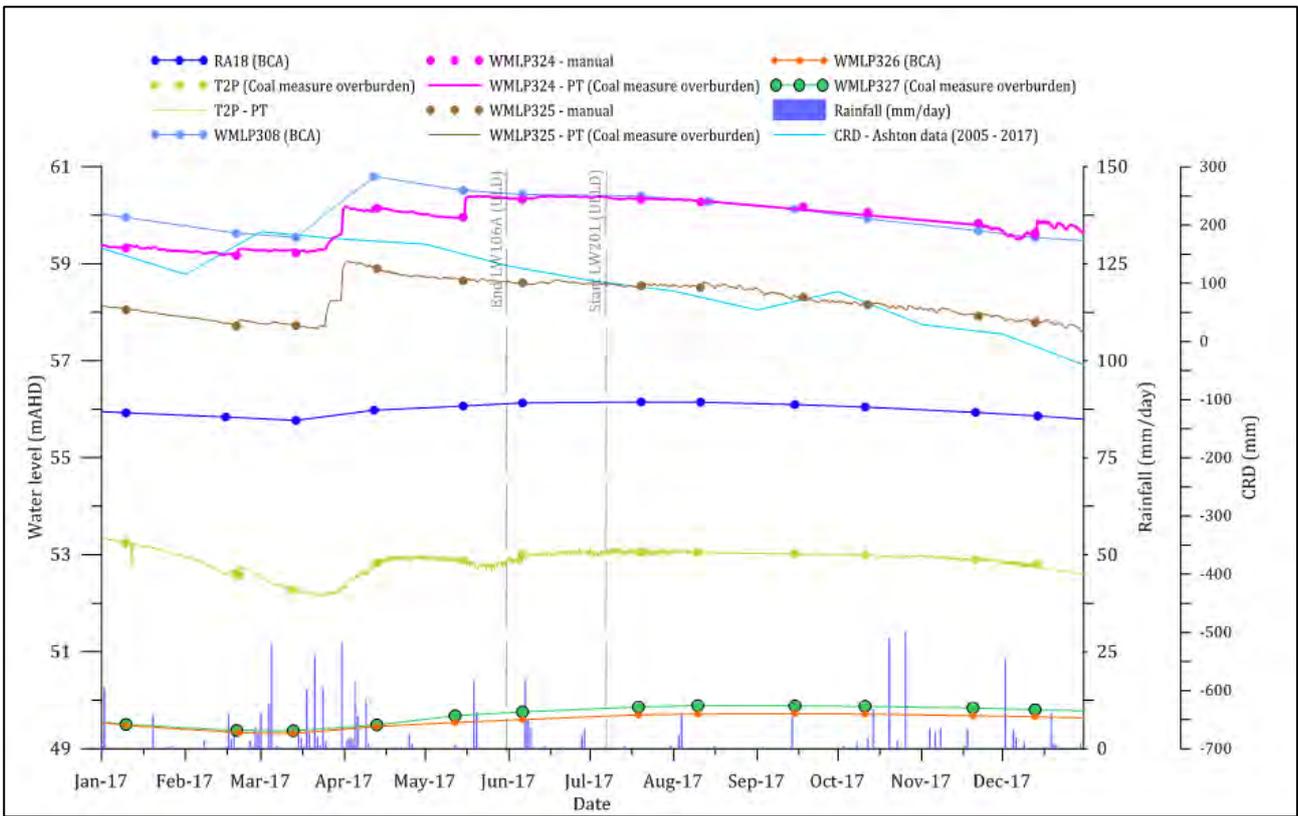
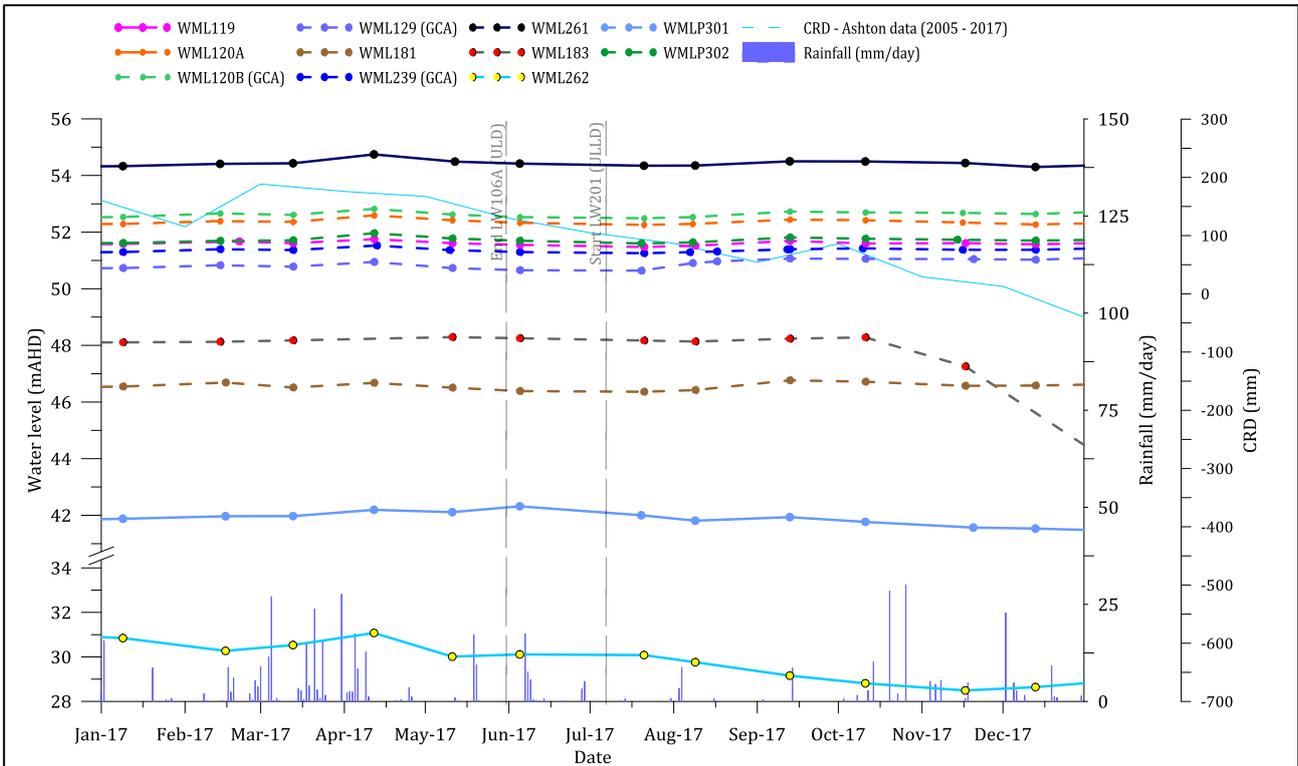
**Figure 4.17 Longwall LW106A specific monitoring bore hydrographs**

**Figure 4.18 Longwall LW201 specific monitoring bore hydrograph**

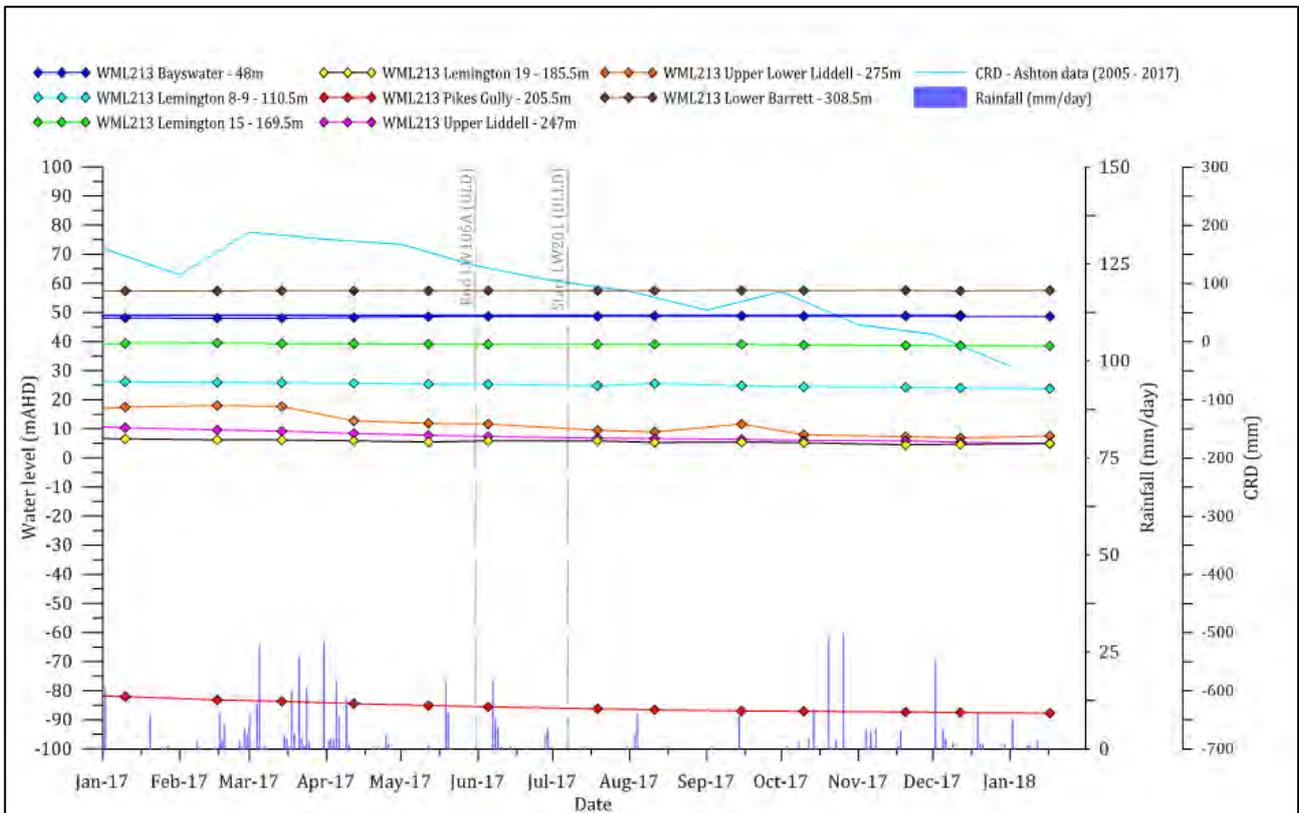
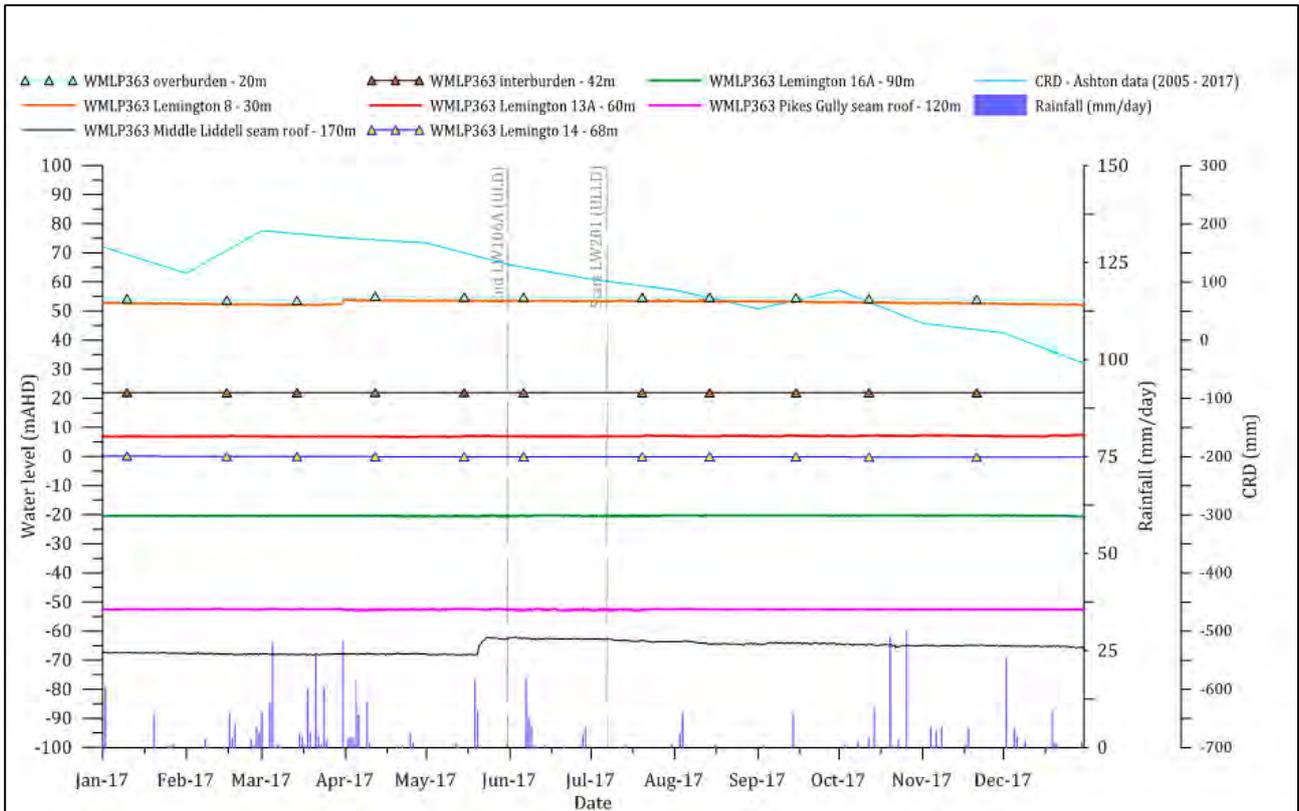
**Figure 4.19 Longwall LW106A VWP WML213**

**Figure 4.20 Longwall LW106A VWP WML363**
