Ashton Coal  
2017 Annual Review

Figure 1 Overview of operations

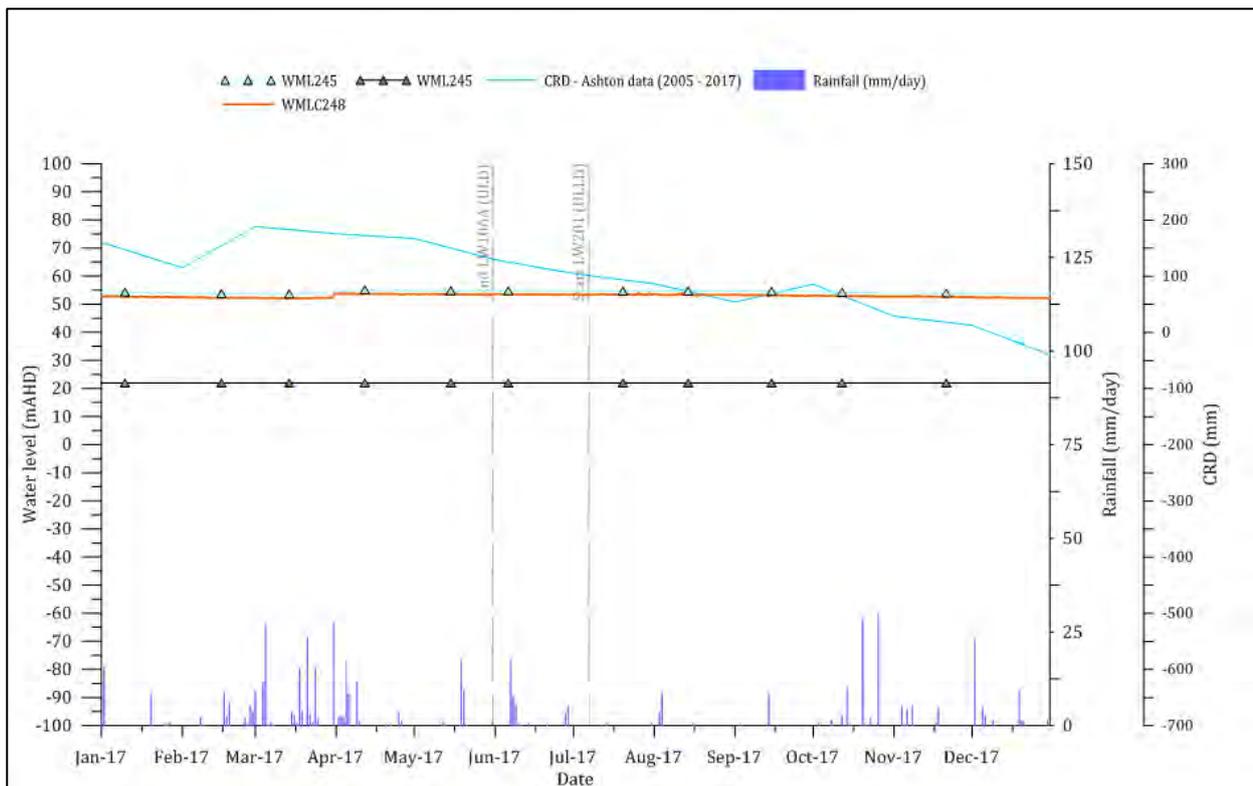
**Figure 4.21 Longwall LW201 VWP WML245 and 248**

- All VWP's in WMLP245 and WML248 (Figure 4.21), located at the northern end of LW106, remained stable throughout the year.

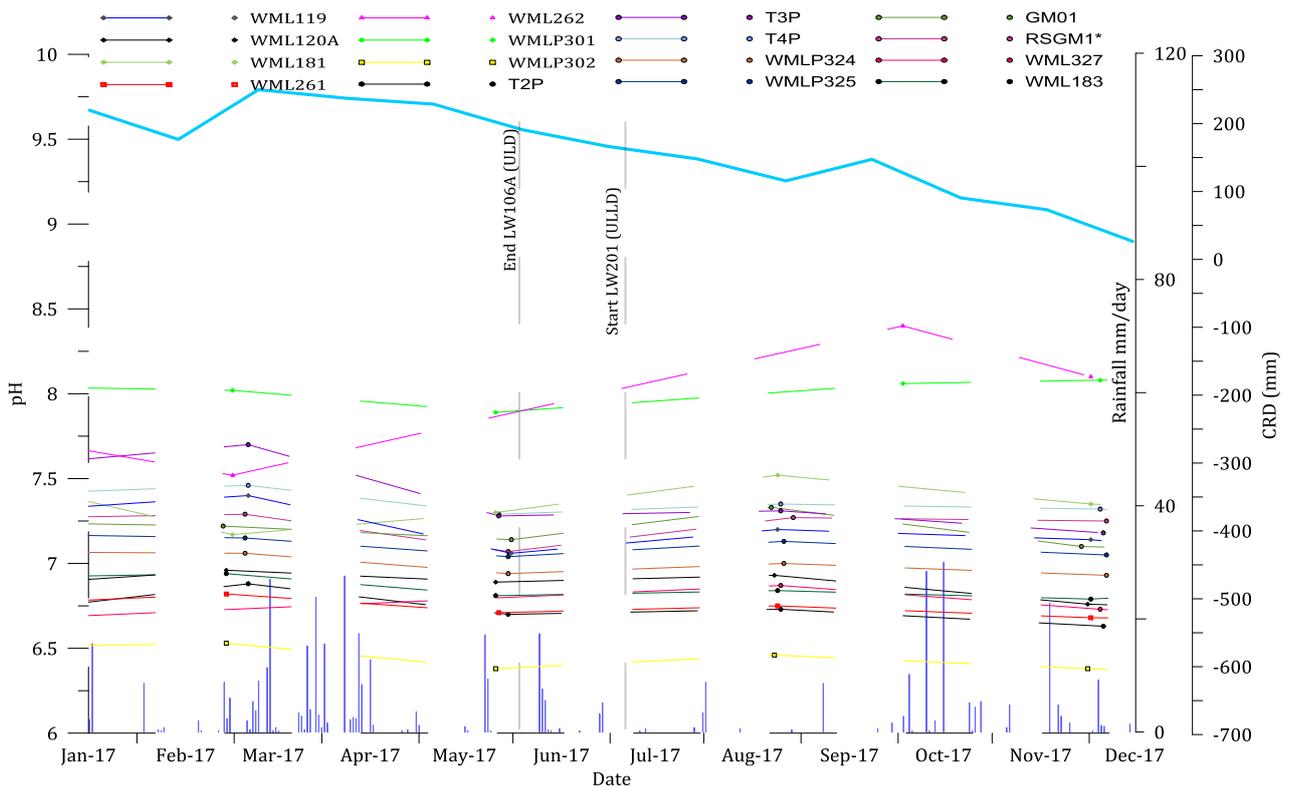
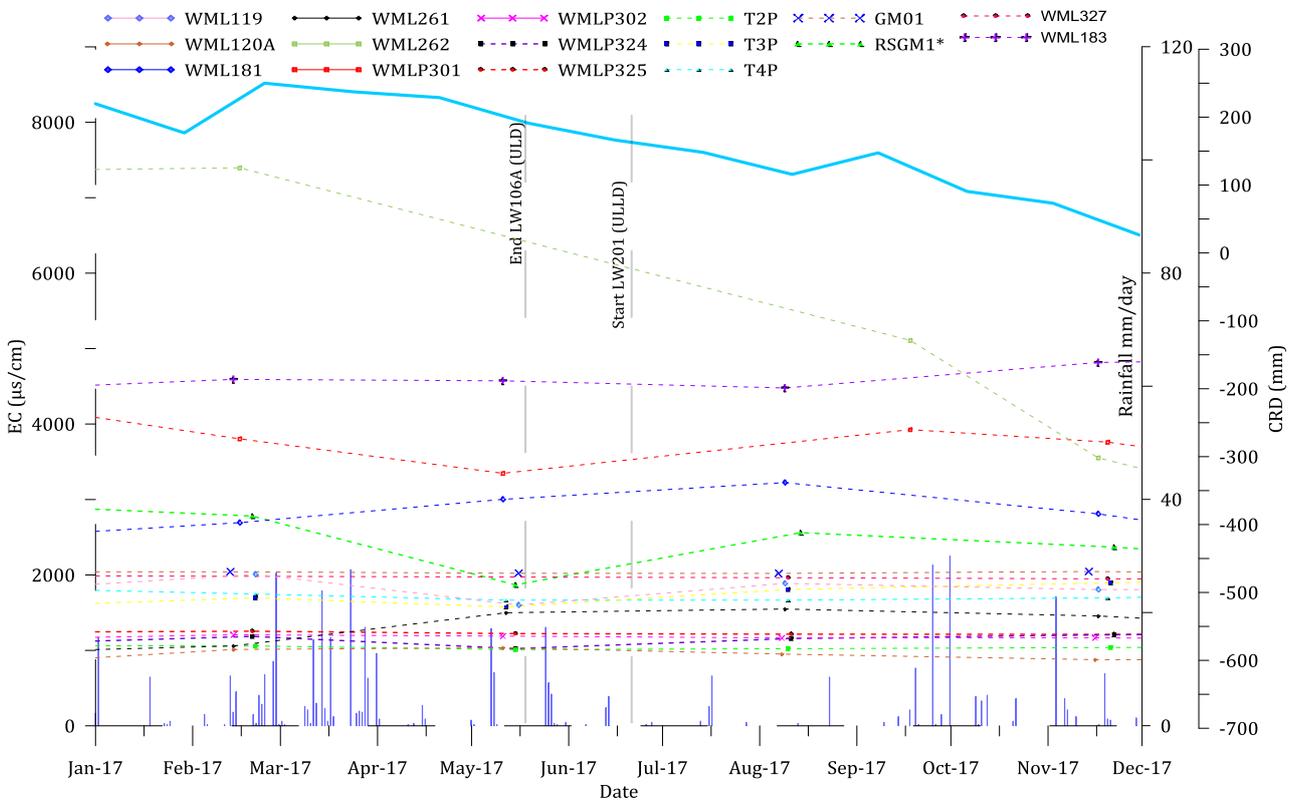
**Figure 4.22 Coal measure pH trends (Graph 1)**

**Figure 4.23 Coal measure EC trends (Graph 2)**

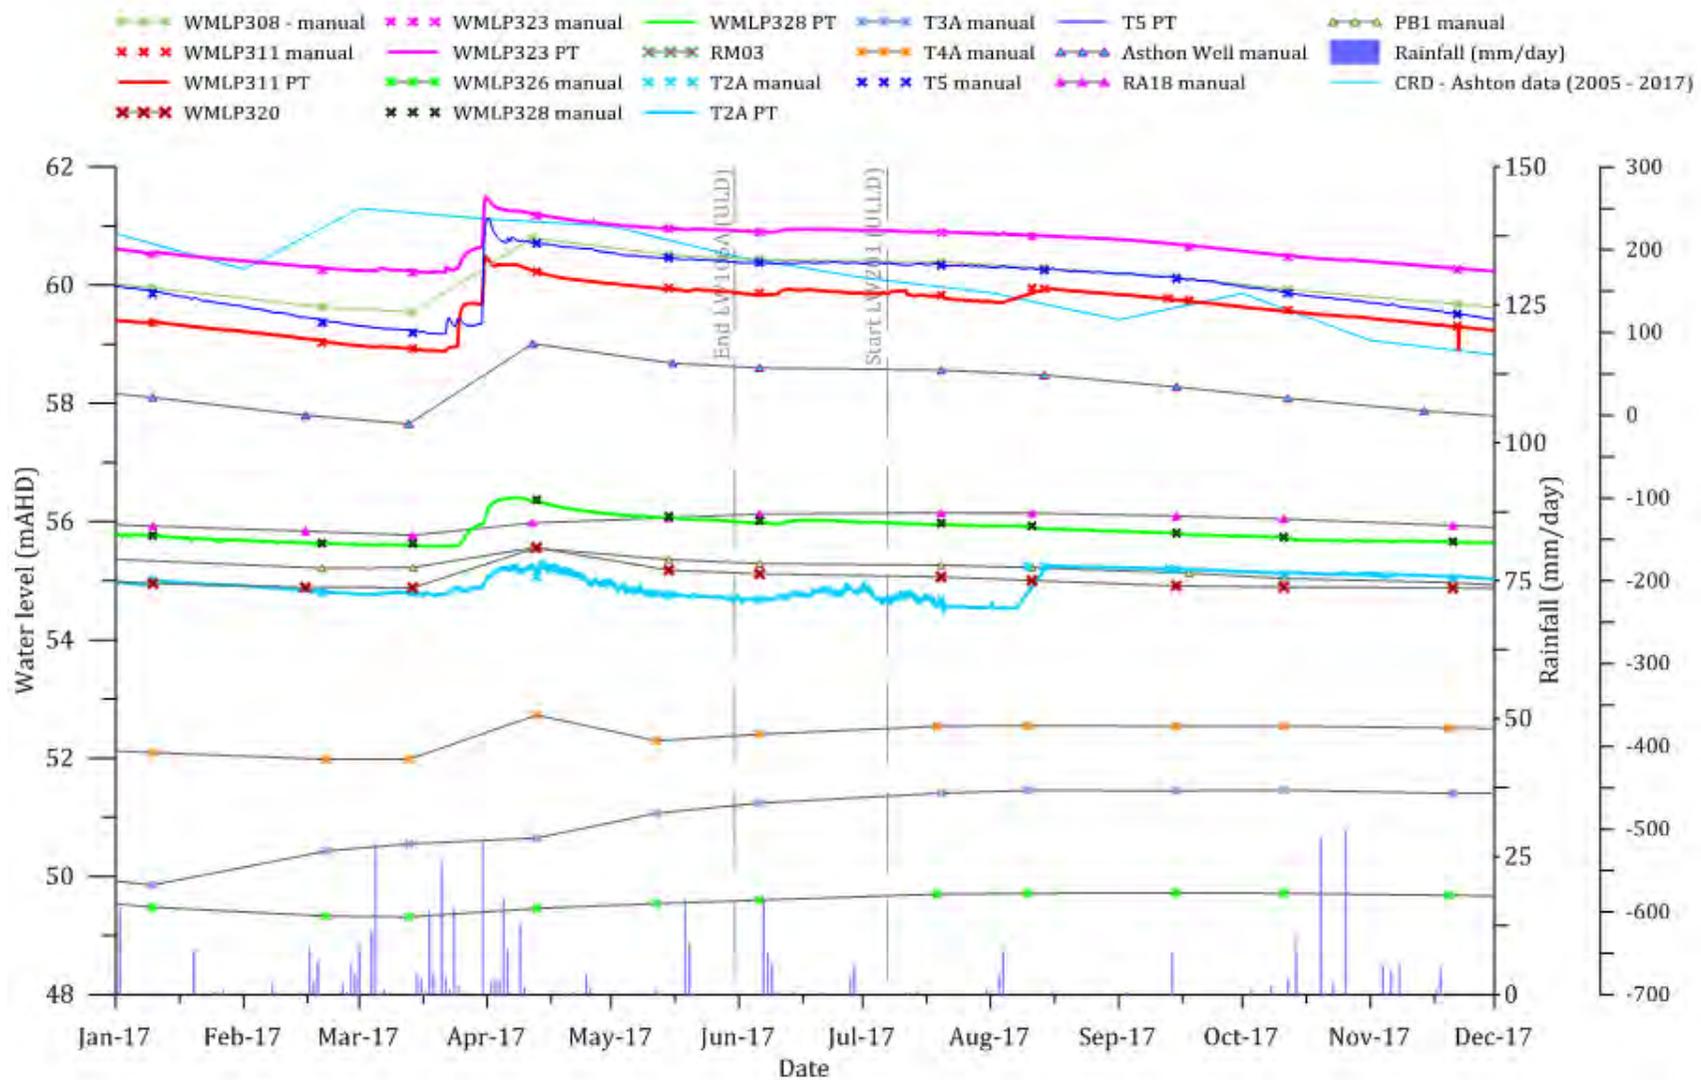
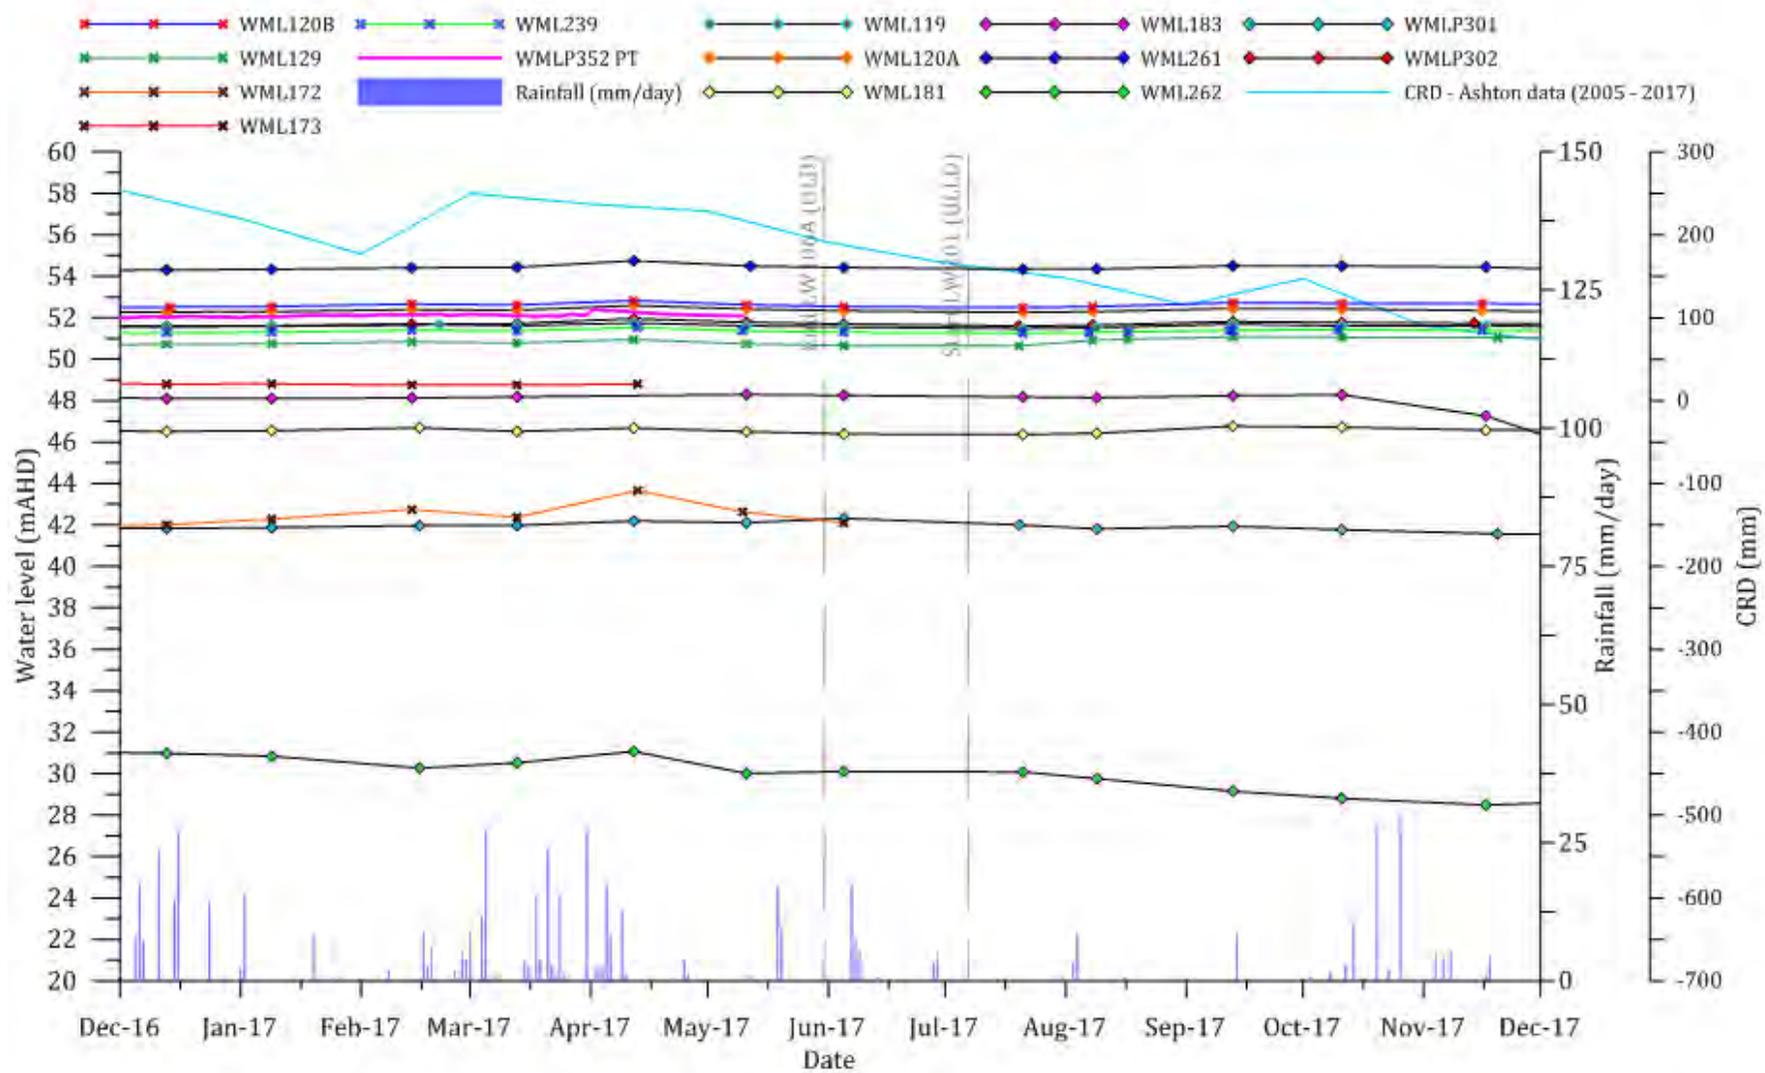
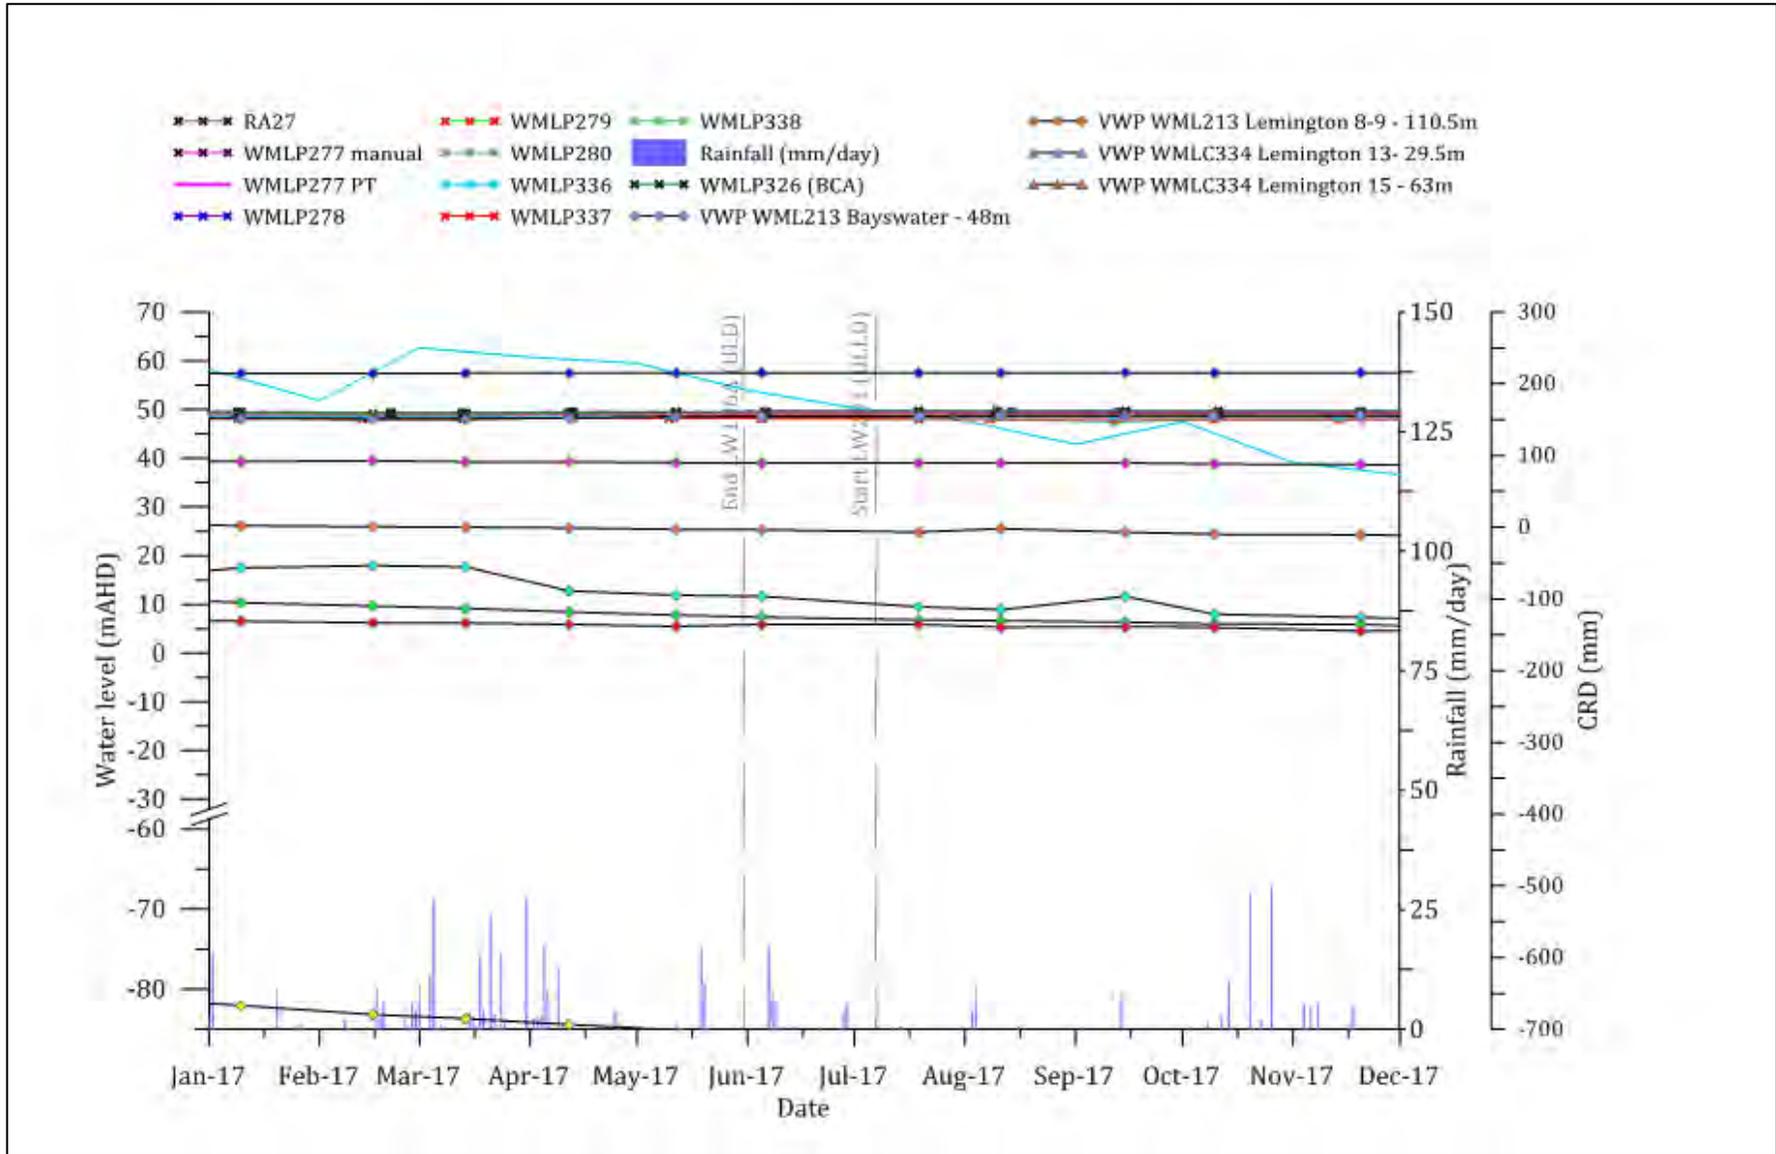
**Figure 10.1 Bowmans Creek alluvium and adjacent coal measure groundwater levels**

**Figure 10.2** Glennies Creek alluvium and adjacent coal measure groundwater levels

**Figure 10.3 Hunter River alluvium and adjacent coal measure groundwater levels**
