# **AIR QUALITY MONITORING DATA**

This report has been prepared in accordance with Consent Condition 9.2 (d) of the Ashton Coal Project Approval and covers the reporting period 1 September 2008 to 1 September 2009. This report has been prepared as a supporting document for the Ashton Coal Operations Ltd 2008-2009 Annual Environmental Management Report.

This document presents a review of the groundwater management work undertaken and the level of compliance with the consent conditions and with the Groundwater Management Plan (GWMP). A brief analysis of trends displayed by the monitoring data is presented, together with a comparison of the observed trends with predictions made in the Environmental Impact Statement (EIS) and the Subsidence Management Plan (SMP) for Pikes Gully Seam LWs1 to 4.

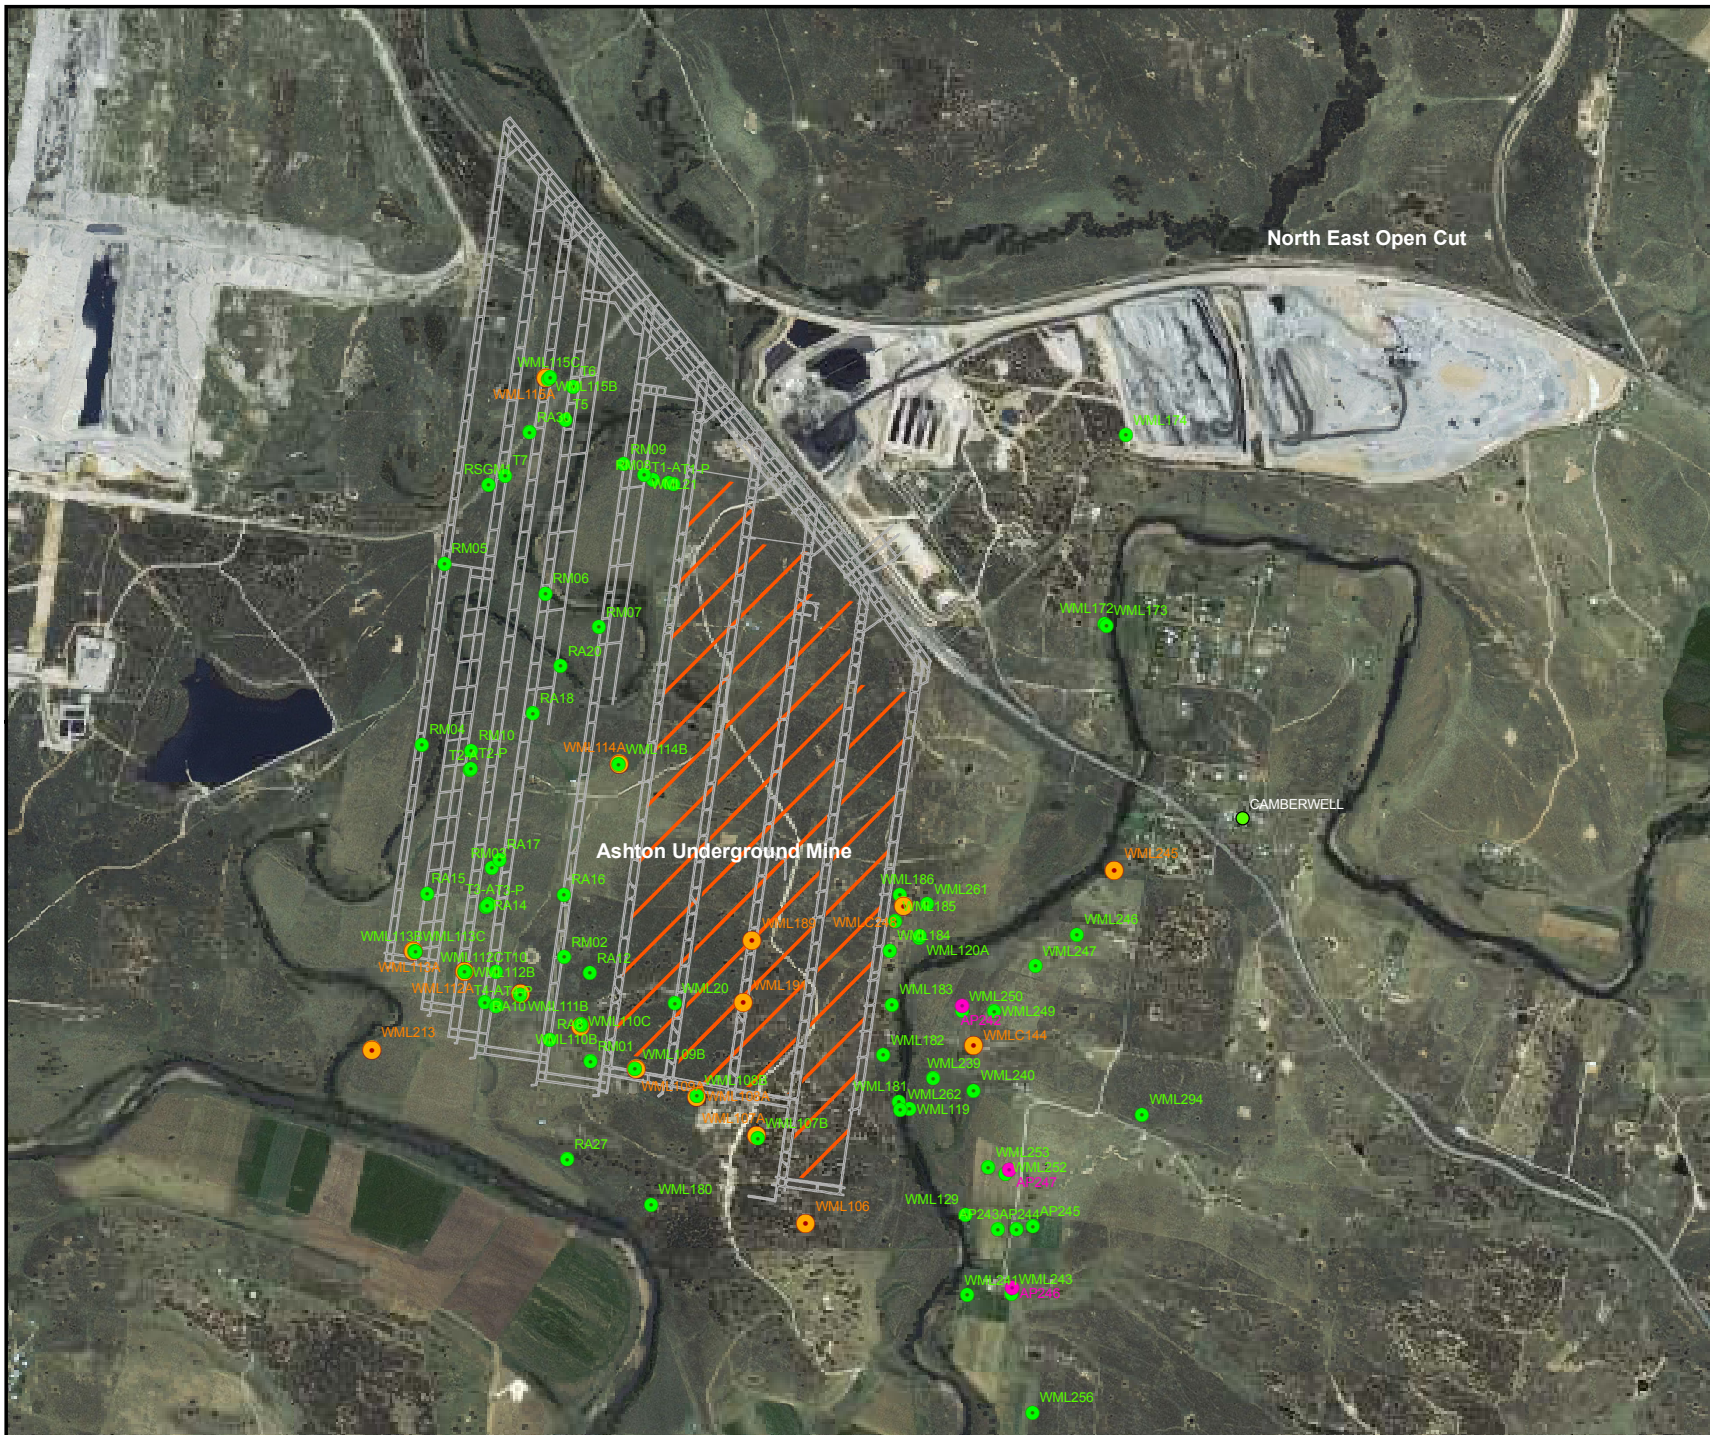
Figure 1:  
Site location and monitoring plan

- Ashton Monitoring Piezometers
- Vibrating Wire
- Stand Pipe
- Test Bore
- Pikes Gully Mine Plan
- ↗ Extent of Longwall mining to date

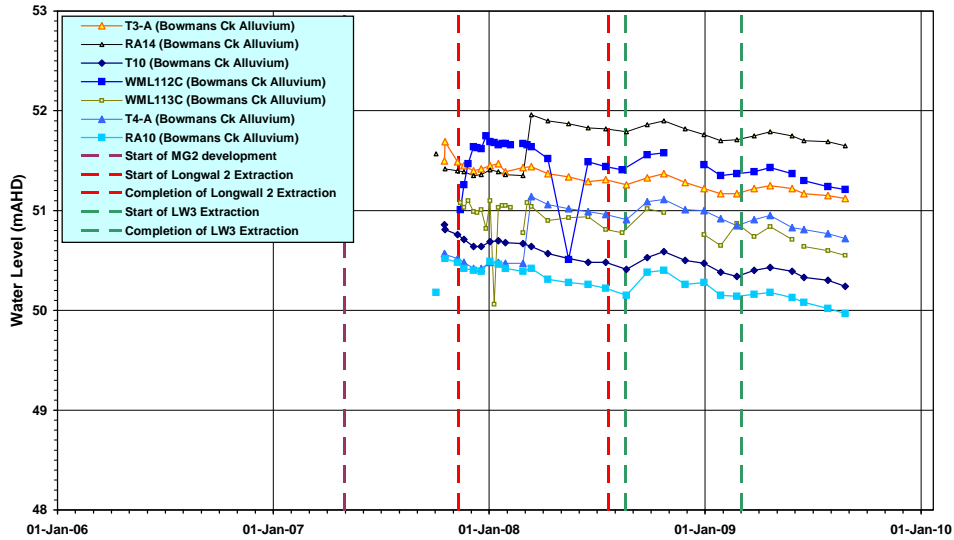
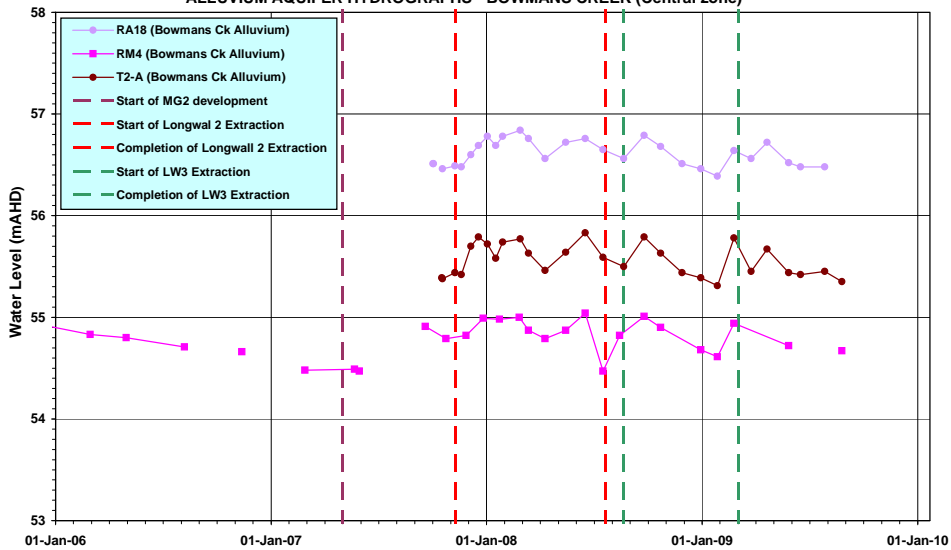
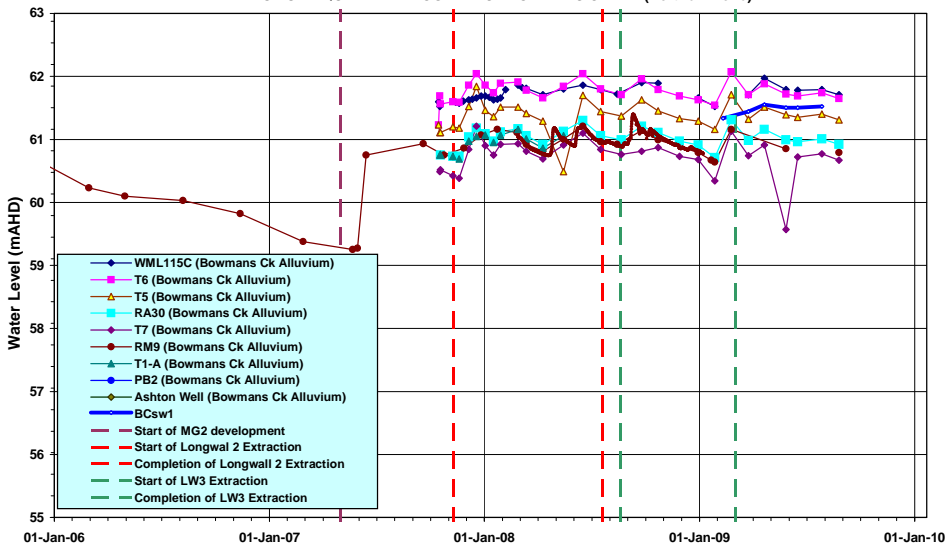
Figure 3

ALLUVIUM AQUIFER HYDROGRAPHS - BOWMANS CREEK (Southern zone)

ALLUVIUM AQUIFER HYDROGRAPHS - BOWMANS CREEK (Central zone)

ALLUVIUM AQUIFER HYDROGRAPHS - BOWMANS CREEK (Northern zone)

GROUNDWATER LEVEL HYDROGRAPHS  
Bowmans Creek Alluvium

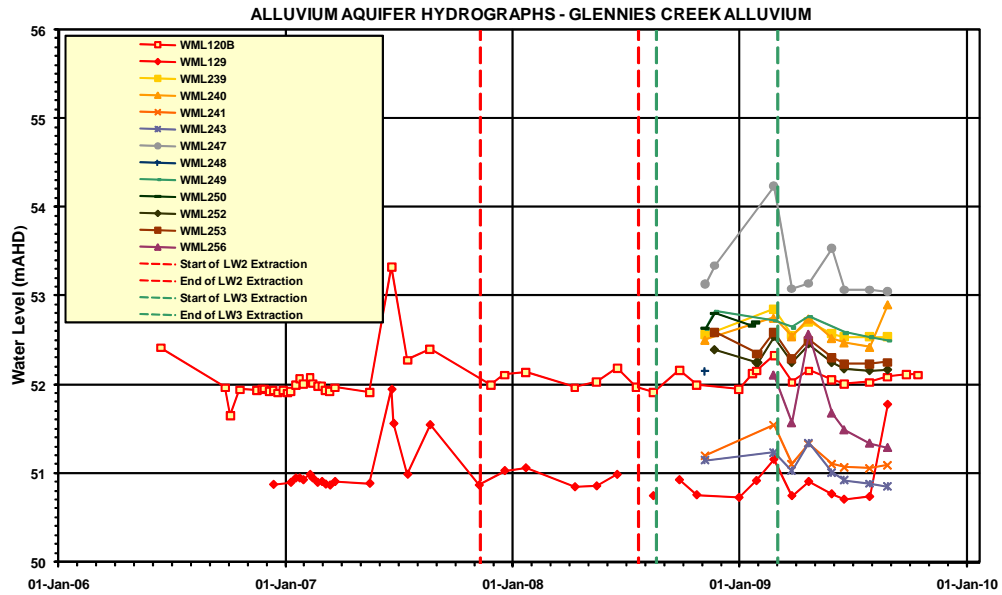
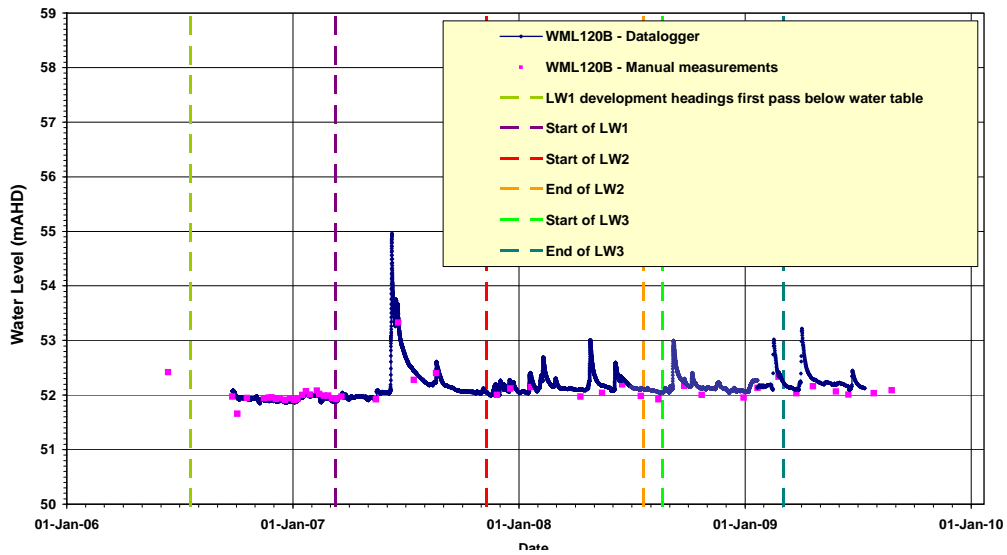
**GROUNDWATER LEVEL HYDROGRAPH - WML120B (Glennies Creek Alluvium)**

**GROUNDWATER LEVEL HYDROGRAPH - WML129 (Glennies Creek Alluvium)**

**GROUNDWATER LEVEL HYDROGRAPHS  
Glennies Creek Alluvium**

Similar responses were observed in the Glennies Creek alluvium (**Figure 4**). The continuous records from WML120B and WML129 (located between LW1 and Glennies Creek) show a very slight upward trend overall, together with short-term sharp responses to rainfall recharge events (**Figure 4**). The slight upward trend at WML120B is suggesting gradual recovery of groundwater levels after the initial impacts from LW1 development in 2006.

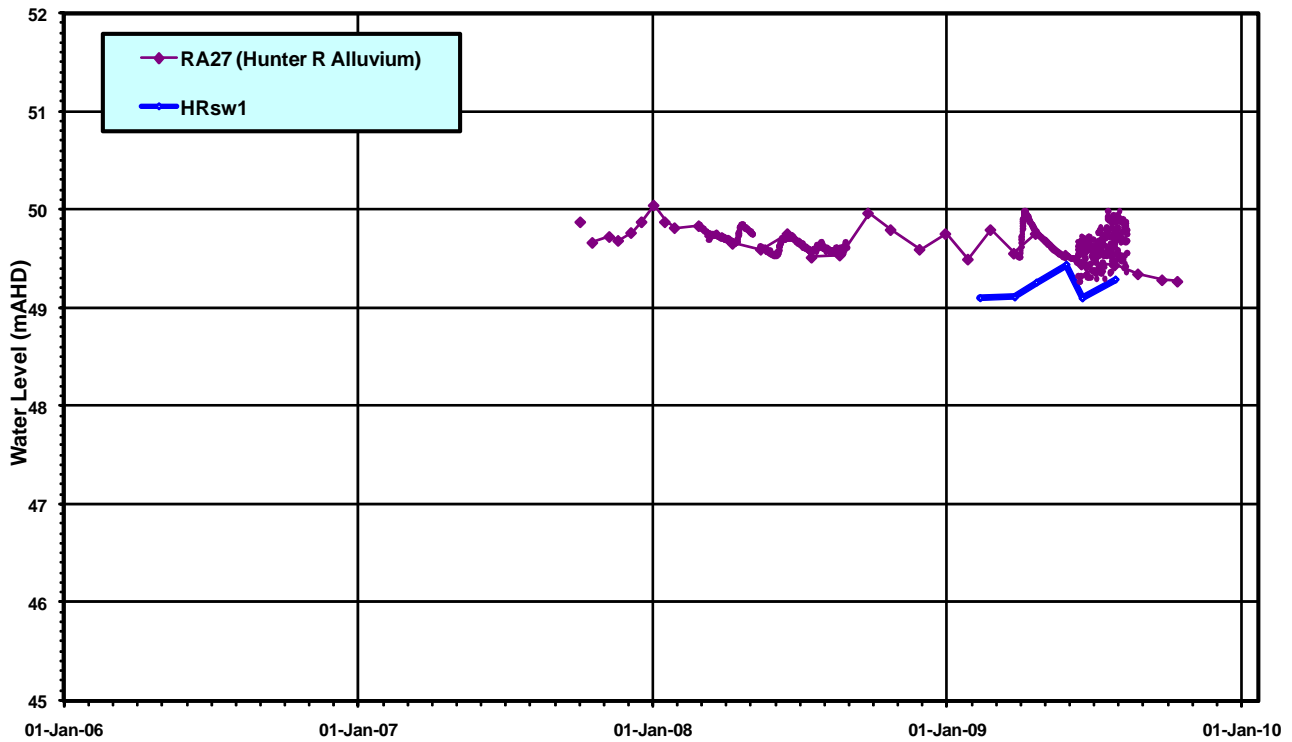
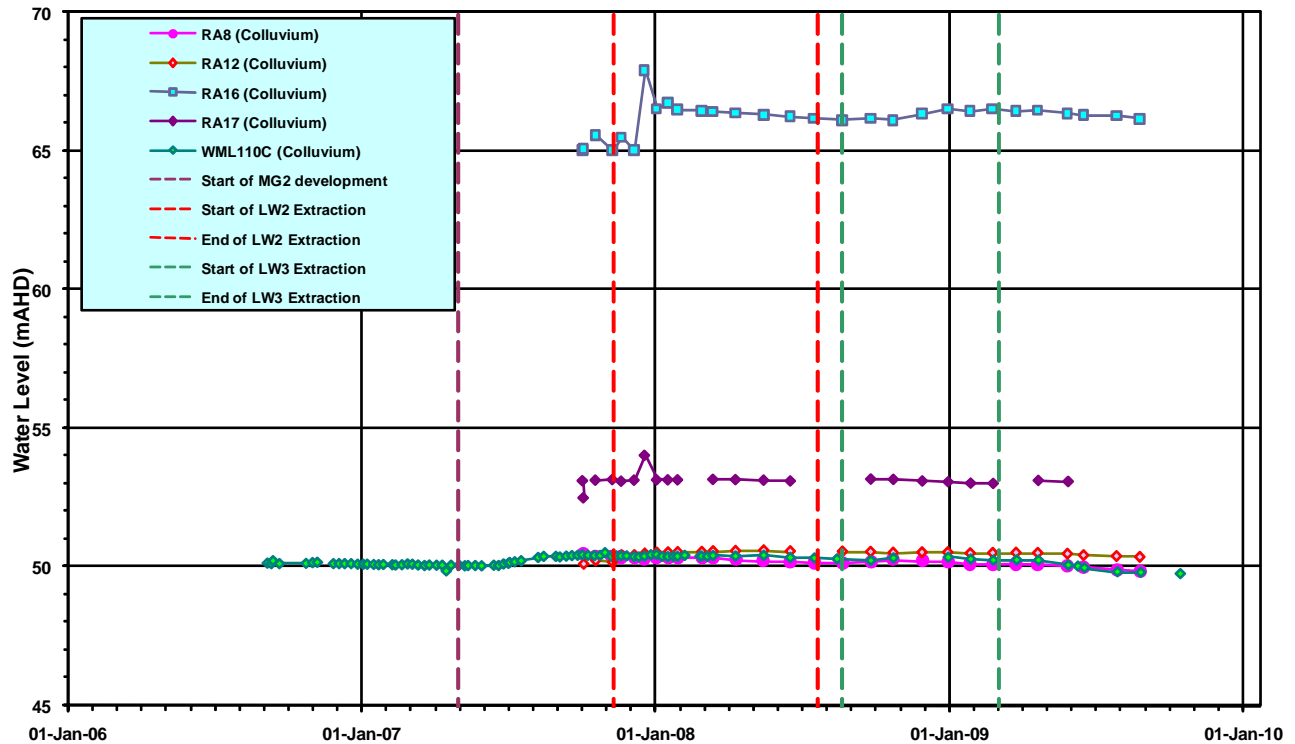
**Figure 5**

### ALLUVIUM AQUIFER HYDROGRAPHS - HUNTER RIVER ALLUVIUM

### ALLUVIUM AQUIFER HYDROGRAPHS - COLLUVIUM / REGOLITH

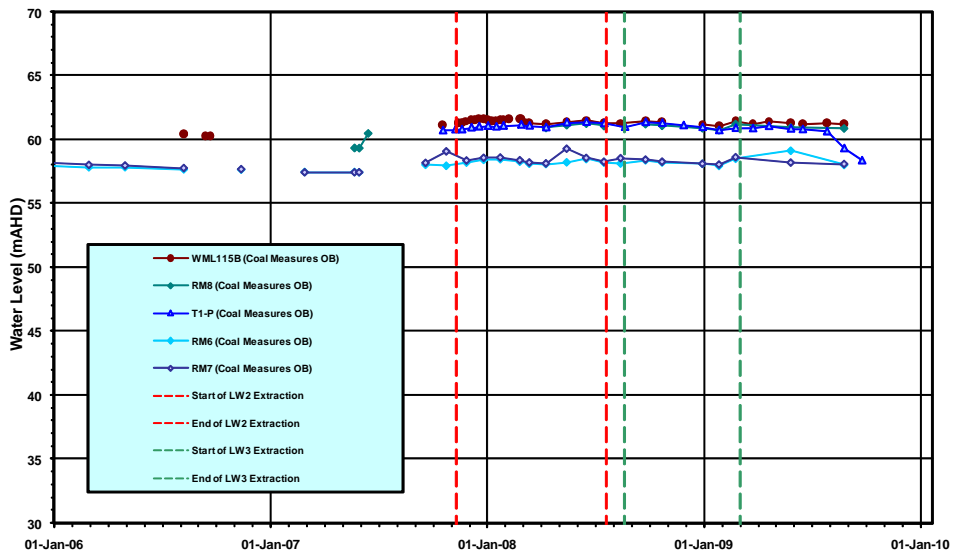
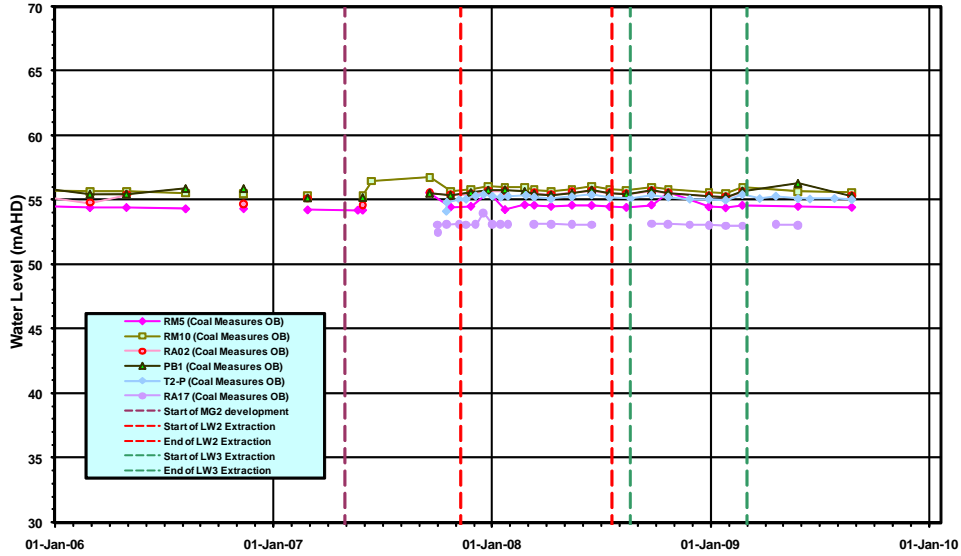
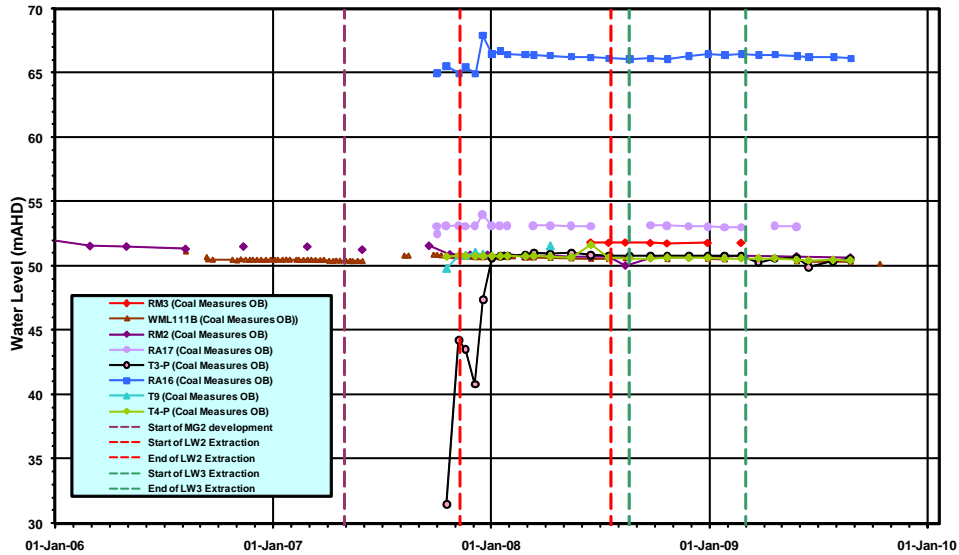
ASHTON - COAL MEASURES OVERBURDEN HYDROGRAPHS (Bowmans Ck Northern Section)

ASHTON - COAL MEASURES OVERBURDEN HYDROGRAPHS (Bowmans Ck Central Section)

ASHTON - COAL MEASURES OVERBURDEN HYDROGRAPHS (Bowmans Creek Southern Section)

GROUNDWATER LEVEL HYDROGRAPHS  
Weathered Near-Surface Coal Measures Overburden

Standpipe piezometers completed into the upper weathered zone of the Permian coal measures in the Bowmans Creek floodplain area mostly show no impact on groundwater levels from underground or open cut mining (**Figure 6**). Several of these bores show a clear and direct response to rainfall recharge events, consistent with the receipt of recharge by vertical infiltration of local rainfall. The exception is bore T1-P, which is completed into the uppermost water-bearing horizon in the Permian at a location within the Bowmans Creek floodplain, 80m west of the northern part of LW4. During August 2009, the groundwater level fell by about 2m in T1-P coinciding with the passage of LW4 past this location. At the same time, no water level impact was observed in the alluvium bore T1-A at the same location.

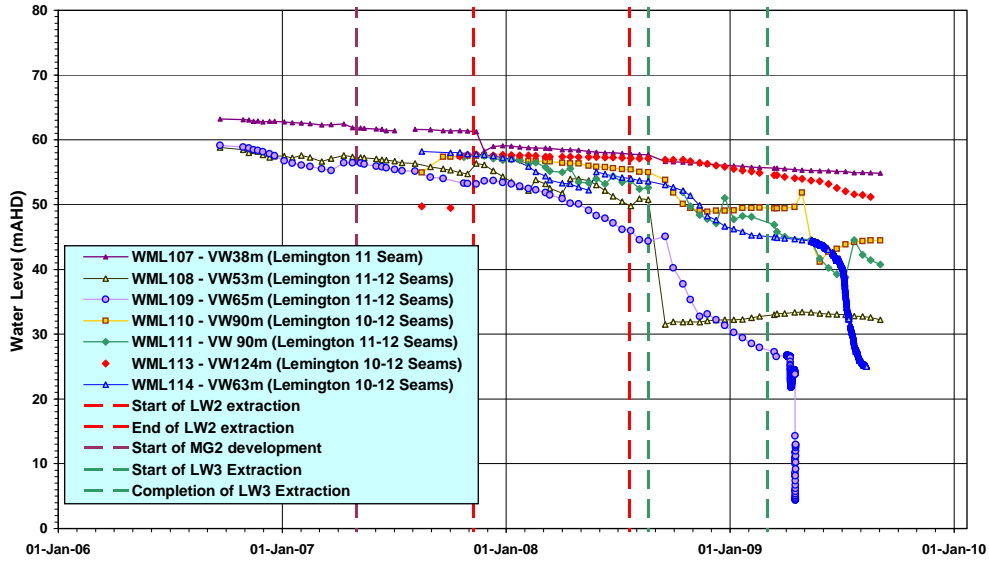
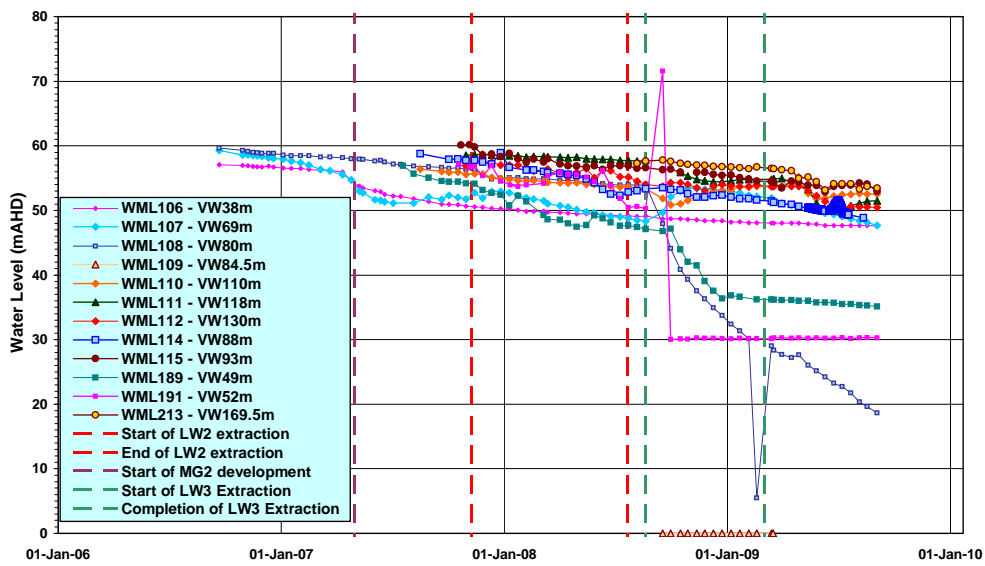
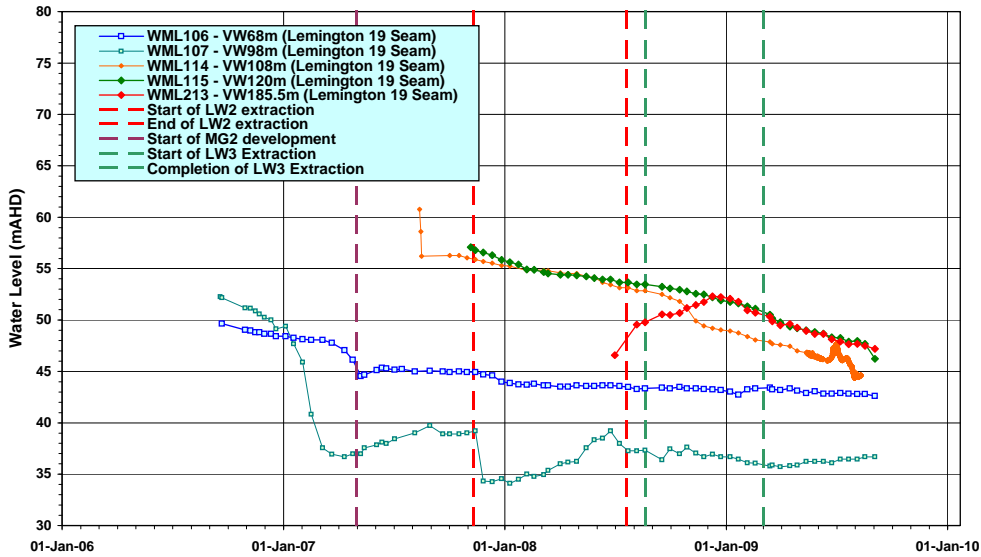
**Figure 8**

**GROUNDWATER LEVEL HYDROGRAPHS  
Bayswater Seam Lemington 1-9 Seams**

### ASHTON - LEMINGTON 10-12 SEAM HYDROGRAPHS

### ASHTON - LEMINGTON 15 SEAM HYDROGRAPHS

### ASHTON - LEMINGTON 19 SEAM HYDROGRAPHS

Varying drawdown impacts have been observed in piezometers which monitor the overlying Bayswater and Lemington seams, in response to underground mining.

Some piezometers located outside of the current mining area (ie LW1-4) have noted steady drawdown responses in the Lemington seams for reasons unrelated to Ashton mining operations, as explained below:

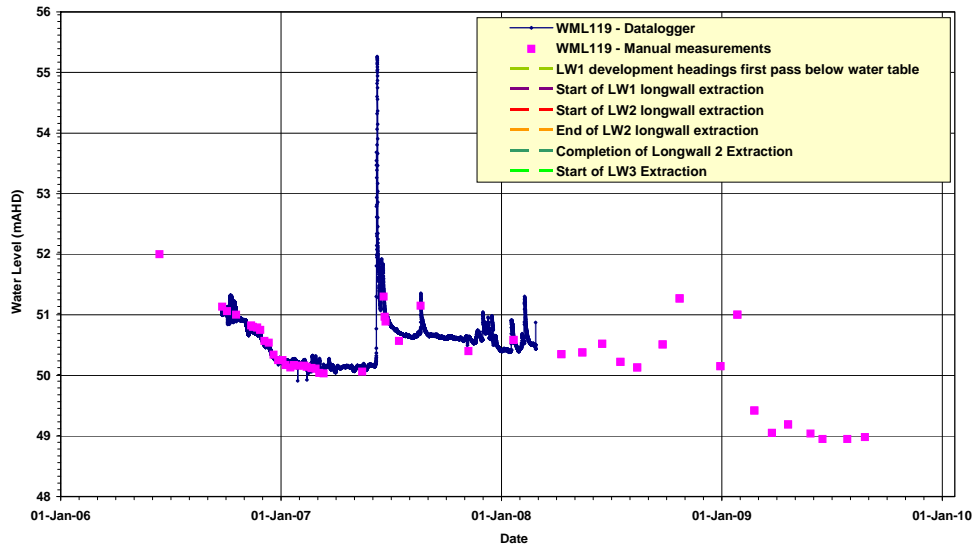
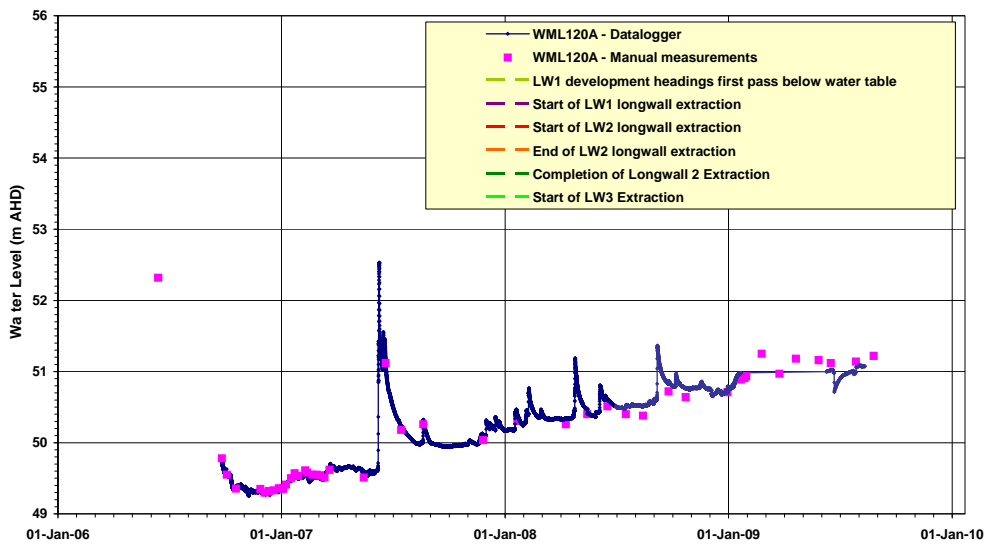
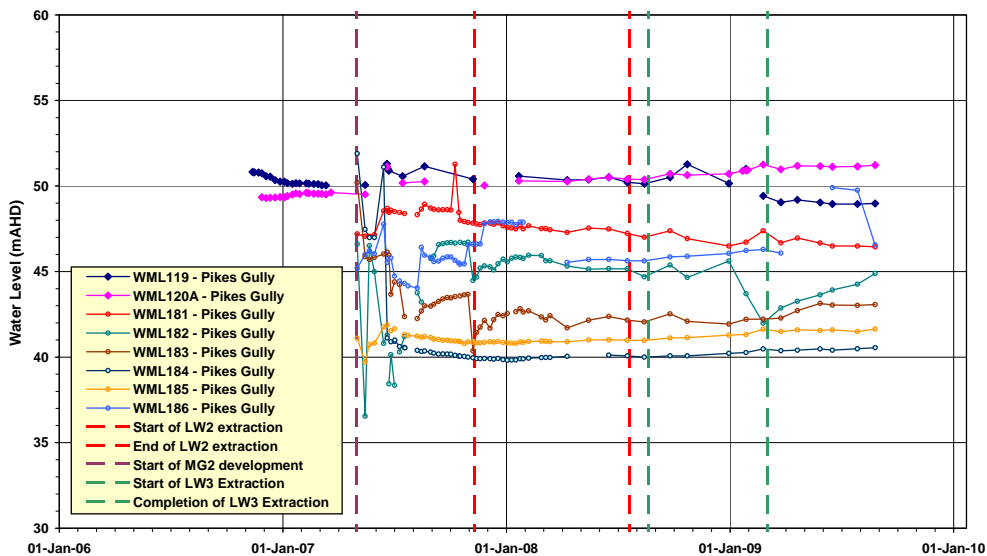
**Figure 9**

**GROUNDWATER LEVEL HYDROGRAPH - WML119 (Pikes Gully Seam)**

**GROUNDWATER LEVEL HYDROGRAPH - WML120A (Pikes Gully Seam)**

**ASHTON - PIKES GULLY SEAM HYDROGRAPHS - EAST OF LW1**

No piezometers east of LW1 (between LW1 and Glennies Creek) showed any further response to underground mining over the reporting period (**Figure 9**). The trends observed in the piezometers are continuations of trends established during the mining of LW1.

Groundwater levels in WML120A have continued to show steady recovery of approximately 0.7m/y, so that more than half of the initial drawdown has now been recovered. This steady recovery is also observed in neighbouring piezometers WML184 to WML186. The partial

recovery in water levels suggests a steady reduction in the hydraulic conductivity of the Pikes Gully Seam, possibly due to partial clogging of the cleat fracture flow pathways. This gradual recovery in water levels has been accompanied by a gradual reduction in the rate of underground seepage inflows. Aside from rainfall recharge events, water levels in WML119, WML181 and WML182 have revealed a steady drawdown trend of approximately 1m/y since the mining of LW1 began. Piezometers remote from the Pikes Gully outcrop have not yet shown any response to the recharge events.

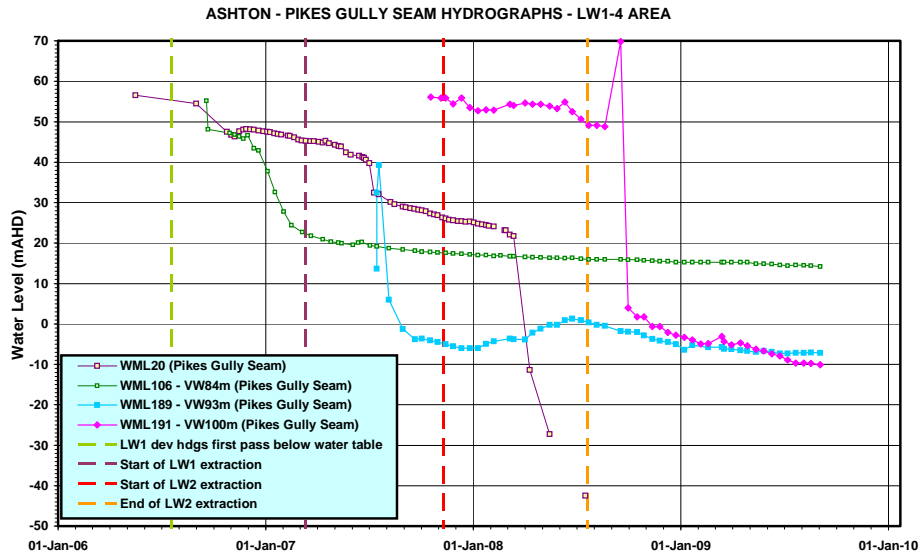
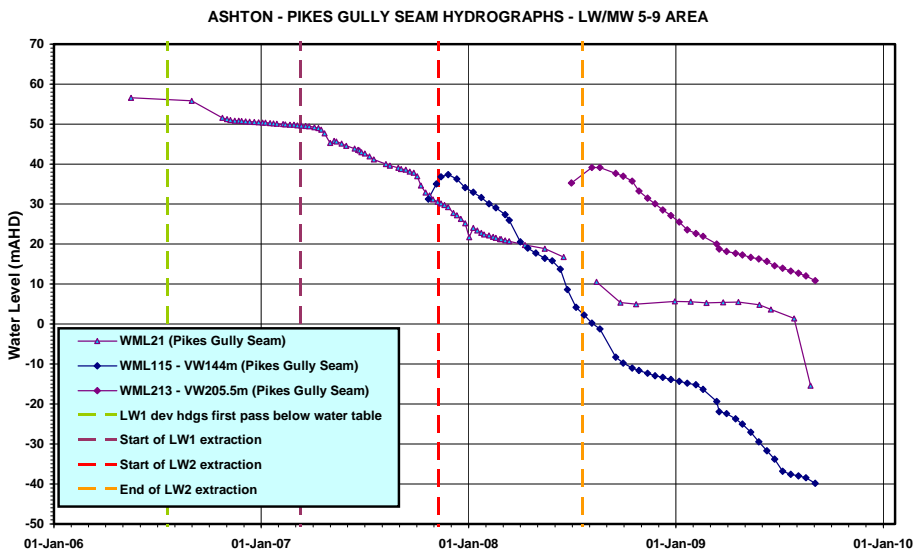
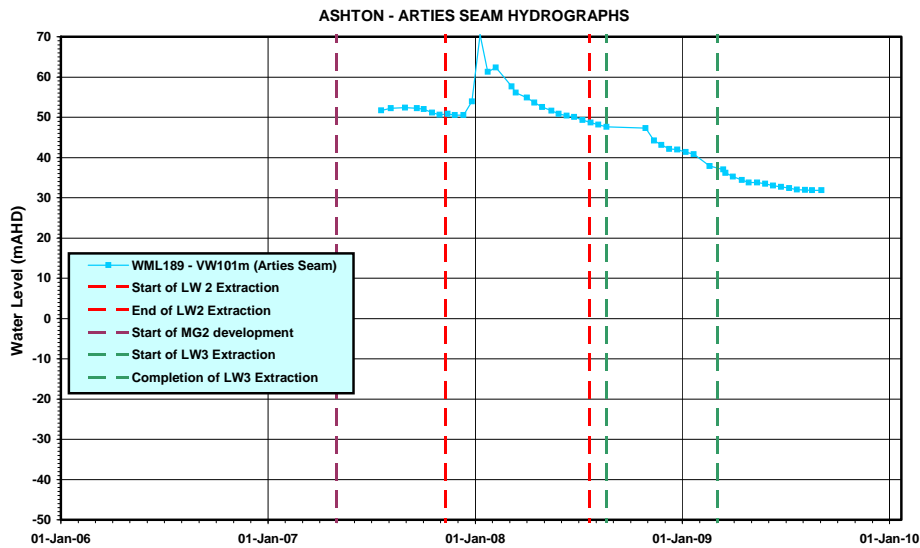
**Figure 10**

**GROUNDWATER LEVEL HYDROGRAPHS  
Pikes Gully Seam LW1-4, LW5-9  
and Arties Seam**

Piezometers which monitor the Pikes Gully Seam in the underground SMP area have all shown responses to mining (**Figure 10**). Whilst most responses were observed during the mining of LW1 and LW2 (2007-08 AEMR reporting period), marked responses have been observed in WML191-100m, WML115-144m, WML213 and WML21 over the 2008-09 reporting period. The pattern of responses observed to date can be summarised as follows:

- ▼ WML108-84m and WML20 responded strongly to LW1 development headings, with WML20 responding further to LW2 headings and the NW mains. No significant responses were observed during the subsequent LW2 extractions. WML20 became dry during the nearby mining of LW3 maingate headings and is no longer monitored.

- ▼ WML21, located in the northern part of LW5, responded strongly to the advance of the NW mains and LW4 development headings past this point.
- ▼ WML115-144m is located closer to the NW Mains than the LW1-4 area. The continued drawdown response observed over the reporting period is believed to be due primarily to drainage into the nearby NW mains and development headings for LW4 and LW5, where the lowest point in the headings near WML115 is at an elevation of around -45mAHD.

- ▼ WML213 is remote from both LW1-4 and the NW Mains. The steady drawdown observed in WML213 is believed to be due to mining activities on neighbouring mine sites, not the Ashton operation.

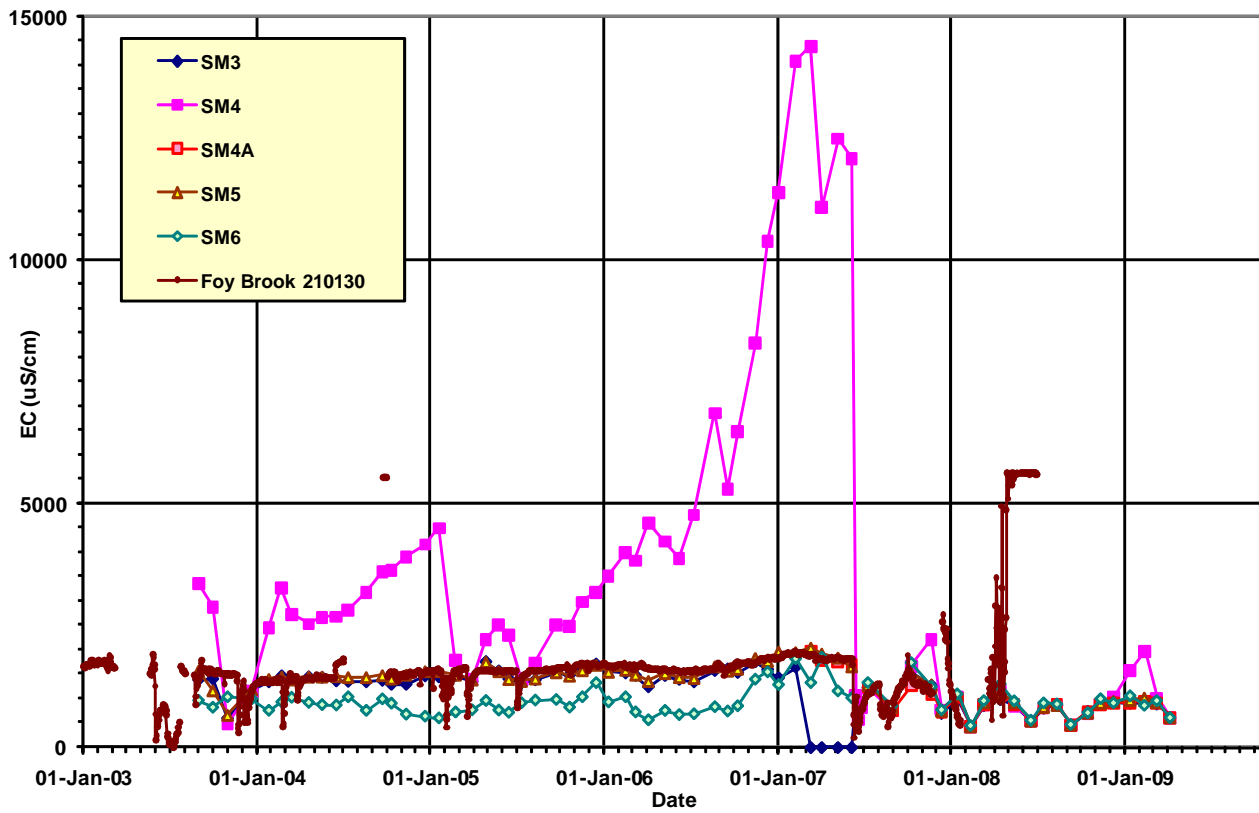
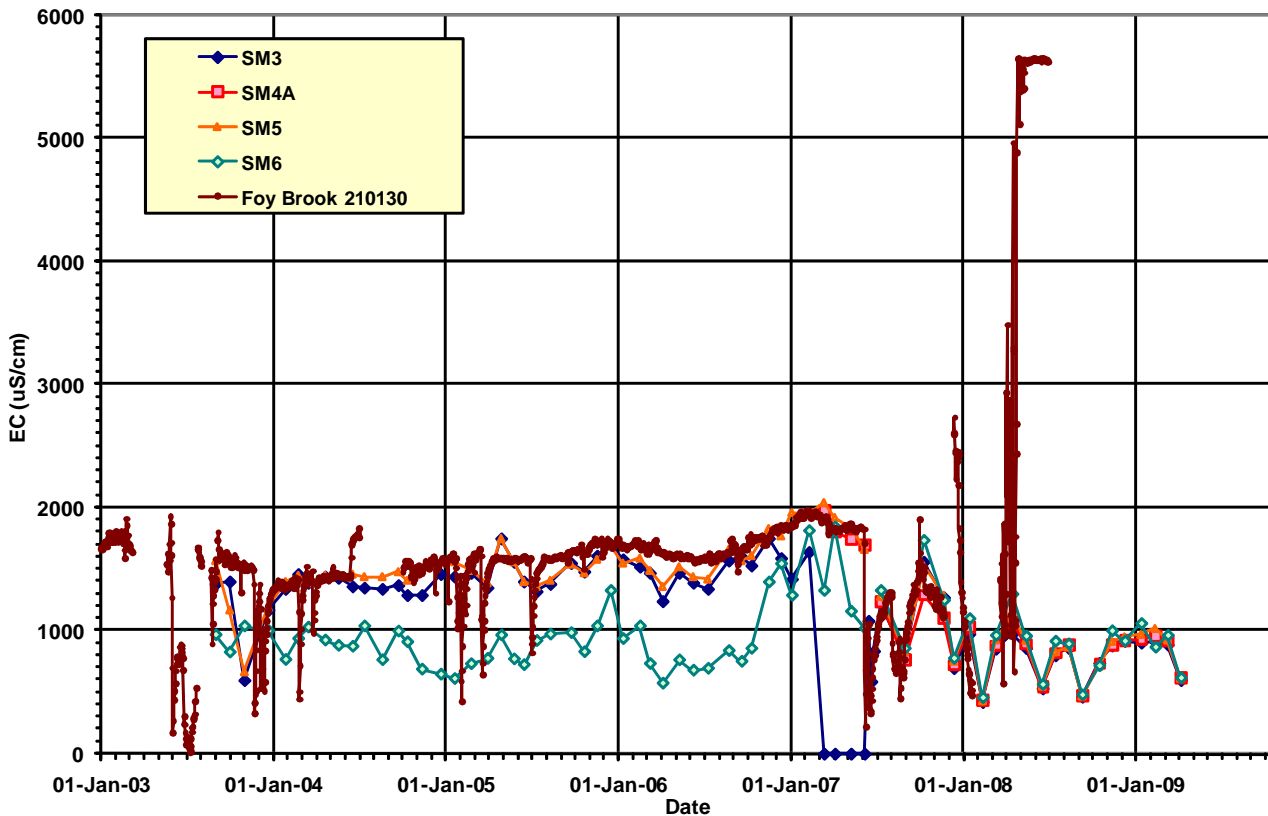
BOWMANS CREEK SURFACE WATER QUALITY - EC

SURFACE WATER QUALITY  
Bowmans Creek - EC

- ▼ Bowmans Creek ceased continuous flow in early 2007, and water was maintained in disconnected pools only by virtue of small volume groundwater baseflow discharges. The total rate of groundwater baseflow was very small, insufficient to maintain continuous flow. The surface water EC at this time increased to 14000  $\mu\text{S}/\text{cm}$ . Flow resumed by June 2007 and ECs then declined rapidly (**Figure 12**). A smaller increase in ECs was noted to occur at site SM4 during the AEMR period, to a maximum of almost 2000  $\mu\text{S}/\text{cm}$  in February 2009, before declining again with subsequent rainfall runoff.

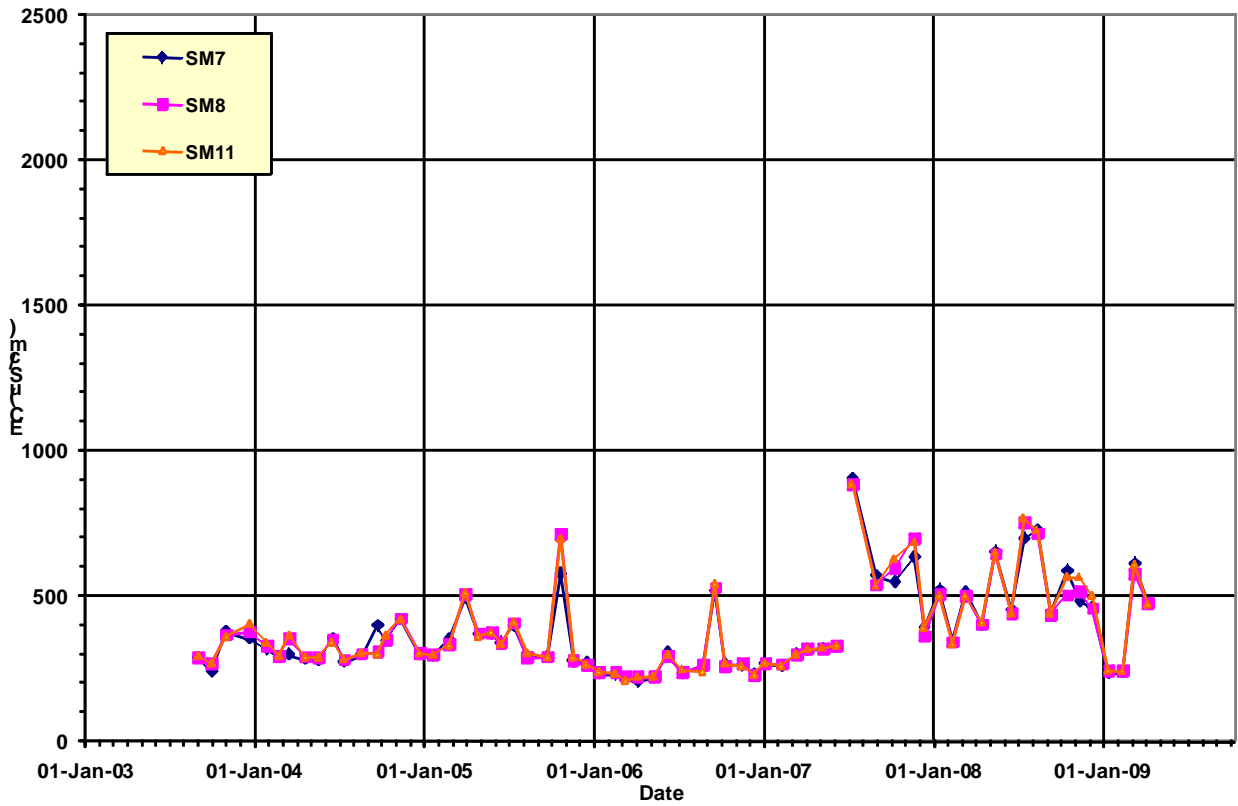
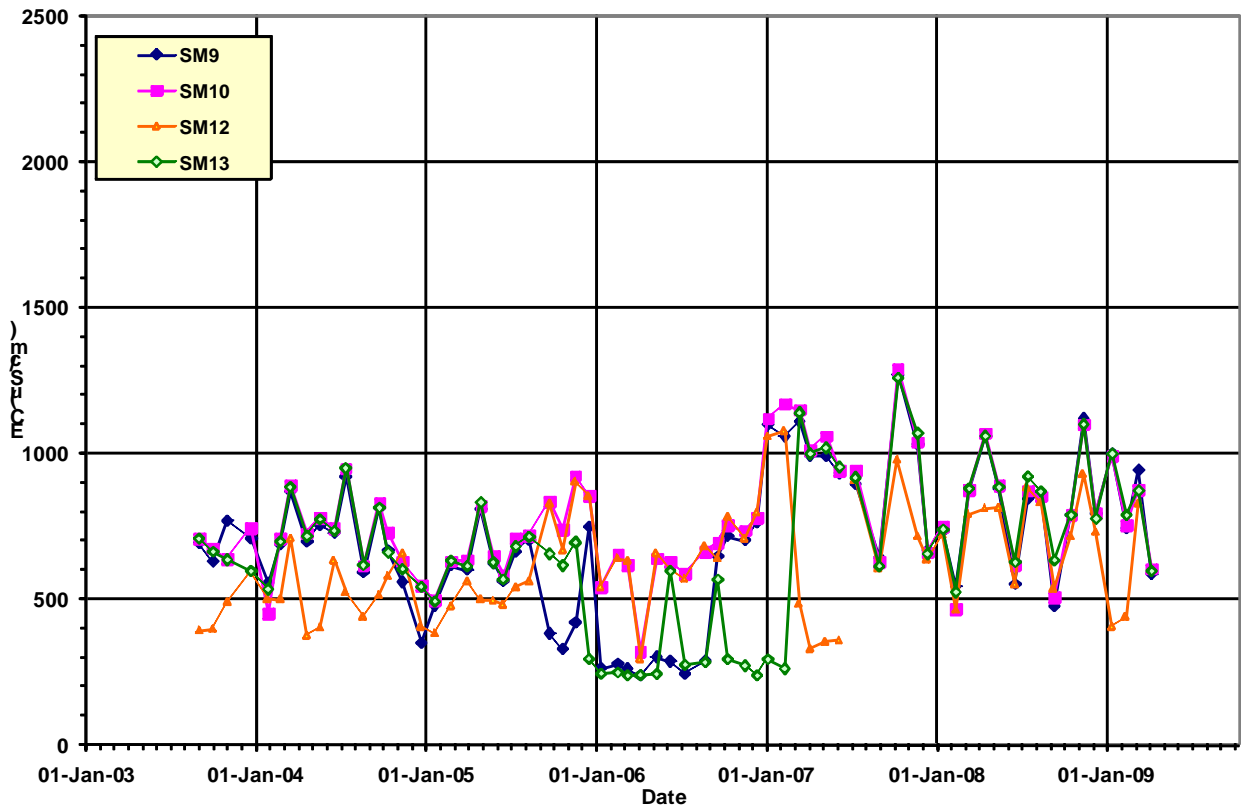
GLENNIES CREEK SURFACE WATER QUALITY - EC

HUNTER RIVER SURFACE WATER QUALITY - EC

SURFACE WATER QUALITY  
Glennies Creek and Hunter River
