# **AIR QUALITY MONITORING DATA**

This report has been prepared in accordance with Consent Condition 9.2 (d) of the Ashton Coal Project Approval and covers the reporting period 1 September 2008 to 1 September 2009. This report has been prepared as a supporting document for the Ashton Coal Operations Ltd 2008-2009 Annual Environmental Management Report.

This document presents a review of the groundwater management work undertaken and the level of compliance with the consent conditions and with the Groundwater Management Plan (GWMP). A brief analysis of trends displayed by the monitoring data is presented, together with a comparison of the observed trends with predictions made in the Environmental Impact Statement (EIS) and the Subsidence Management Plan (SMP) for Pikes Gully Seam LWs1 to 4.

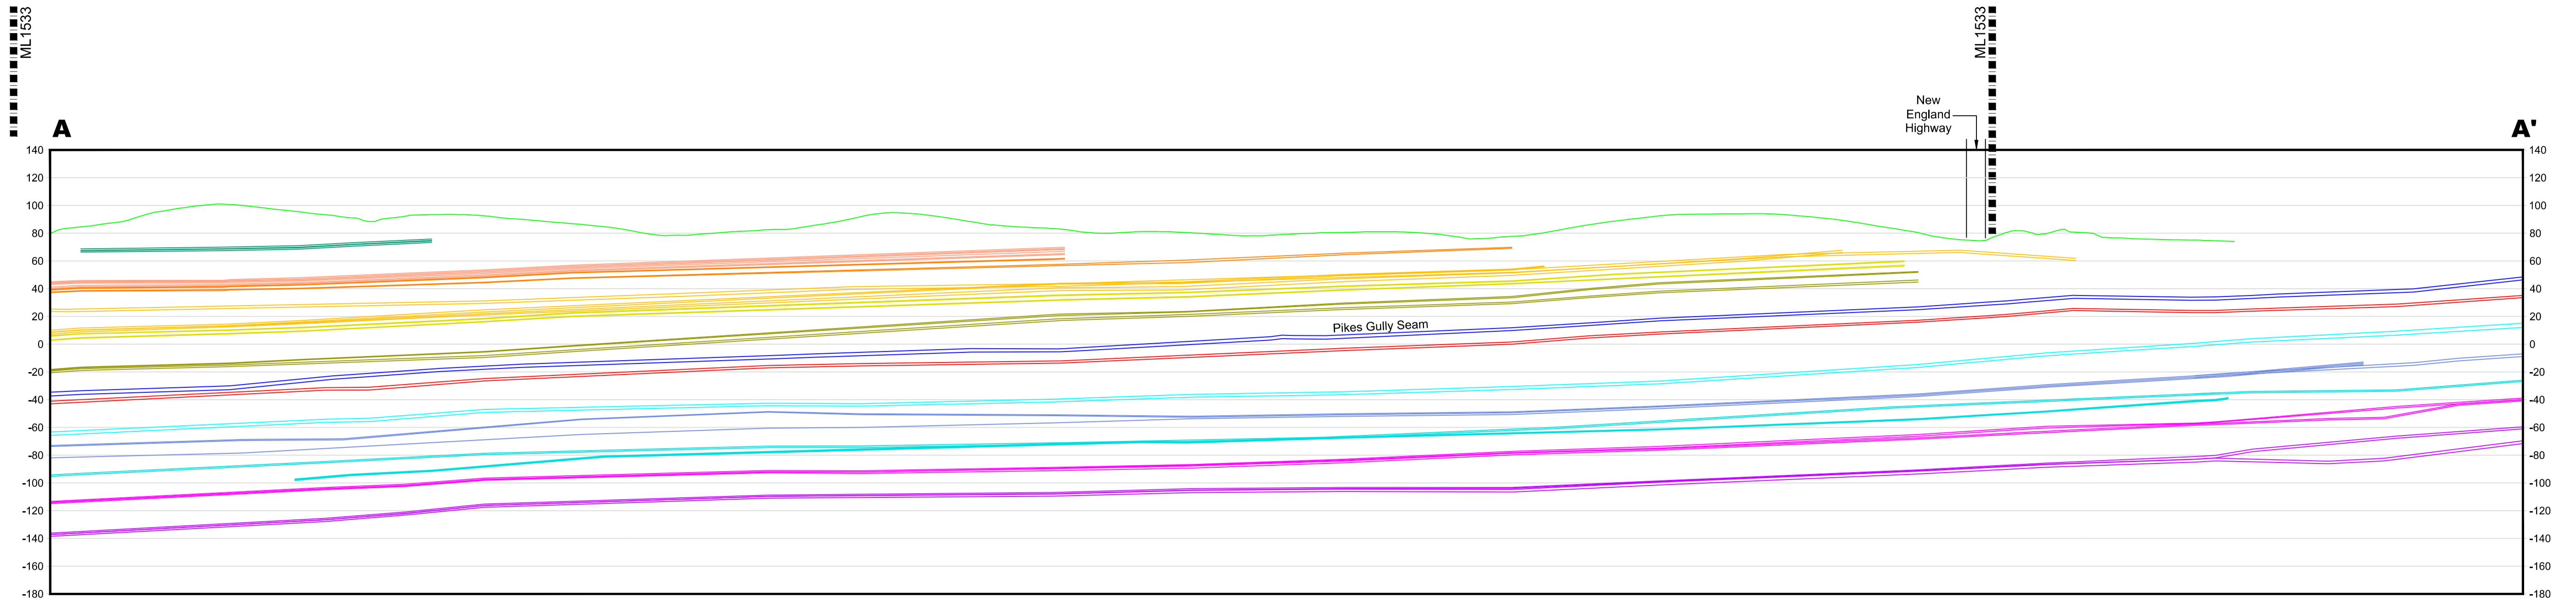
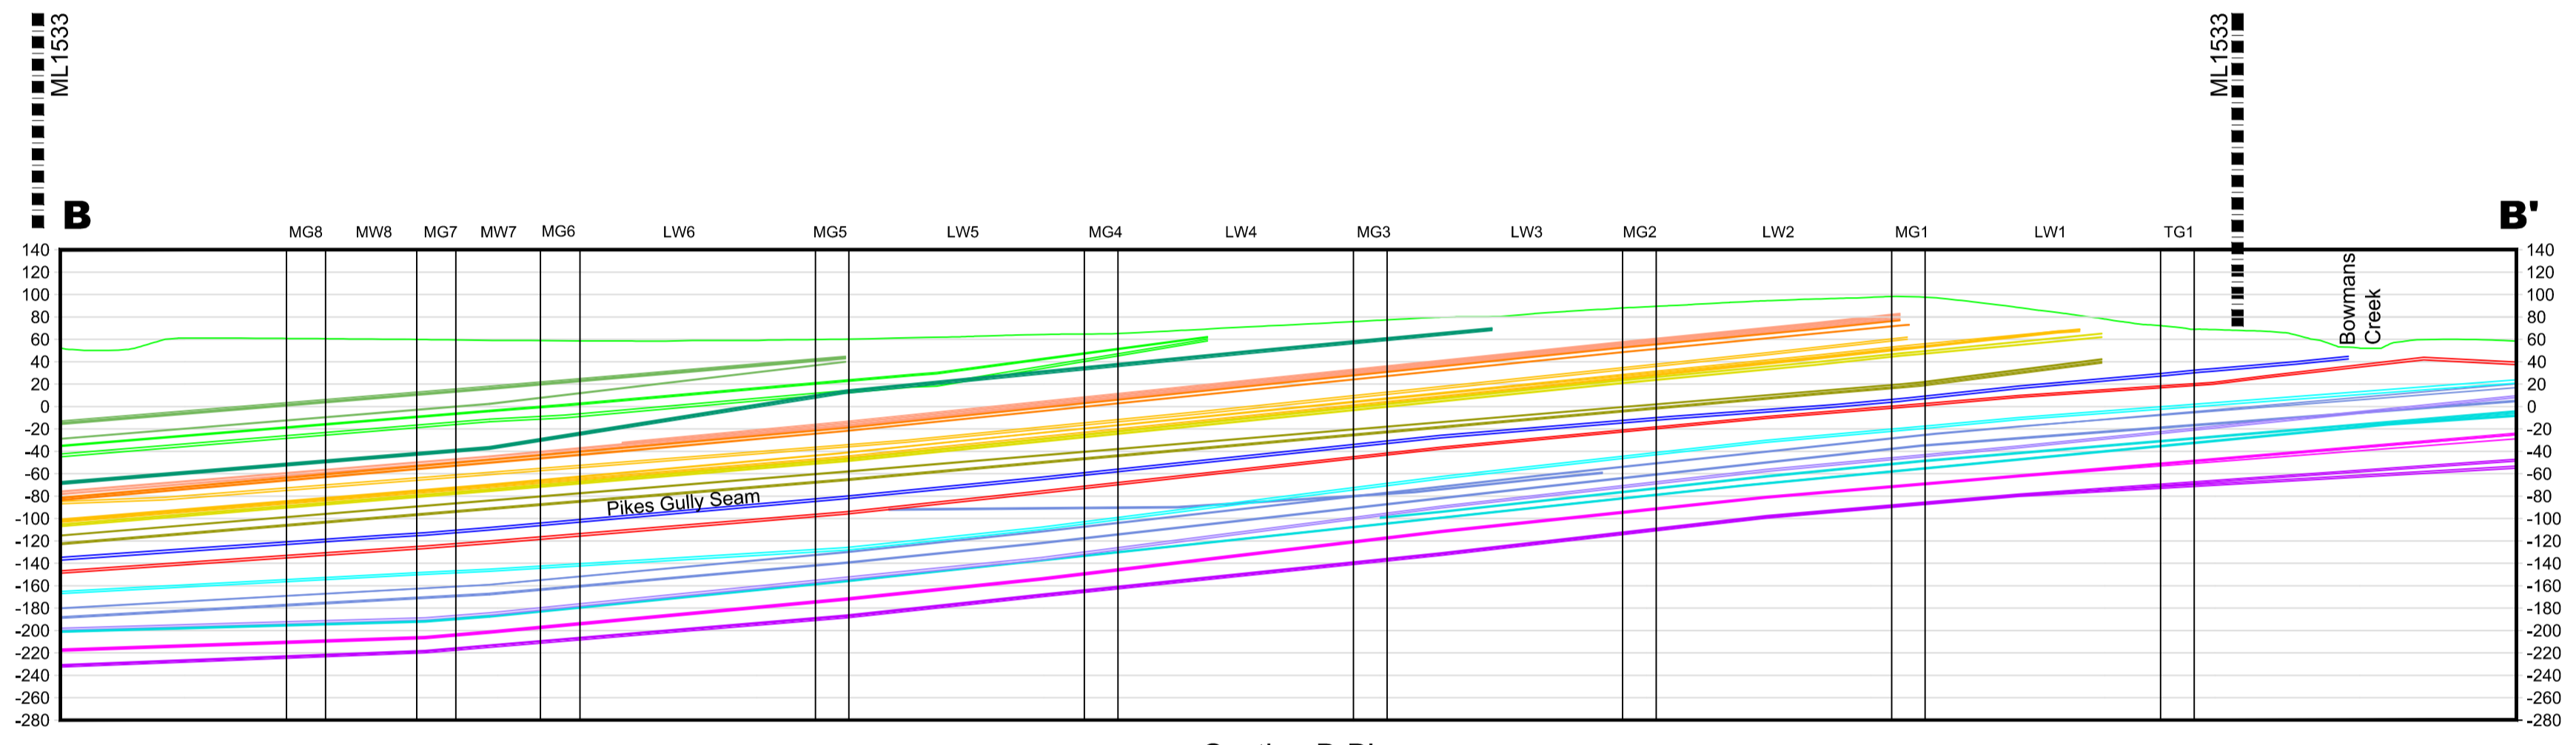
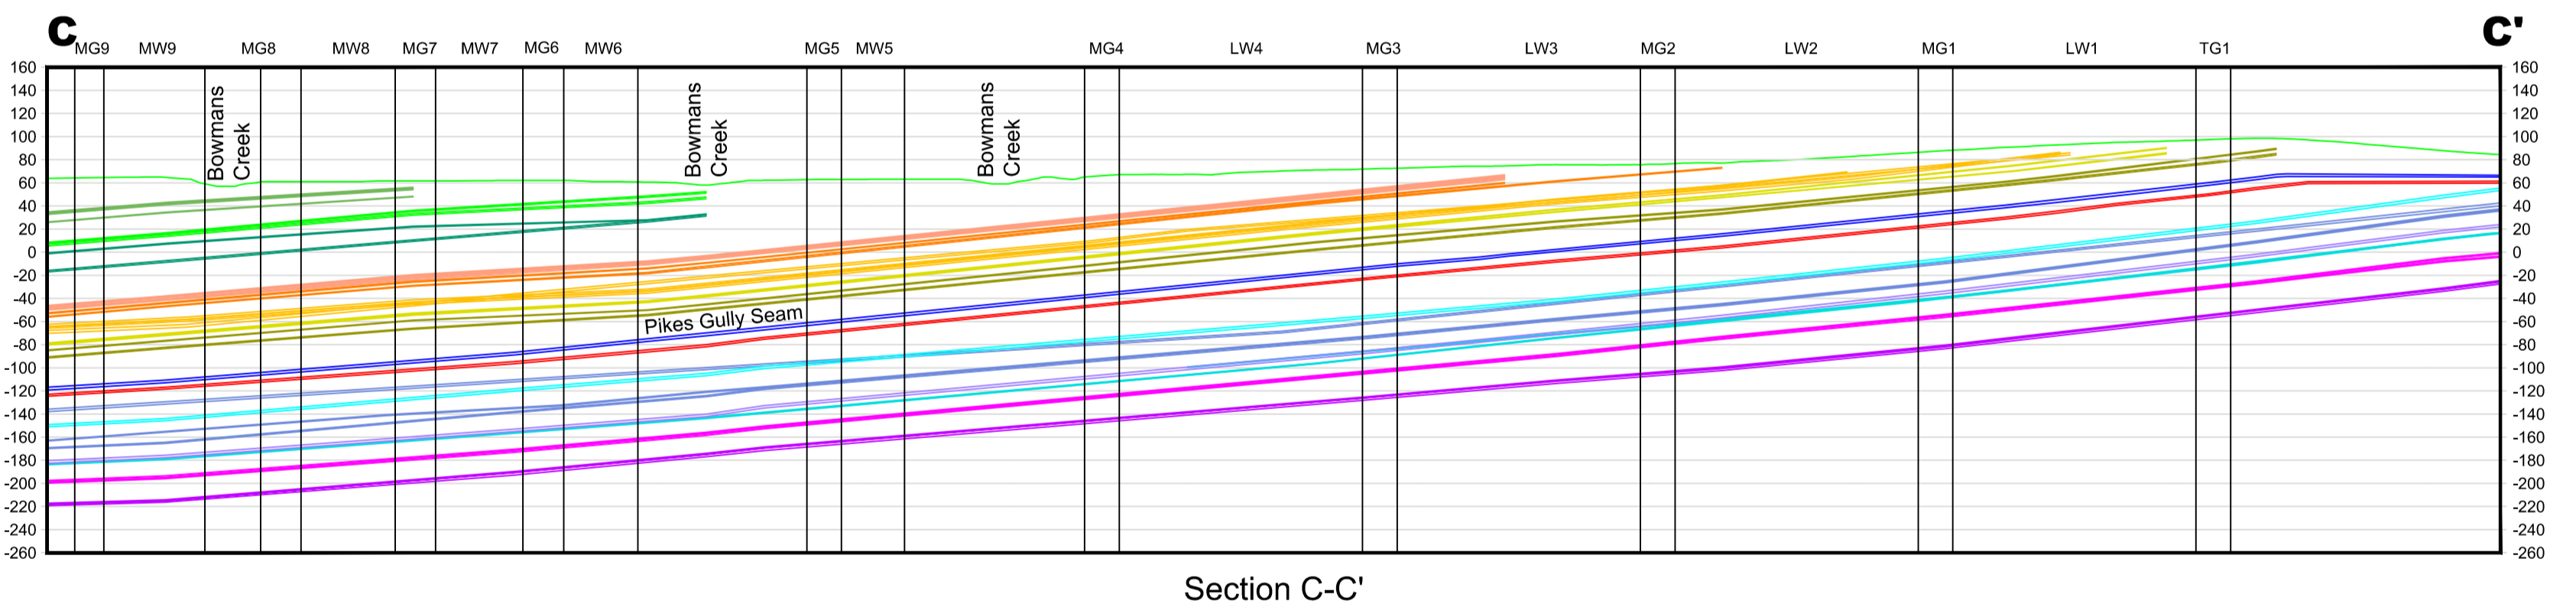
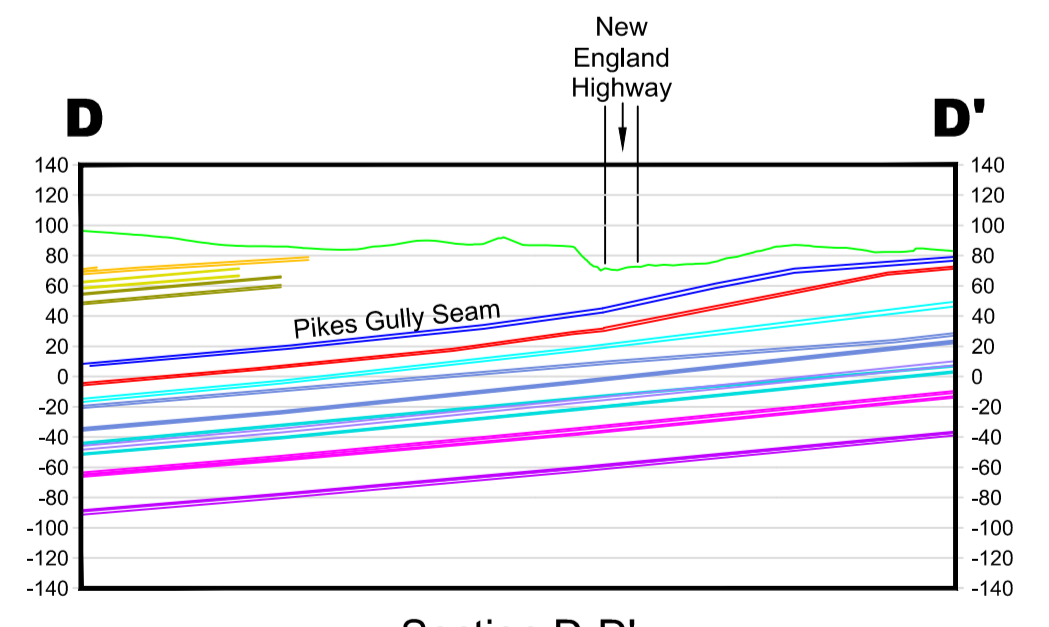
ASHTON UNDERGROUND MINE  
AEMR  
PLAN 7 (b) - Sections

Section A-A'  
Vertical Scale 1:2,500  
Horizontal Scale 1:5,000

Section B-B'  
Vertical Scale 1:5,000  
Horizontal Scale 1:5,000

Section C-C'  
Vertical Scale 1:5,000  
Horizontal Scale 1:5,000

Section D-D'  
Vertical Scale 1:5,000  
Horizontal Scale 1:5,000
