Ashton Coal Operations Pty Limited Annual Environmental Management Report 2008/2009

ANNUAL ENVIRONMENTAL MANAGEMENT REPORT

Name of mine	Ashton Coal Mine		
Titles/Mining Leases	ML1526 and ML1533		
MOP Commencement Date	1/11/2007	MOP Completion Date	31/12/2012
AEMR Commencement Date	2/09/2008	AEMR Completion Date	1/09/2009
Name of Leaseholder	White Mining NSW Limited & ICRA (Ashton) Pty Ltd & International Marine Corporation		
Name of Operator (if different)	Ashton Coal Operations Pty Ltd		
Reporting Officer	Peter Barton		
Title	General Manager		
Signature

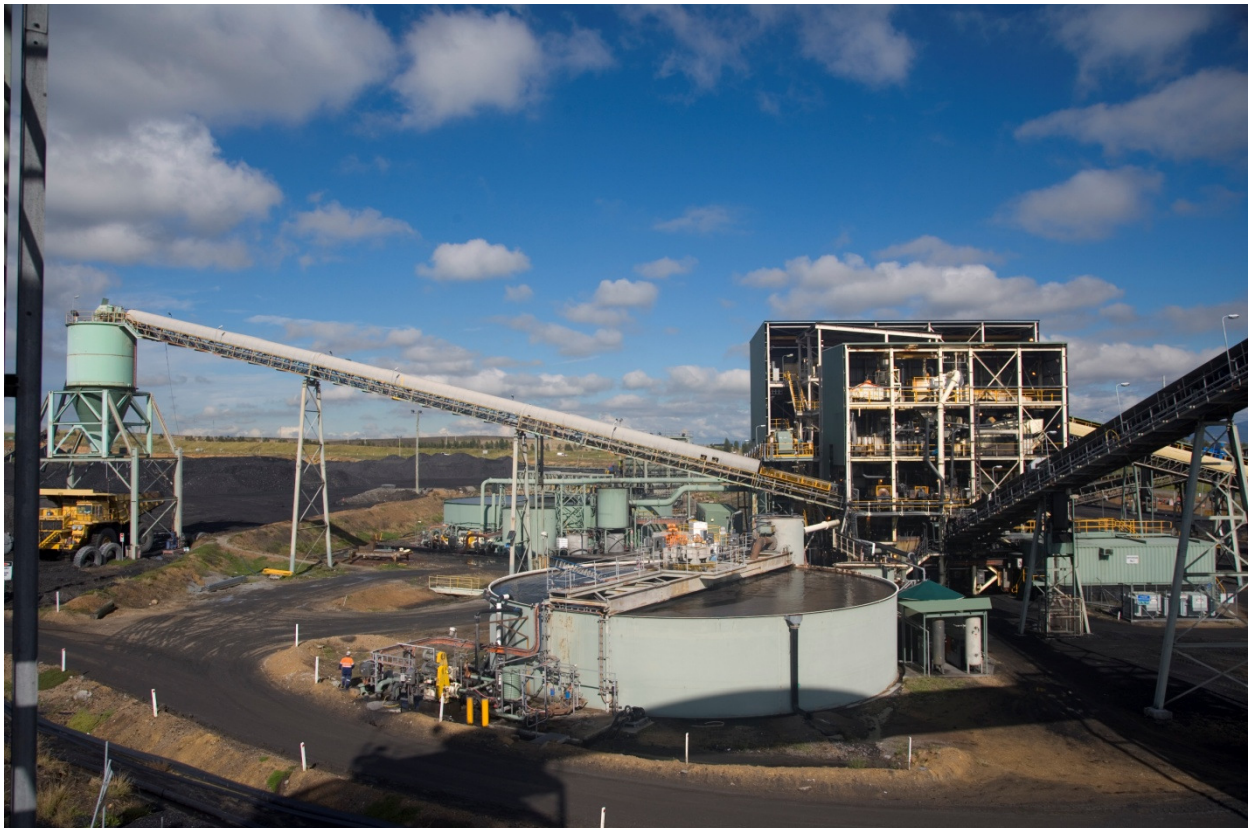
Figure 2. Coal Handling Preparation Plant

The CHPP processed 5.26Mt ROM coal during the reporting period to produce 3.23Mt of semi-soft and thermal product coal. Coal was transported by rail to the Port of Newcastle for sale on the export market. Some semi soft coking coal was sold to domestic steel mills.

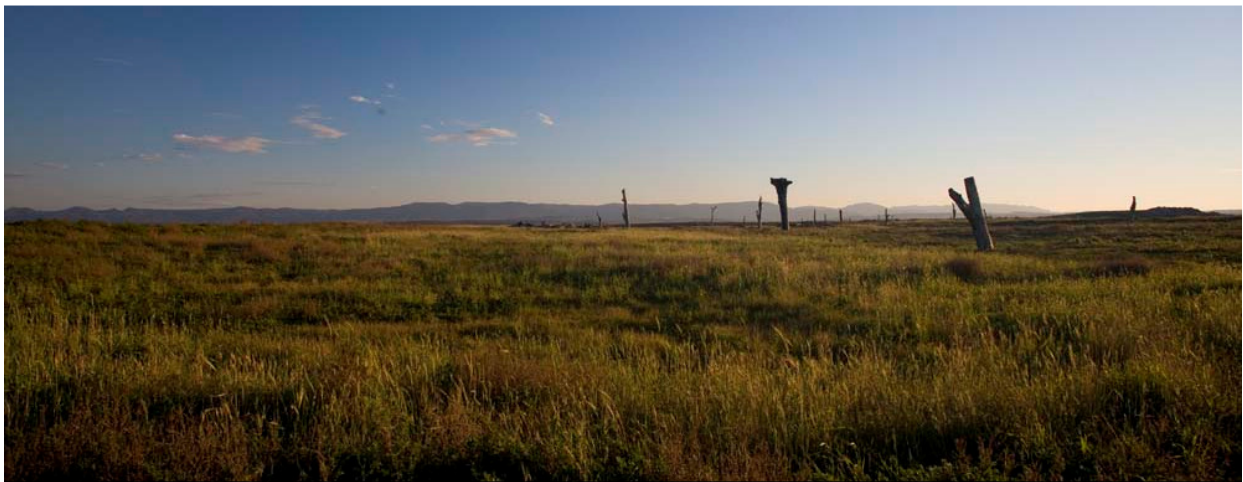
Top of eastern emplacement rehabilitation

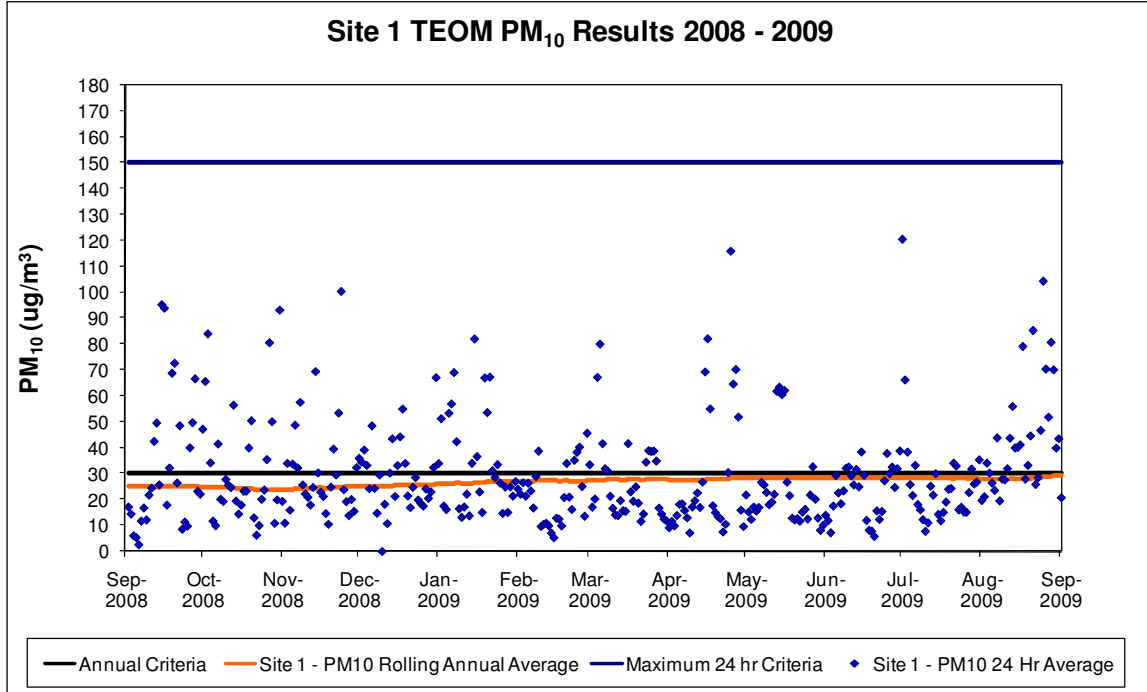
Site 1 TEOM

Site 1 is located in the northern portion of the village of Camberwell. 99% of data was captured for Site 1 for the reporting period. Results of PM₁₀ monitoring at this location were as follows.

The rolling average PM₁₀ results for Site 1 demonstrates compliance with the annual goal of 30µg/m³. Site 1 also demonstrated compliance with the maximum 24hr Criteria of 150µg/m³.

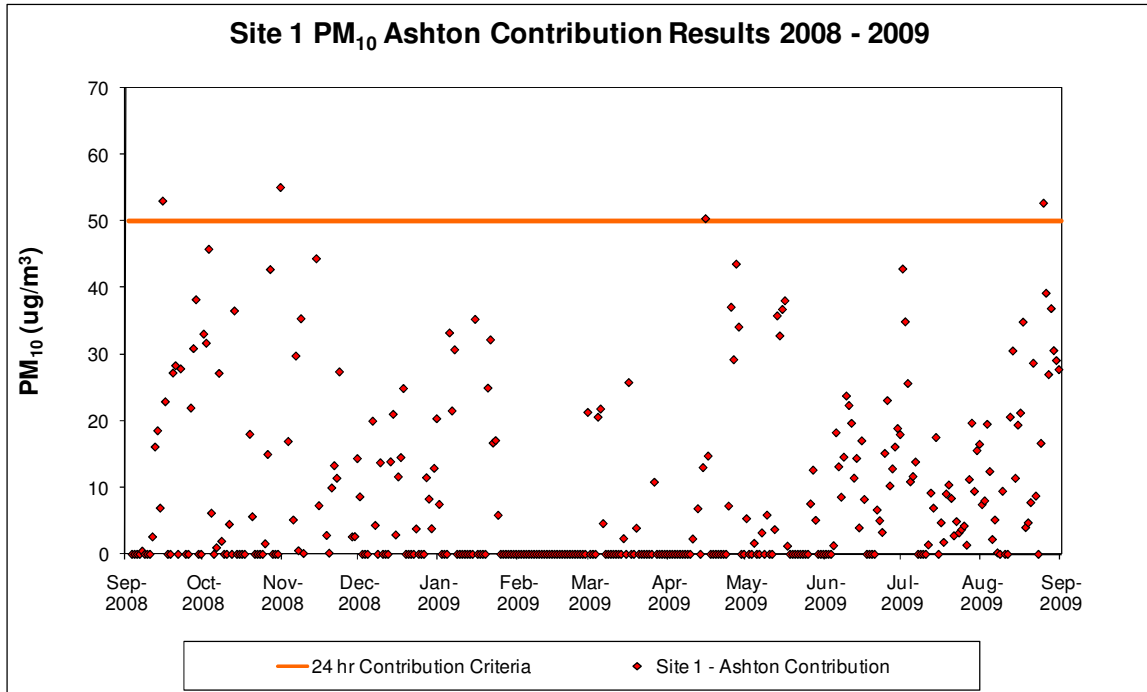
Note: Ashton Contributions are calculated where there is a NW wind direction otherwise the contribution is plotted as 0.

There were 3 instances where Ashton’s community contribution was recorded above the criteria of 50µg/m³. These exceedences are addressed above.

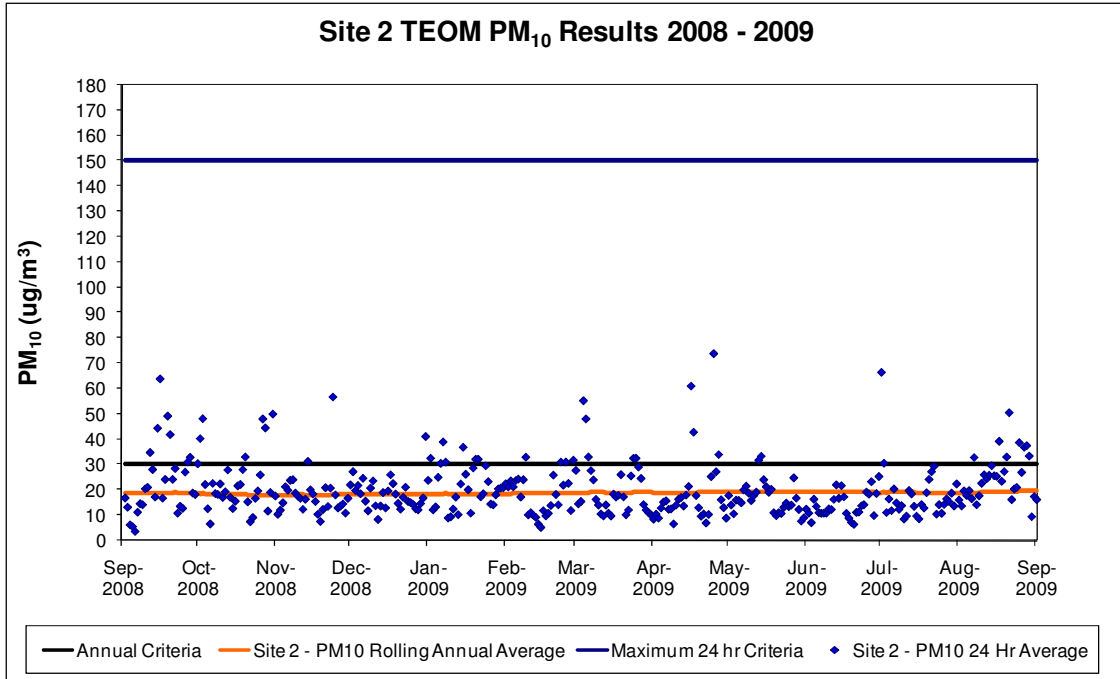
Site 2 is located in Camberwell village on the south side of the New England Highway. 100% of data was captured from Site 2 for the reporting period. Results of PM₁₀ monitoring at this location were as follows:

The rolling average PM₁₀ results for Site 2 demonstrates compliance with the annual criteria of 30µg/m³ and with the maximum 24 hour criteria of 150µg/m³.

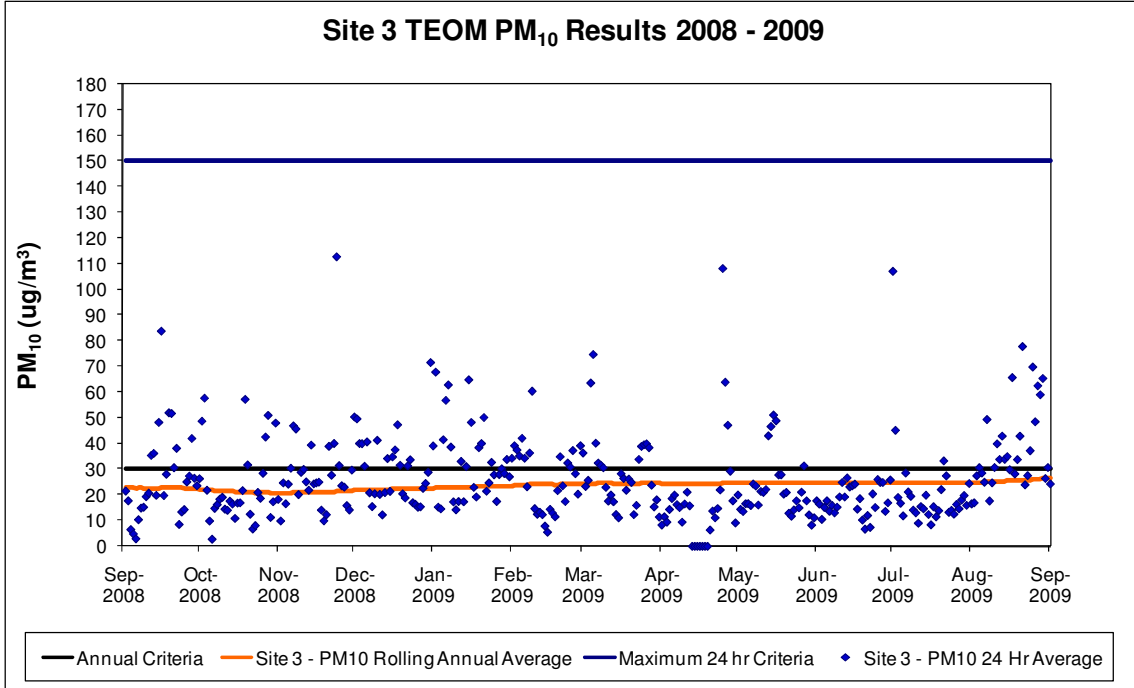
Site 3 is located on a farming property to the east of the Eastern Emplacement Area. 98% of data was recovered at Site 3 for the reporting period. Results of PM₁₀ monitoring at this location were as follows:

The rolling average PM₁₀ results for Site 3 demonstrates compliance with the annual criteria of 30µg/m³. Site 3 also complied with the maximum 24 hour criteria of 150µg/m³.

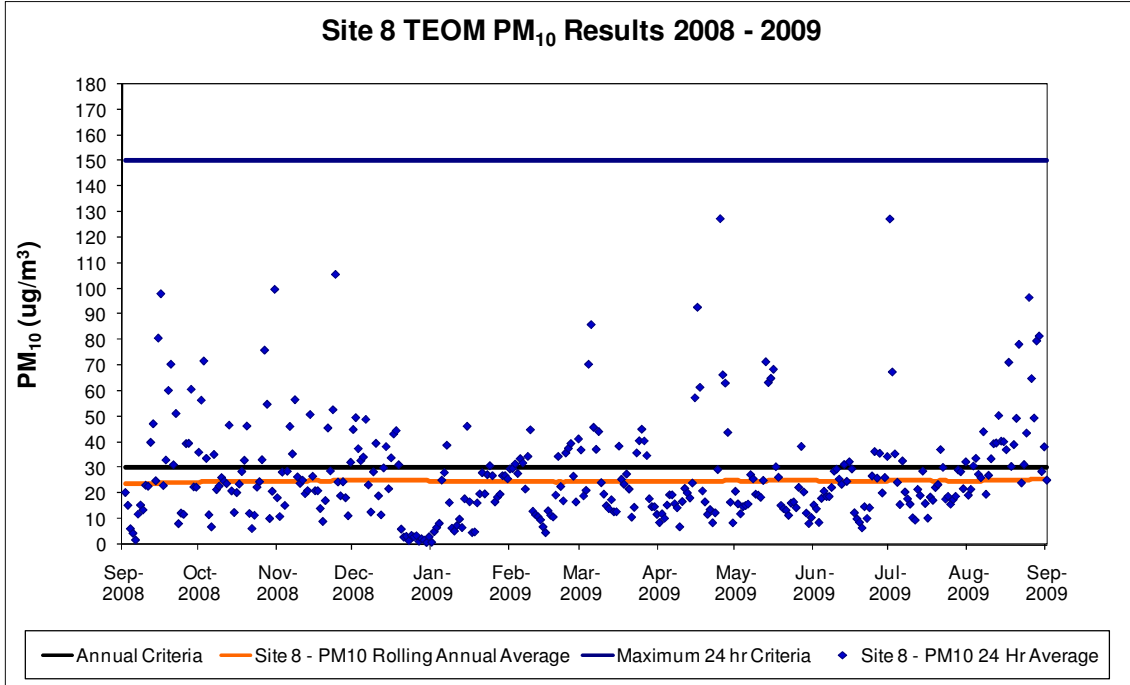
Site 8 is located on the eastern side of Camberwell Village. The site recorded a 100% data recovery rate.

Site 8 showed compliance with the annual criteria of $30\mu\text{g}/\text{m}^3$. Site 8 also complied with the maximum 24 hour criteria of $150\mu\text{g}/\text{m}^3$.

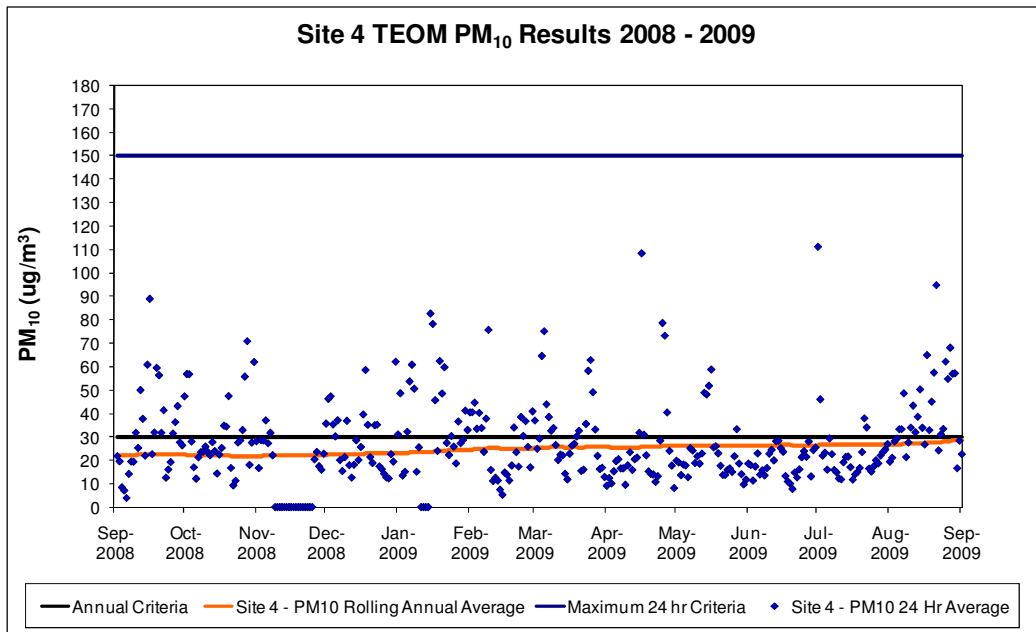
Site 4 is located on the eastern tip of the eastern emplacement area, next to Dam 5/6. 94 % of data was recovered at site 4 for the reporting period. Data loss was caused by a power surge which damaged the unit.

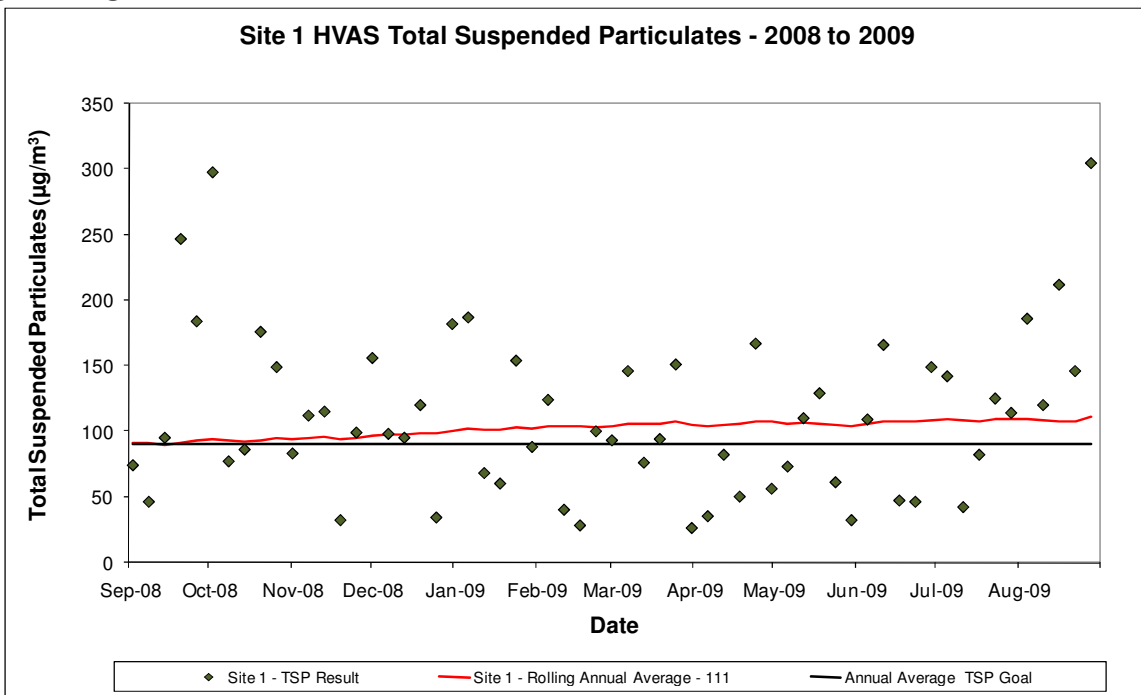
Site 1 HVAS

The cumulative rolling annual average for TSP at site 1 demonstrated non-compliance with the annual average criteria of 90µg/m³. The annual average for the reporting period was 111µg/m³. The figure above shows a general increase in TSP results at Site 1 over the past 12 months.

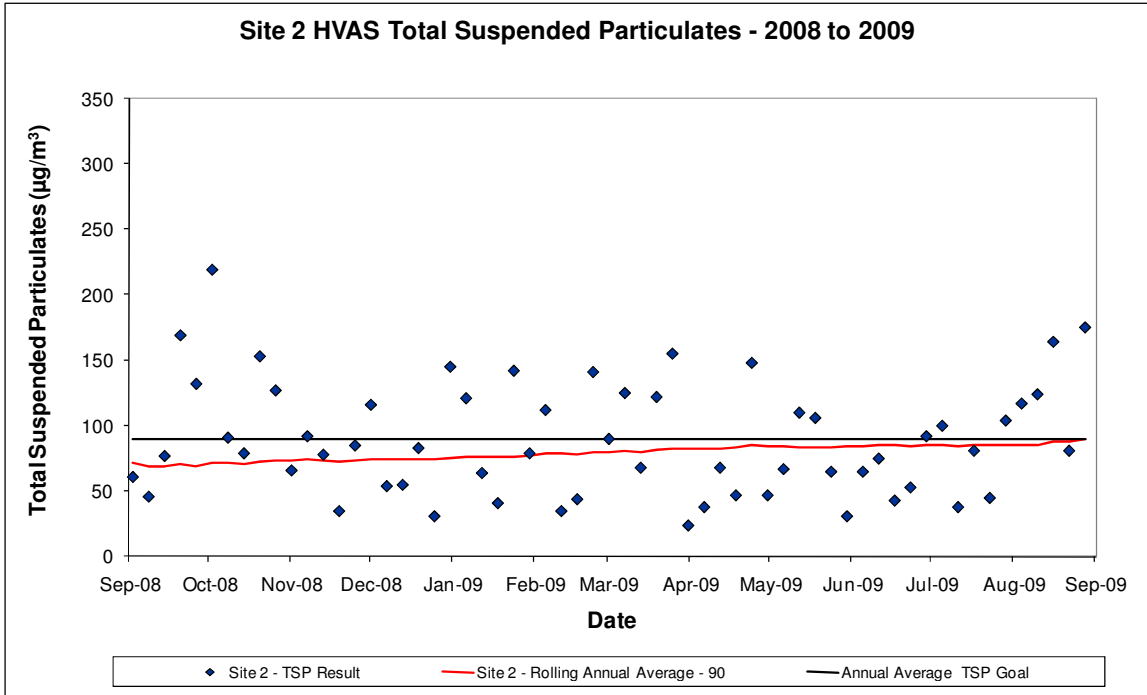
Site 2 HVAS

The cumulative rolling average TSP results for Site 2 complied with the annual average TSP goal of 90µg/m³ for the reporting period. The annual average for the reporting period at Site 2 was 90µg/m³.

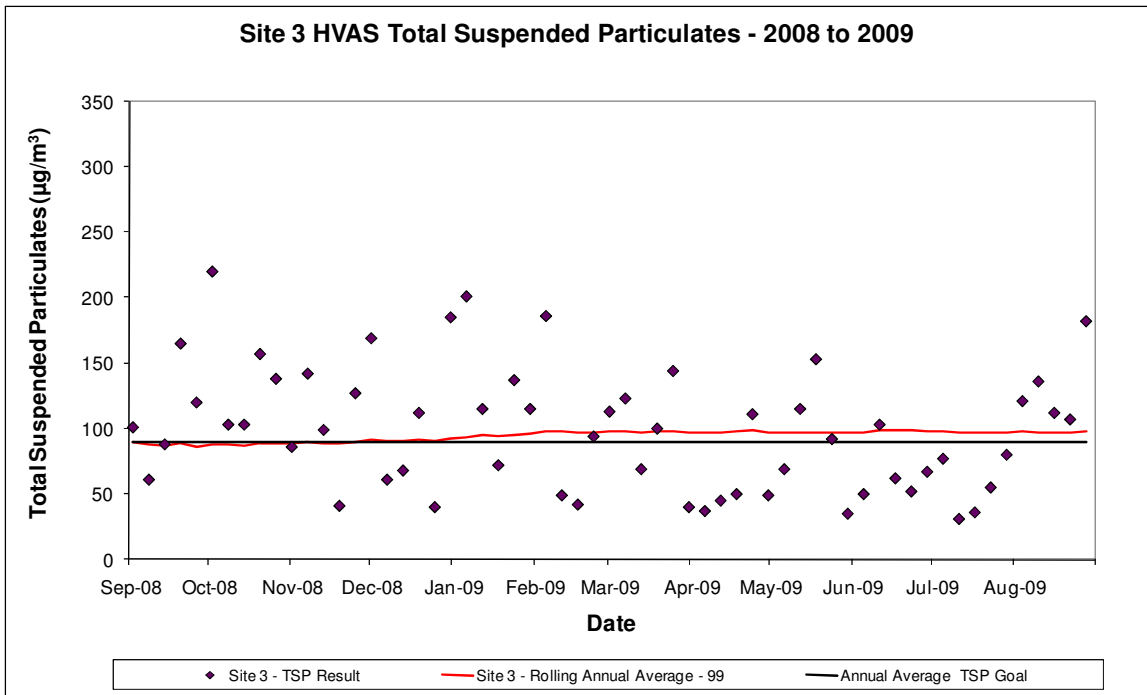
Site 3 HVAS

The cumulative rolling average TSP results for Site 3 exceeded the annual average TSP goal of 90µg/m³ during the reporting period. The annual average for the reporting period at Site 3 was 99µg/m³.

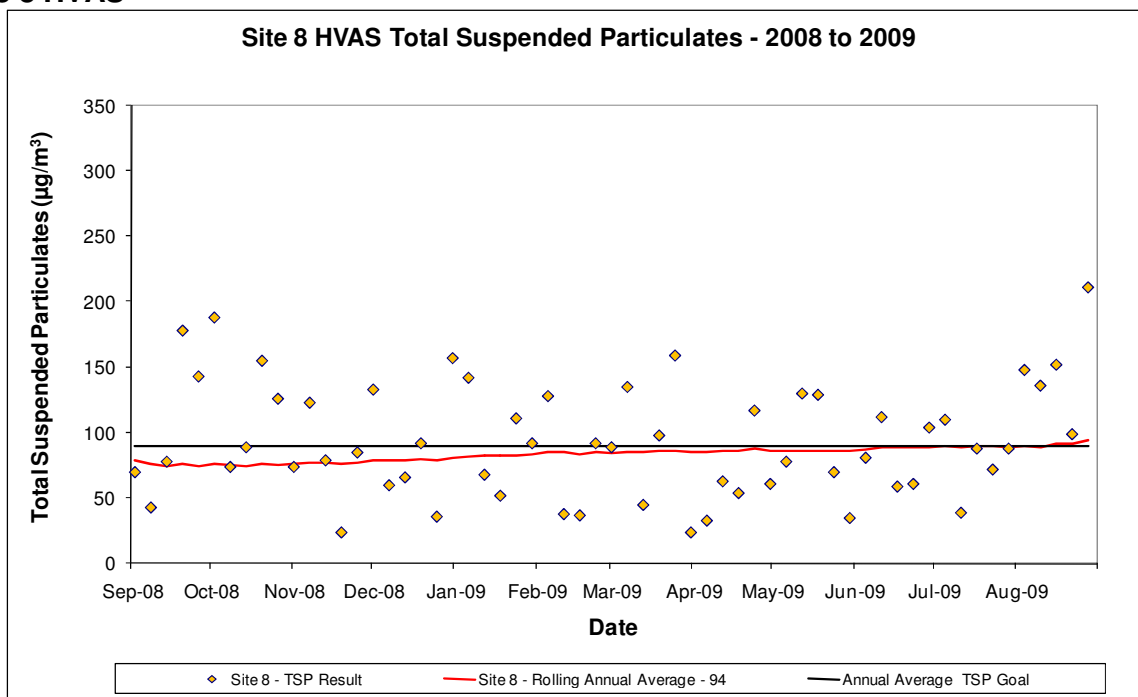
Site 8 HVAS

The cumulative TSP rolling annual average exceeded Ashton Coals criteria (90µg/m³) for the reporting period. The annual average at Site 8 for the reporting period was 94µg/m³.

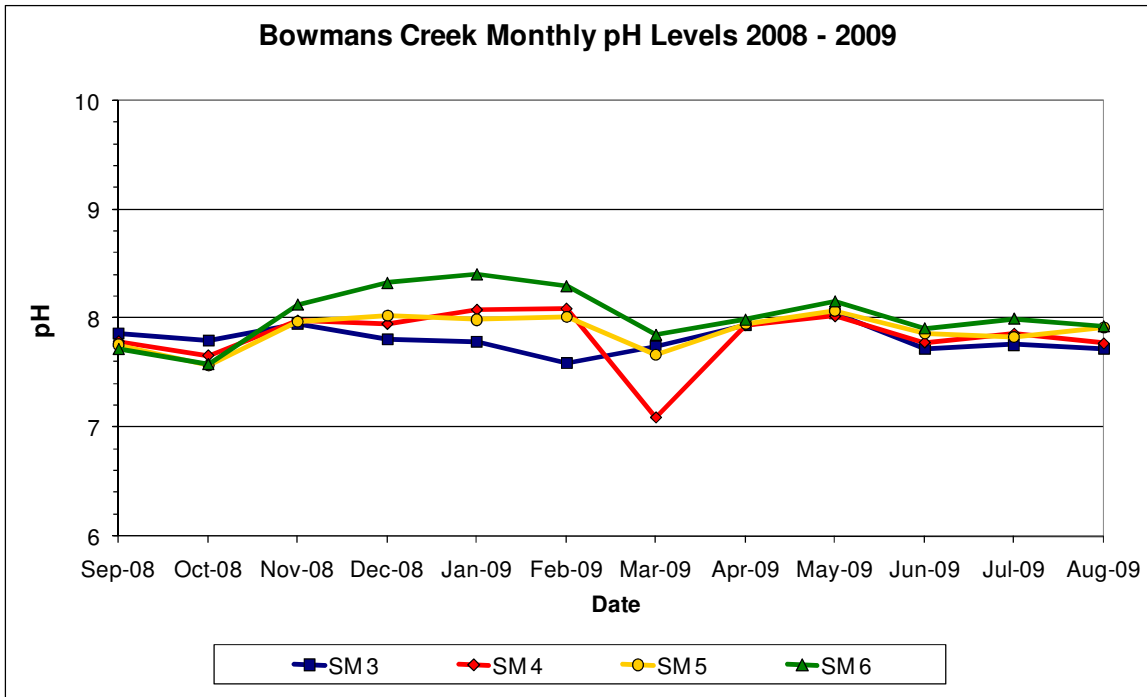
pH levels in Bowmans Creek (SM3, SM4, SM5 and SM6) were neutral to slightly alkaline (ranging from 7.1 to 8.4) and remained within the acceptable recommended pH range.

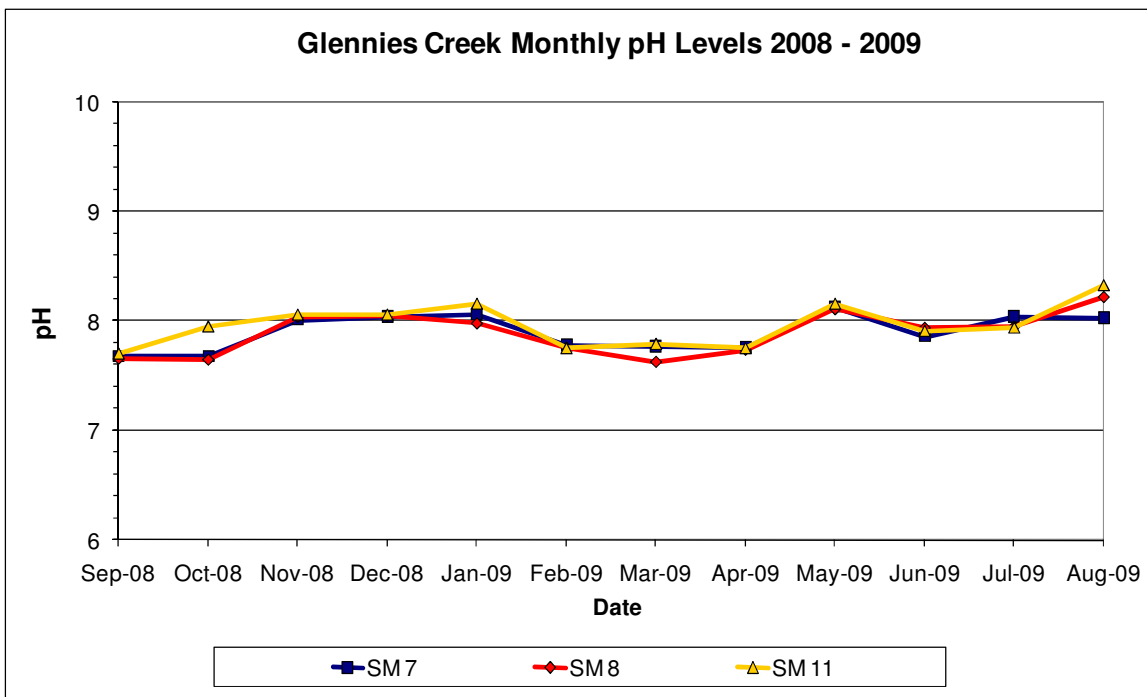
Glennies Creek (SM7, SM8 and SM11) pH levels were neutral to slightly alkaline (ranging from 7.7 to 8.2) with little variation between sites, and remained within the acceptable recommended pH range.

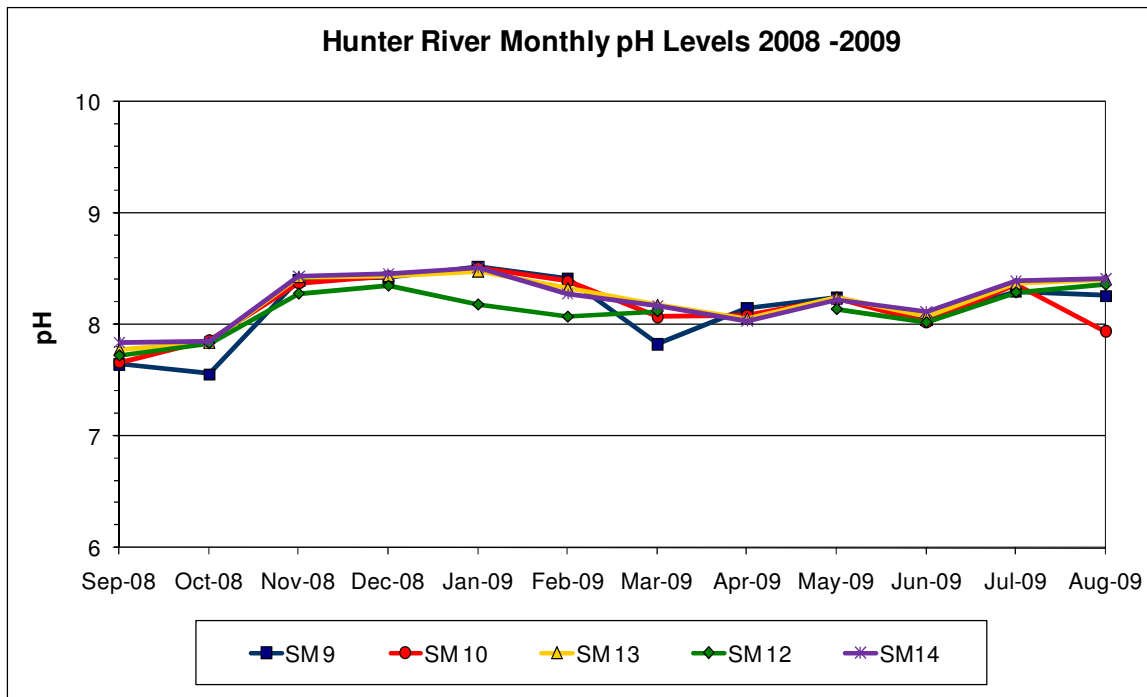
pH levels in the Hunter River (SM9, SM10, SM12, SM13 and SM14) were neutral to slightly alkaline (ranging from 7.6 to 8.5) with minimal variation between sites, and remained within the acceptable recommended pH range. Similar to Glennies Creek slight pH fluctuations throughout the reporting period followed a very similar pattern across all sites. pH is often slightly lower at SM12 (particularly during dry spells) as it is located downstream of the confluence with Glennies Creek.

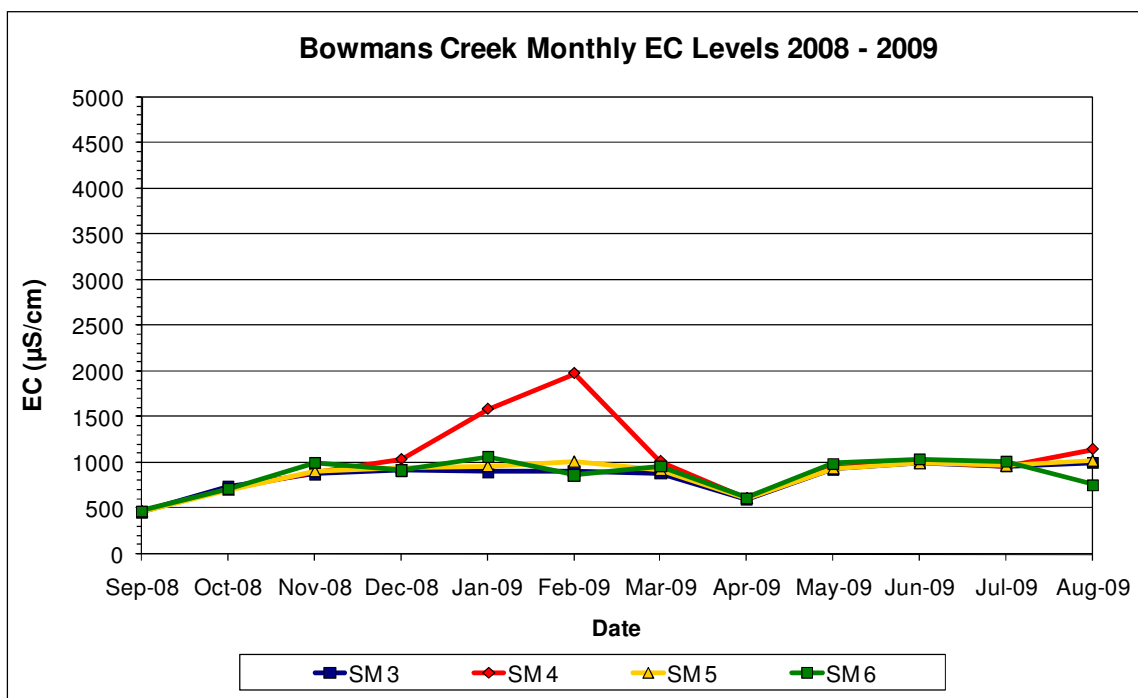
Electrical Conductivity (EC) levels in Bowmans Creek fluctuated between 463µS/cm and 1980µS/cm. During the dry spell in January and early February 2009 Bowmans Creek ceased to flow and saline groundwater inflows (>10,000µS/cm) became the dominant water source for the pool at SM4. As a result EC levels began to increase. This has been identified in the past with EC levels >10,000µS/cm being recorded in the past.

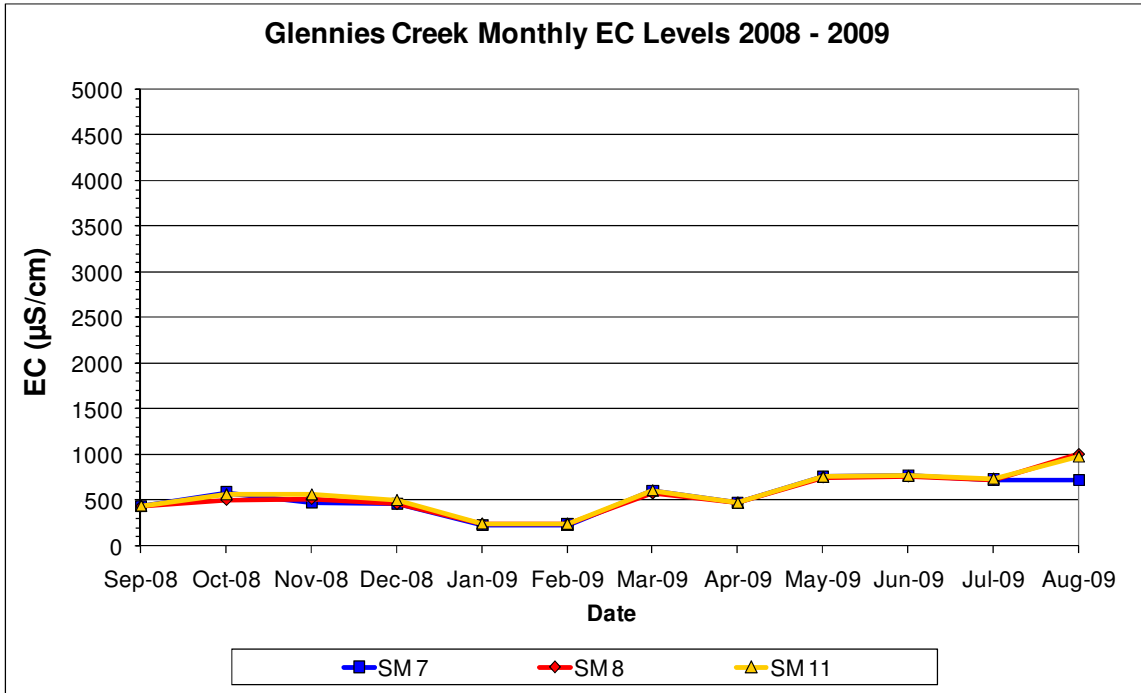
The EC of water in Glennies Creek (SM7, SM8 and SM11) remained consistently low. All three sites trended together throughout the period indicating no impacts from Ashton Coal Operations.

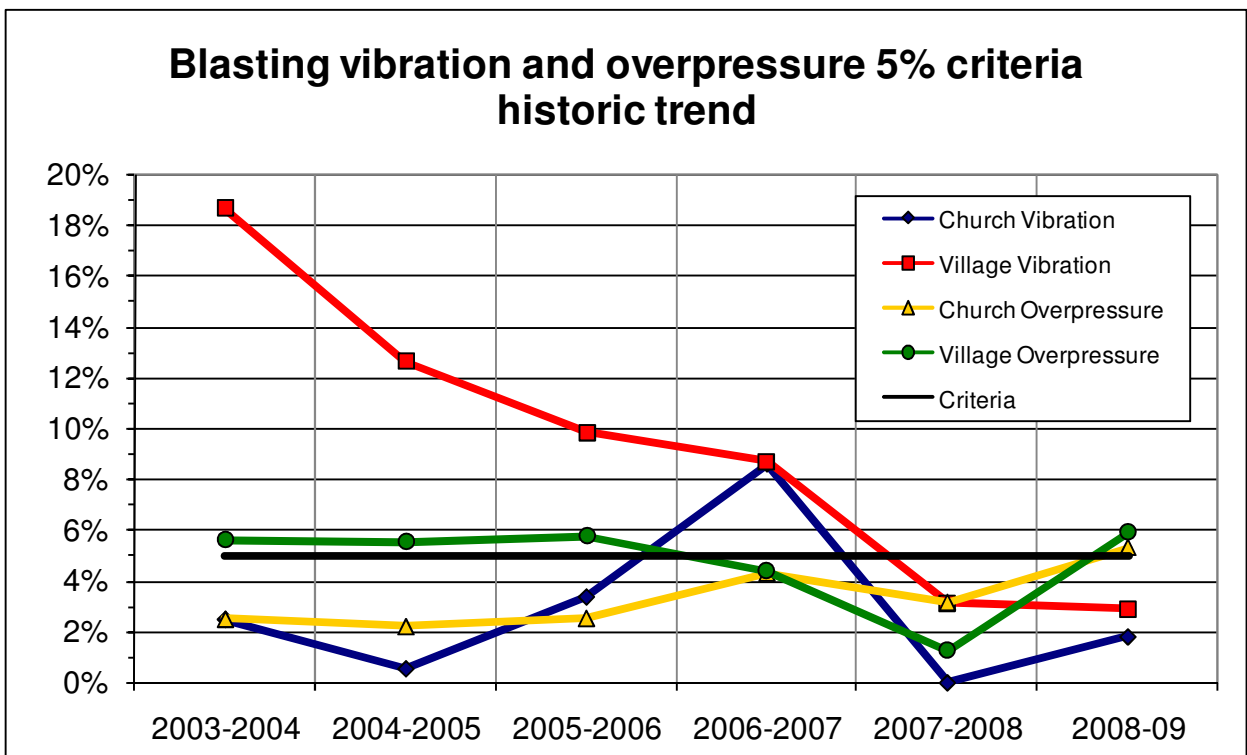
Figure 13. Blasting vibration and overpressure 5% criteria historic trend

Long term blasting trends are presented in **Figure 13**. Compliance with the 5% criteria for overpressure and vibration has significantly improved over the past 6 years of operation. Electronic detonation has allowed the continued decrease in blast vibration results at both the Church and Village monitors. The increase in overpressure results above 115dB_L is primarily the result of the close proximity of blasting to Camberwell Village during the last quarter of the period. During this time a number of surface shots (including the 120dB_L) exceedence were fired. These figures are expected to decline again once these surface shots have been completed.

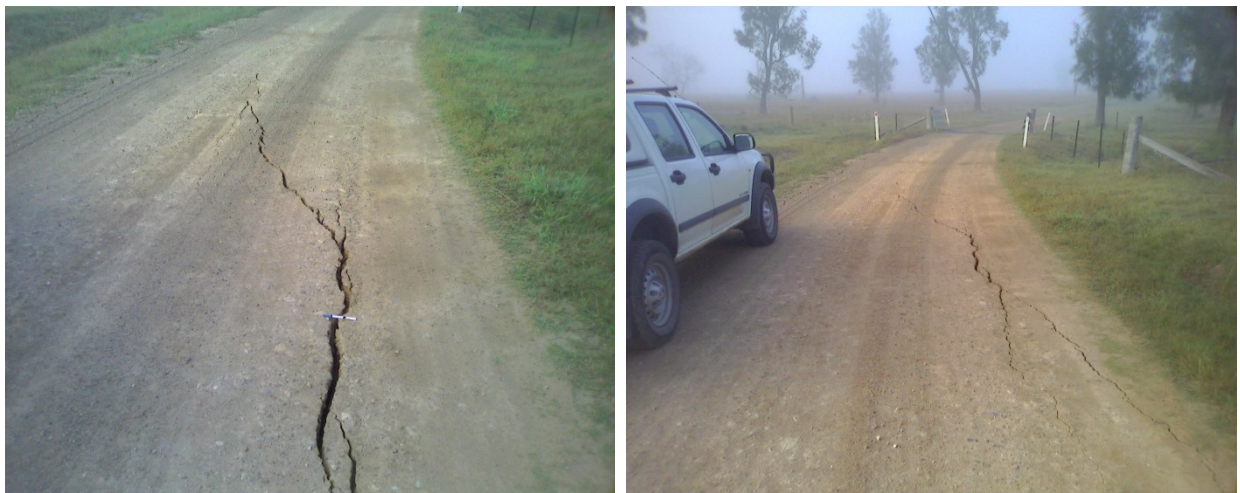
Figure 14. Subsidence cracks, Longwall 3

In general, the maximum subsidence movements detected were less than those predicted. There is no indication of any significant lateral movement of the steep slope adjacent Glennies Creek or of the New England Highway cutting.

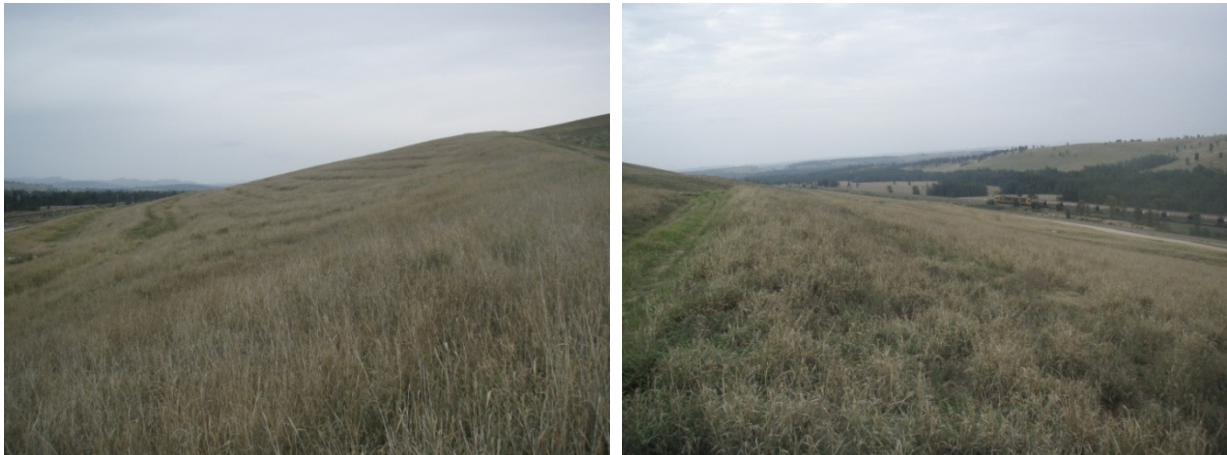
Figure 20. Pasture rehabilitation seeded Autumn 2008

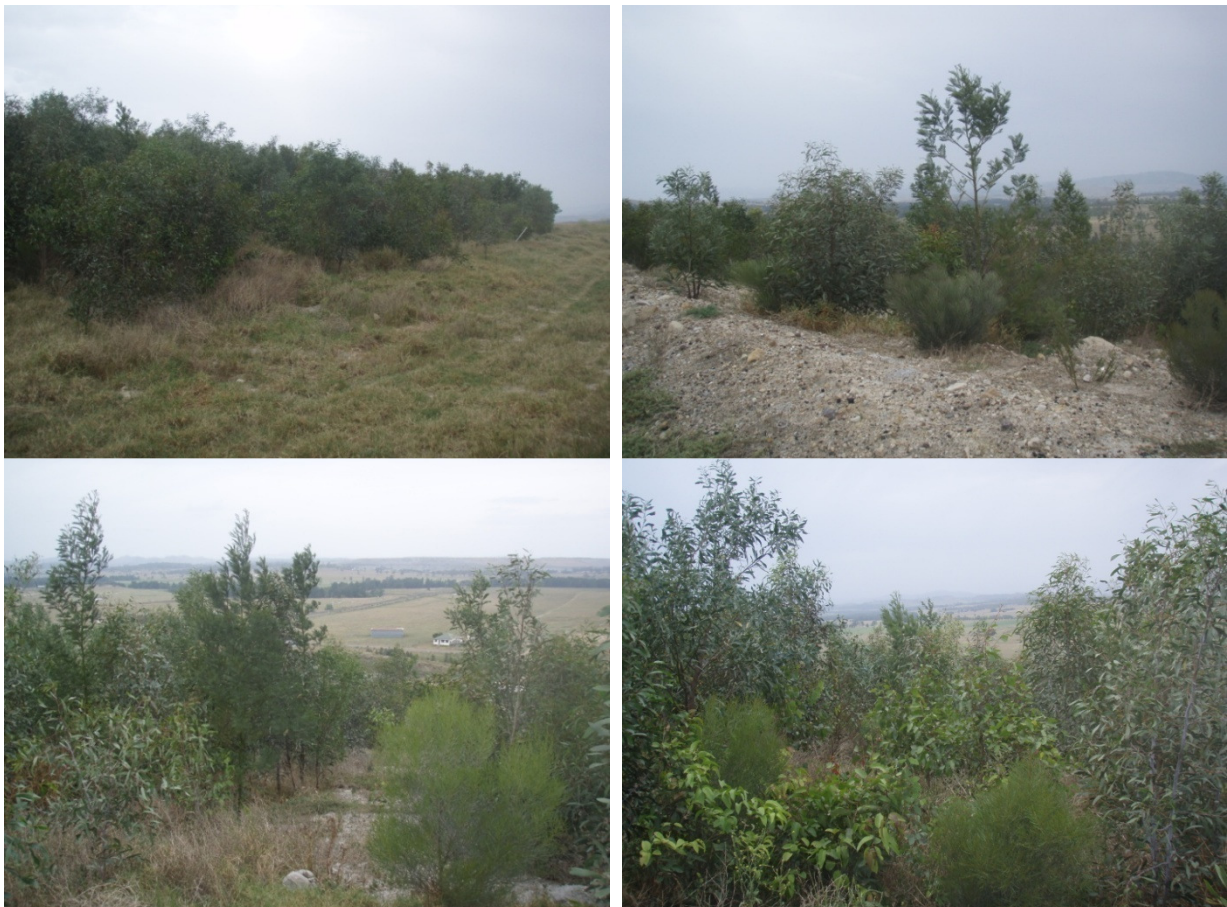
Figure 21. Woodland rehabilitation seeded Autumn 2007

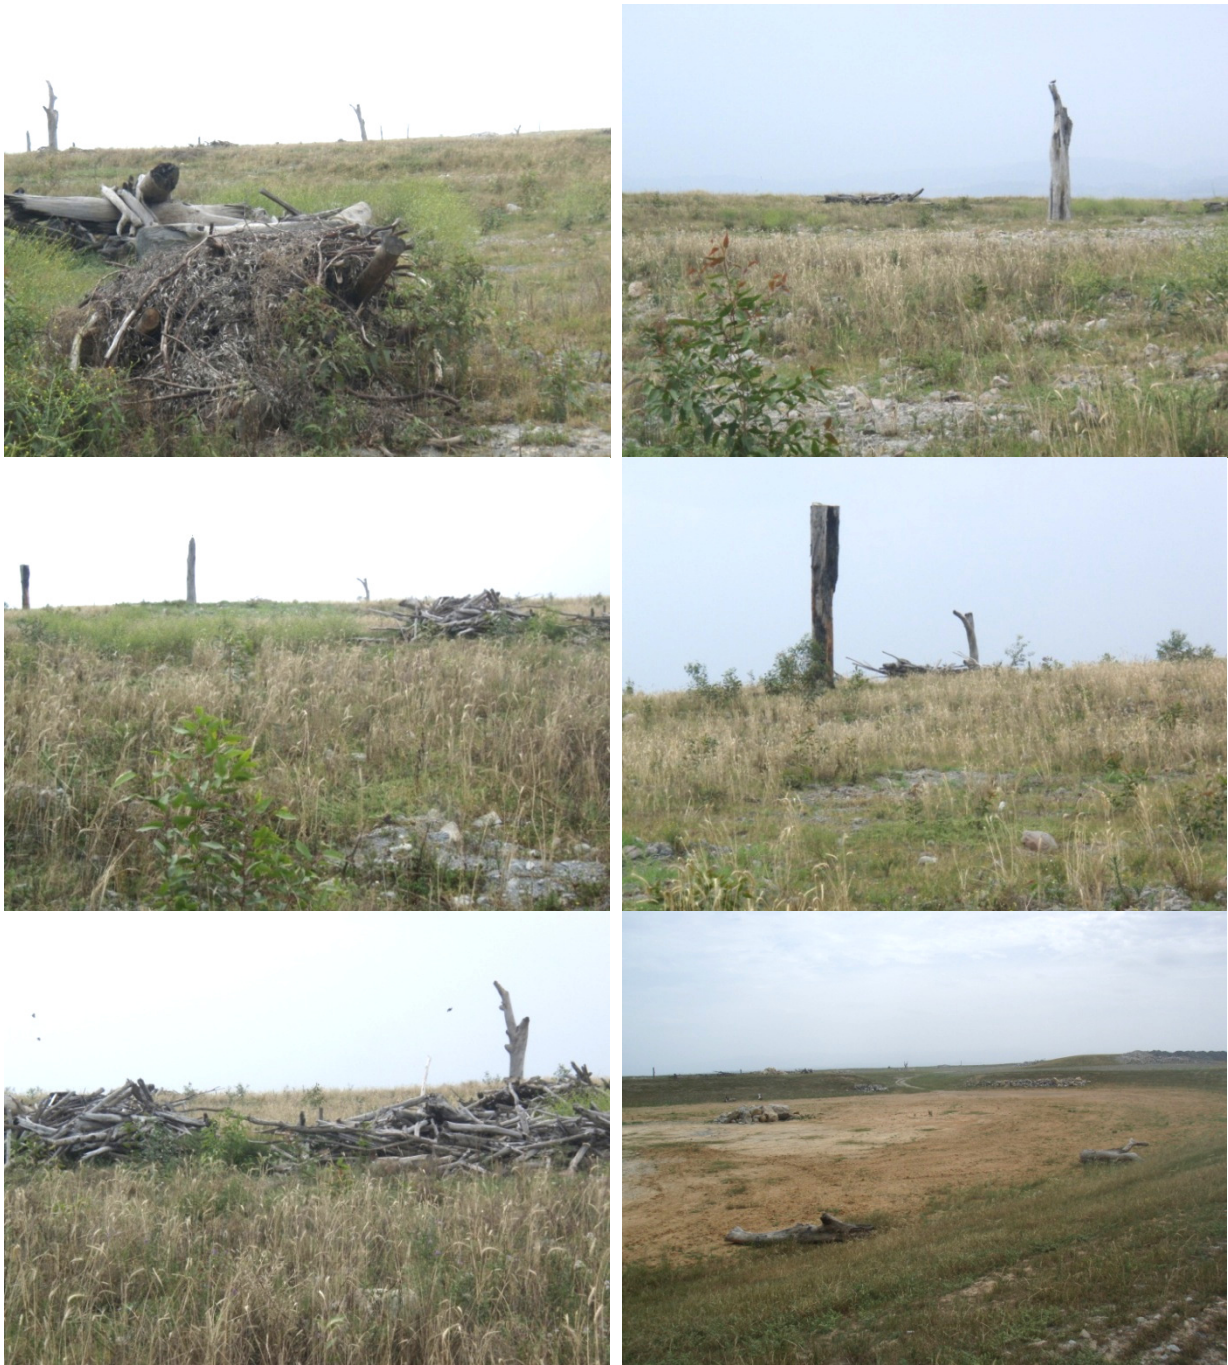
Figure 22. Woodland rehabilitation on the top of the EEA including habitat augmentation seeded Autumn 2008
