# Ashton Coal Operations Pty Limited Annual Environmental Management Report 2009/2010

**ANNUAL ENVIRONMENTAL MANAGEMENT REPORT**

<b>Name of Mine:</b>	Ashton Coal Mine
<b>Titles/Mining Leases:</b>	ML1526 and ML1533
<b>MOP Commencement Date:</b>	1 November 2007
<b>MOP Completion Date:</b>	31 December 2012
<b>AEMR Commencement Date:</b>	2 September 2009
<b>AEMR Completion Date:</b>	1 September 2010
<b>Name of Leaseholder:</b>	White Mining NSW Limited & ICRA (Ashton) Pty Ltd & International Marine Corporation
<b>Name of Operator (if different):</b>	Ashton Coal Operations Pty Ltd
<b>Reporting Officer:</b>	Brian Wesley
<b>Title:</b>	General Manager

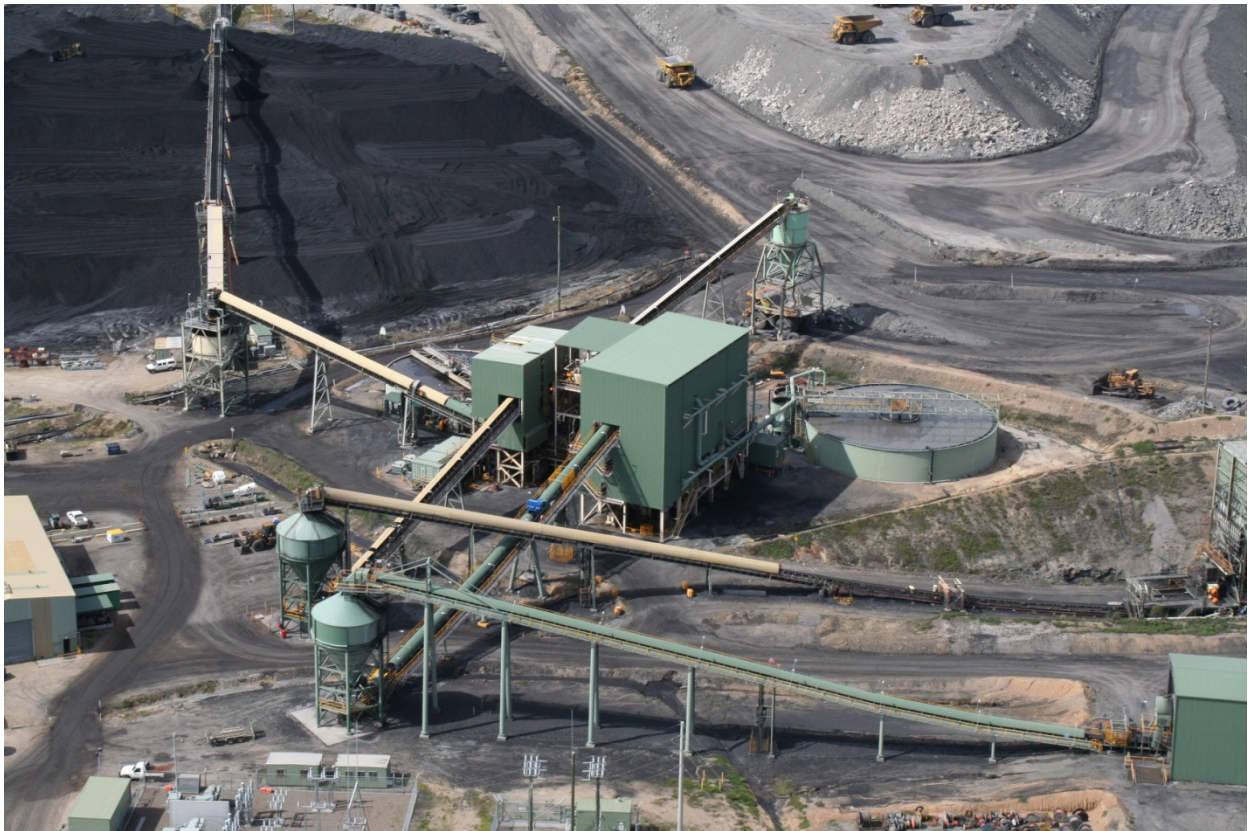
**Figure 2. Coal Handling Preparation Plant**

The CHPP processed 4.44Mt ROM coal during the reporting period to produce 2.53Mt of semi-soft and thermal product coal. Coal was transported by rail to the Port of Newcastle for sale on the export market. Some semi soft coking coal was sold to domestic steel mills.

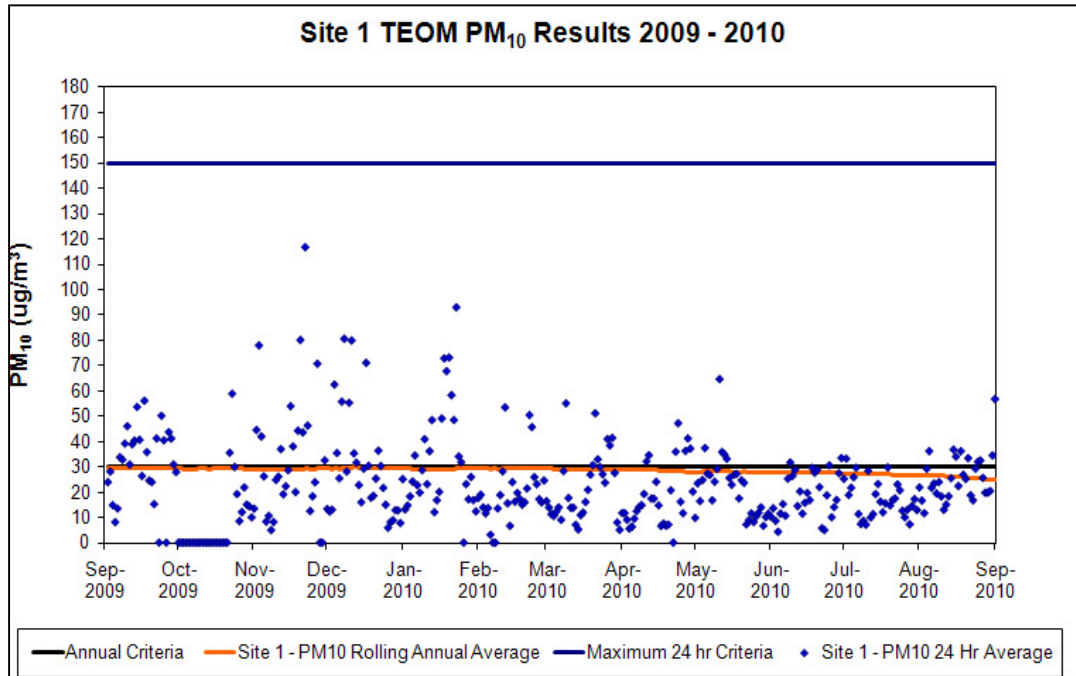
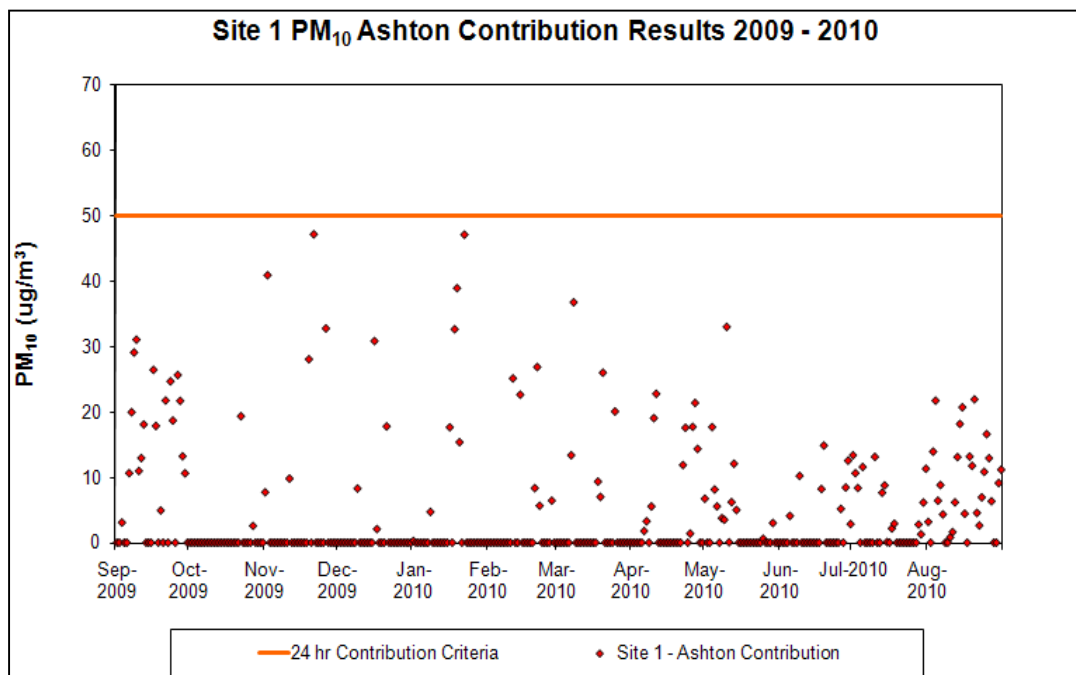
Site 1 is located in the northern portion of the village of Camberwell. 93% of data was captured for Site 1 for the reporting period. Results of PM<sub>10</sub> monitoring at this location were as follows.

The rolling average PM<sub>10</sub> results for Site 1 (25µg/m<sup>3</sup>) demonstrates compliance with the annual goal of 30µg/m<sup>3</sup>. Site 1 also demonstrated compliance with the maximum 24hr Criteria of 150µg/m<sup>3</sup>.

Note: Ashton Contributions are calculated where there is a NW wind direction otherwise the contribution is plotted as 0.

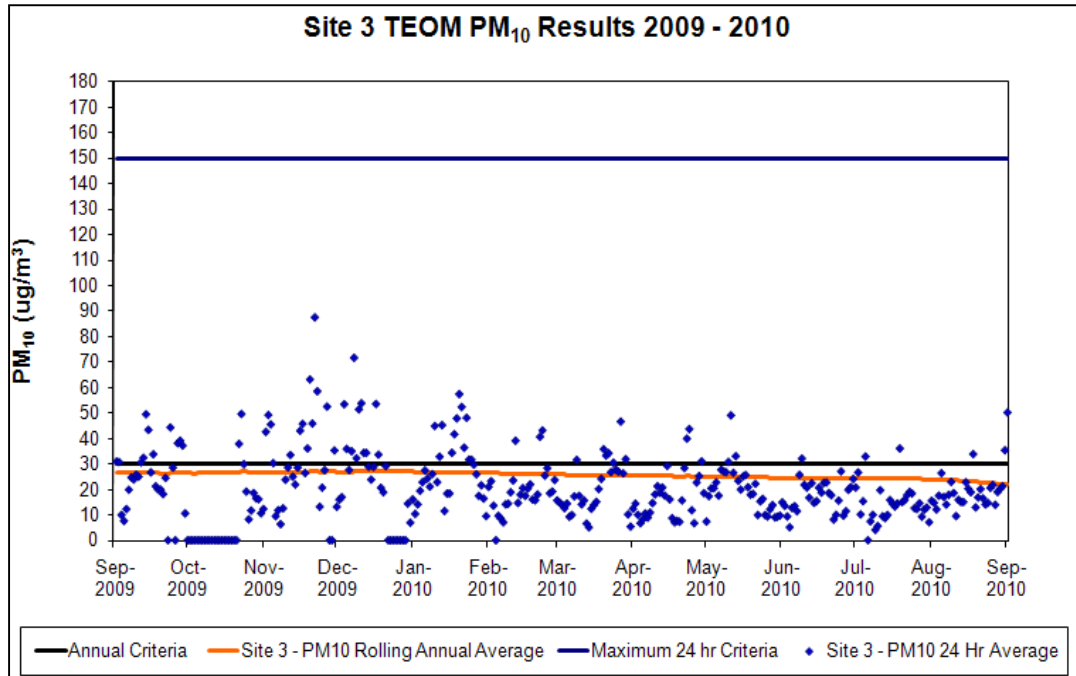
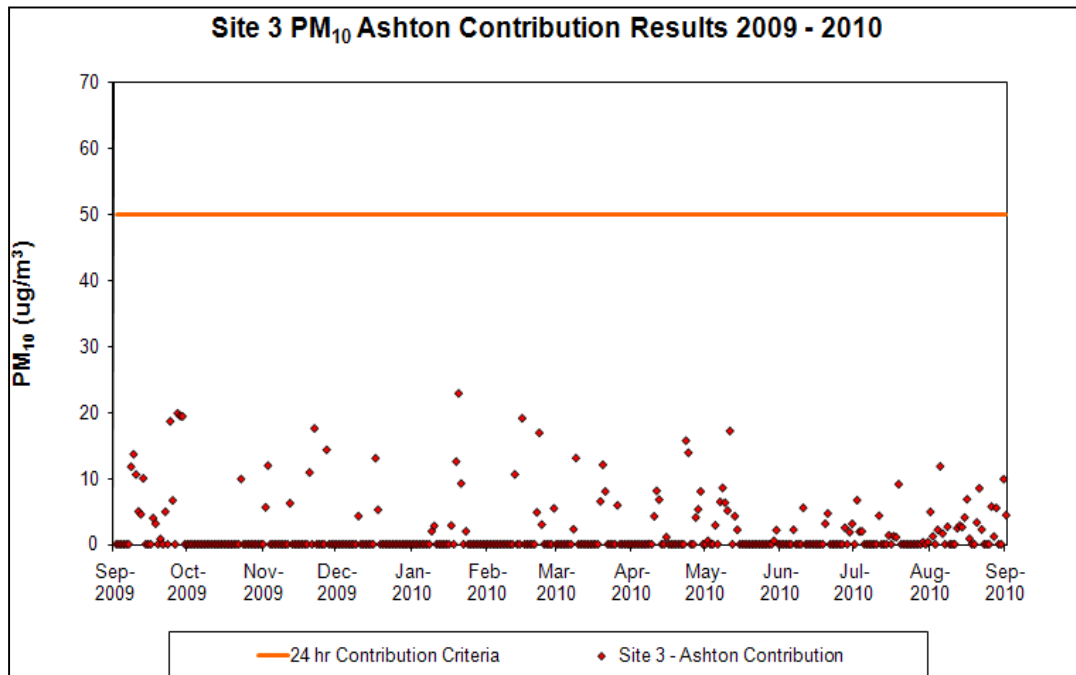
Site 3 is located on a farming property to the east of the Eastern Emplacement Area. 92% of data was recovered at Site 3 for the reporting period. Results of PM<sub>10</sub> monitoring at this location were as follows:

The rolling average PM<sub>10</sub> results for Site 3 (22 µg/m<sup>3</sup>) demonstrates compliance with the annual criteria of 30µg/m<sup>3</sup>. Site 3 also complied with the maximum 24 hour criteria of 150µg/m<sup>3</sup>.

Note: Ashton Contributions are calculated where there is a NW wind direction otherwise the contribution is plotted as 0.

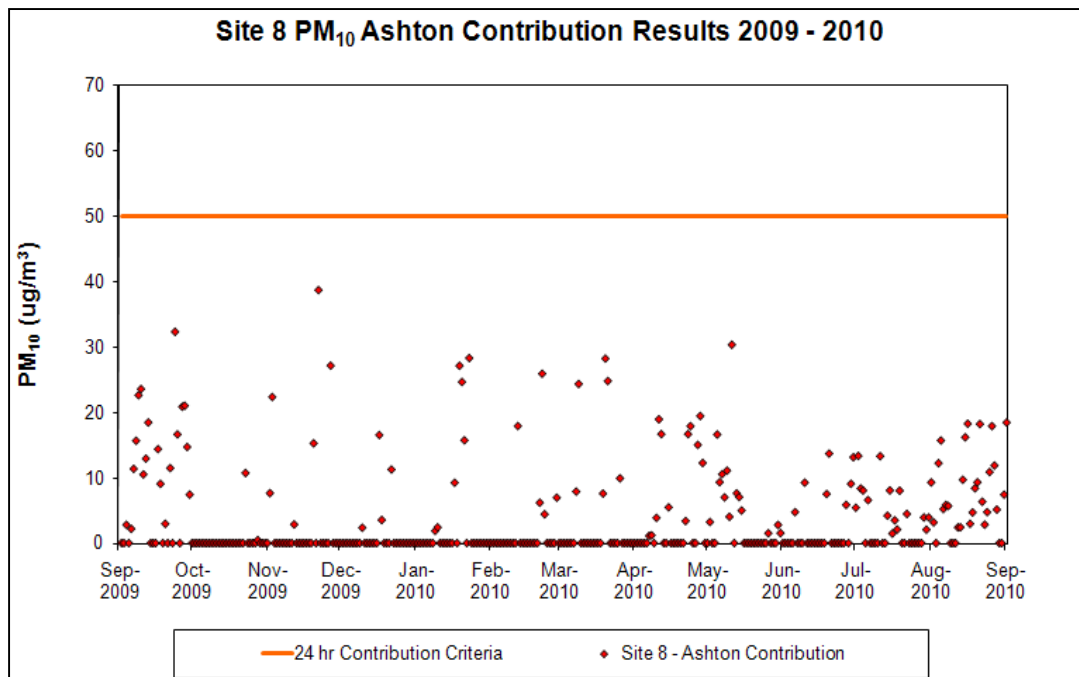
Site 8 is located on the eastern side of Camberwell Village. The site recorded a 94% data recovery rate.

Site 8 ( $24\mu\text{g}/\text{m}^3$ ) showed compliance with the annual criteria of  $30\mu\text{g}/\text{m}^3$ . Site 8 also complied with the maximum 24 hour criteria of  $150\mu\text{g}/\text{m}^3$ .

Note: Ashton Contributions are calculated where there is a NW wind direction otherwise the contribution is plotted as 0.

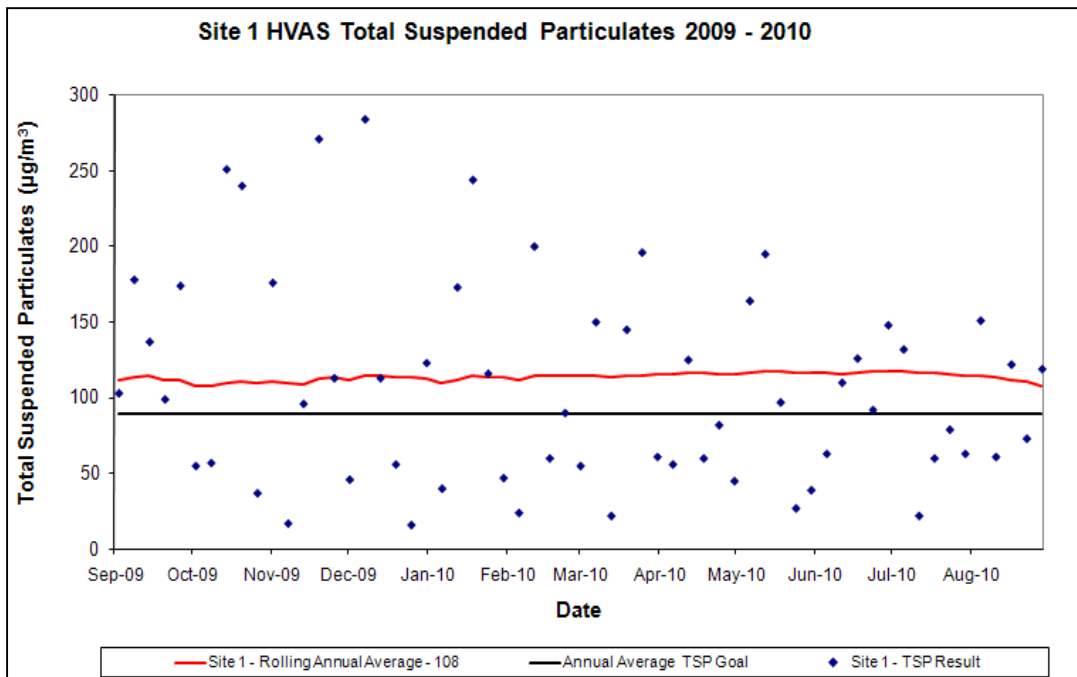
**Site 1 HVAS**

The cumulative rolling annual average for TSP at Site 1 demonstrated non-compliance with the annual average criteria of  $90\mu\text{g}/\text{m}^3$ . The annual average for the reporting period was  $108\mu\text{g}/\text{m}^3$ . The figure above shows a fairly constant rolling annual average of TSP results at Site 1 over the past 12 months, with a slight decrease at the end of the reporting period.

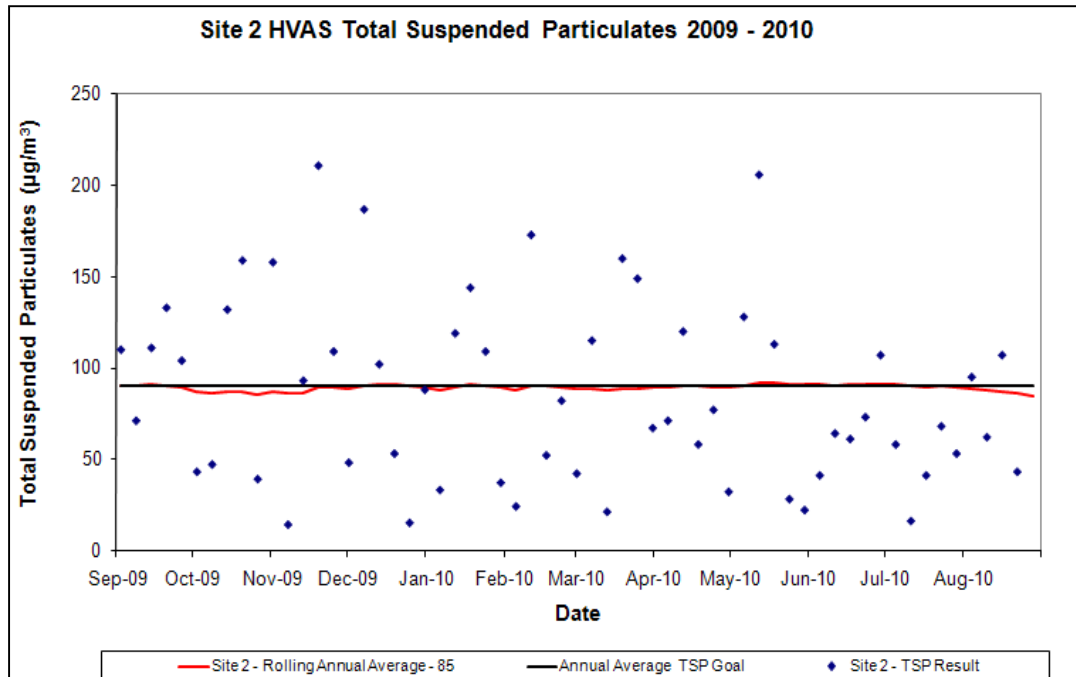
**Site 2 HVAS**

The cumulative rolling average TSP results for Site 2 complied with the annual average TSP goal of 90µg/m<sup>3</sup> for the reporting period. The annual average for the reporting period at Site 2 was 85µg/m<sup>3</sup>.

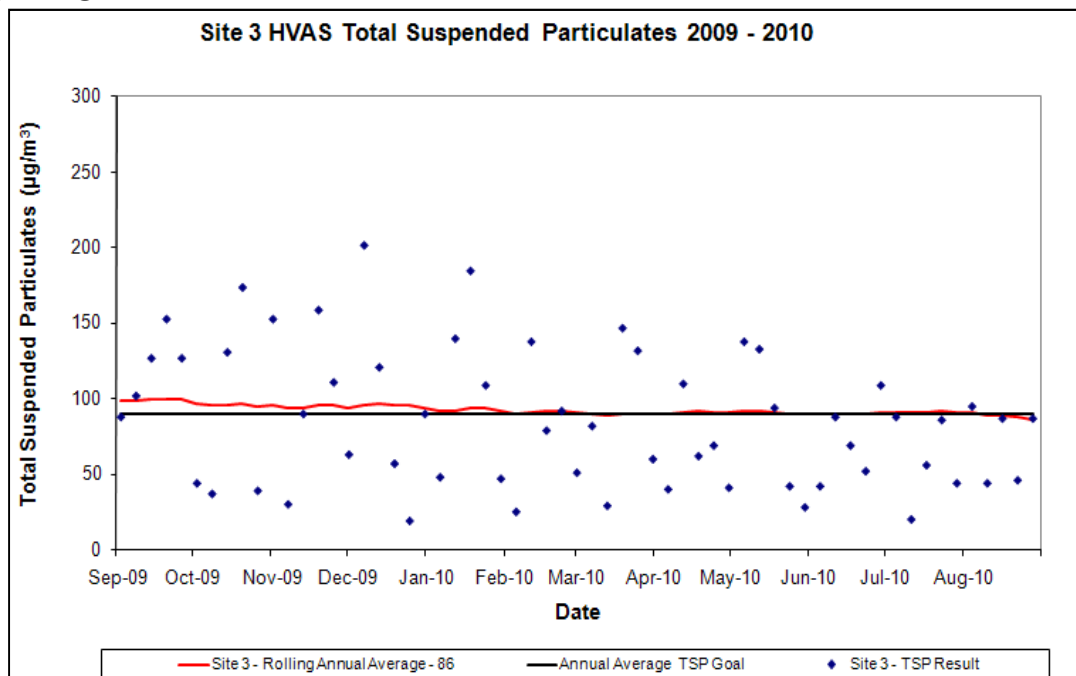
**Site 3 HVAS**

The cumulative rolling average TSP results for Site 3 complied with the annual average TSP goal of 90µg/m<sup>3</sup> for the reporting period. The annual average for the reporting period at Site 3 was 86µg/m<sup>3</sup>.

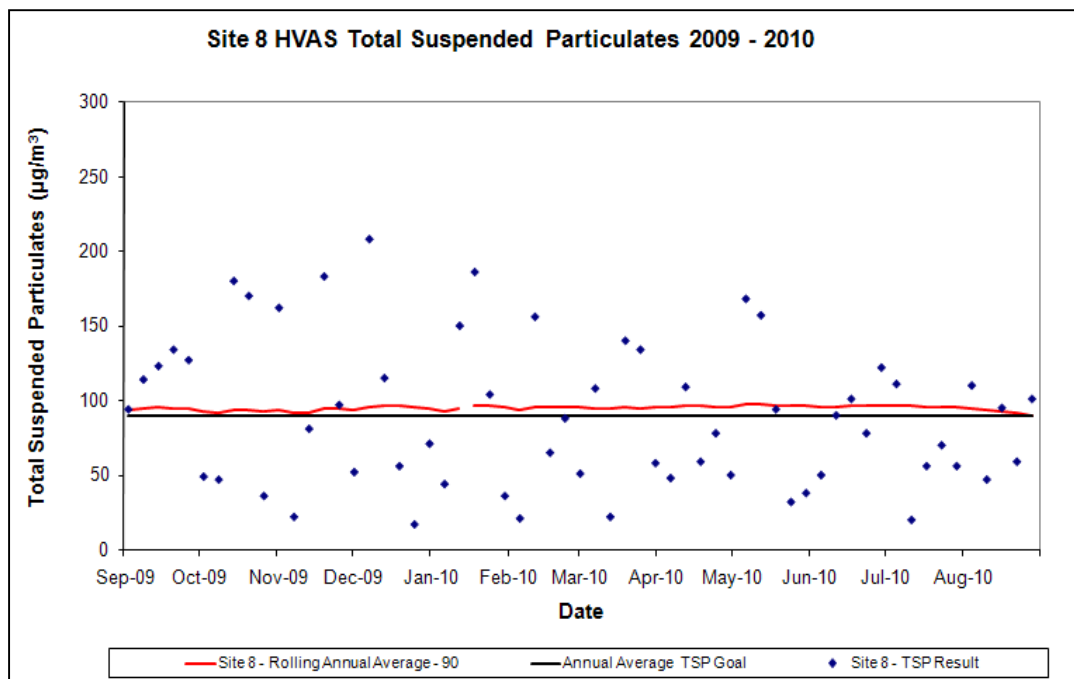
**Site 8 HVAS**

The cumulative rolling average TSP results for Site 8 complied with the annual average TSP goal of 90µg/m<sup>3</sup> for the reporting period. The annual average for the reporting period at Site 8 was 90µg/m<sup>3</sup>.

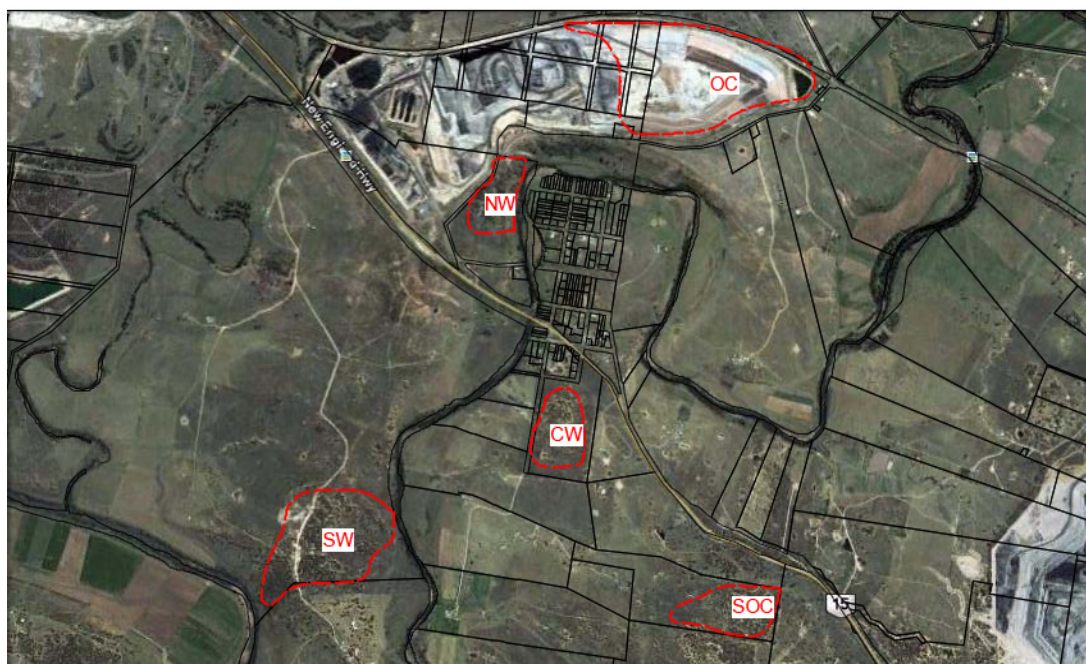
**Figure 9. Monitoring survey sites**

The Autumn 2010 survey was conducted by PEA consulting. The survey areas have been increased to assess fauna return to rehabilitation areas and now include five sites (3 analogue and 2 impact). These sites are the South Woodland (SW), Northern Woodland (NW), South East Open Cut Proposed Reserve Area (SOC), Open Cut Regeneration Area (OC) and Common Woodland (CW). **Figure 9** shows their locations.

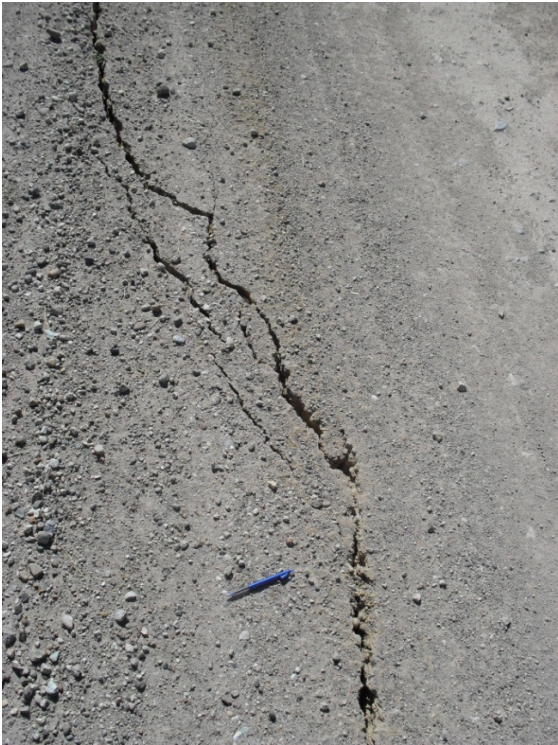
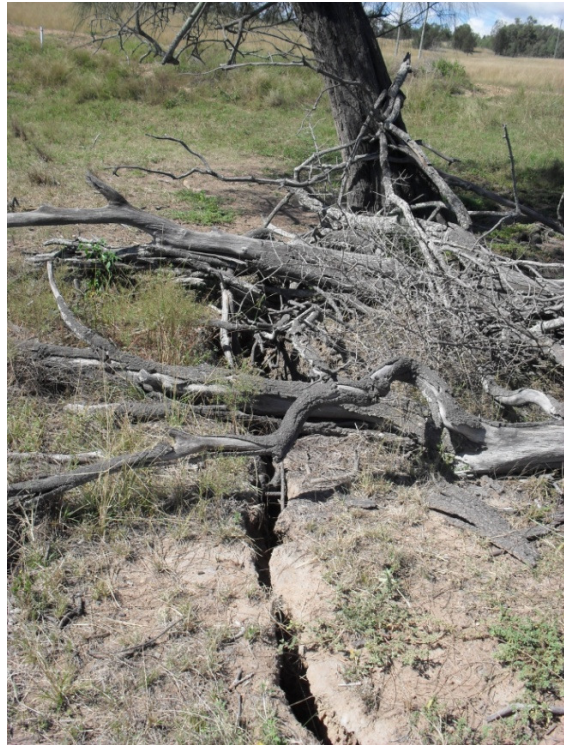
**Figure 20. Subsidence cracks, Longwall 4**

negligible subsidence on the steep slopes of Glennies Creek. Visual inspection revealed that near complete subsidence occurred immediately after passage of the longwall. Cracks in land and the access road to Property 130 have been repaired satisfactorily to date.
