ASHTON COAL PROJECT

ANNUAL ENVIRONMENTAL MANAGEMENT REPORT 2013

Ashton Coal AEMR 2013

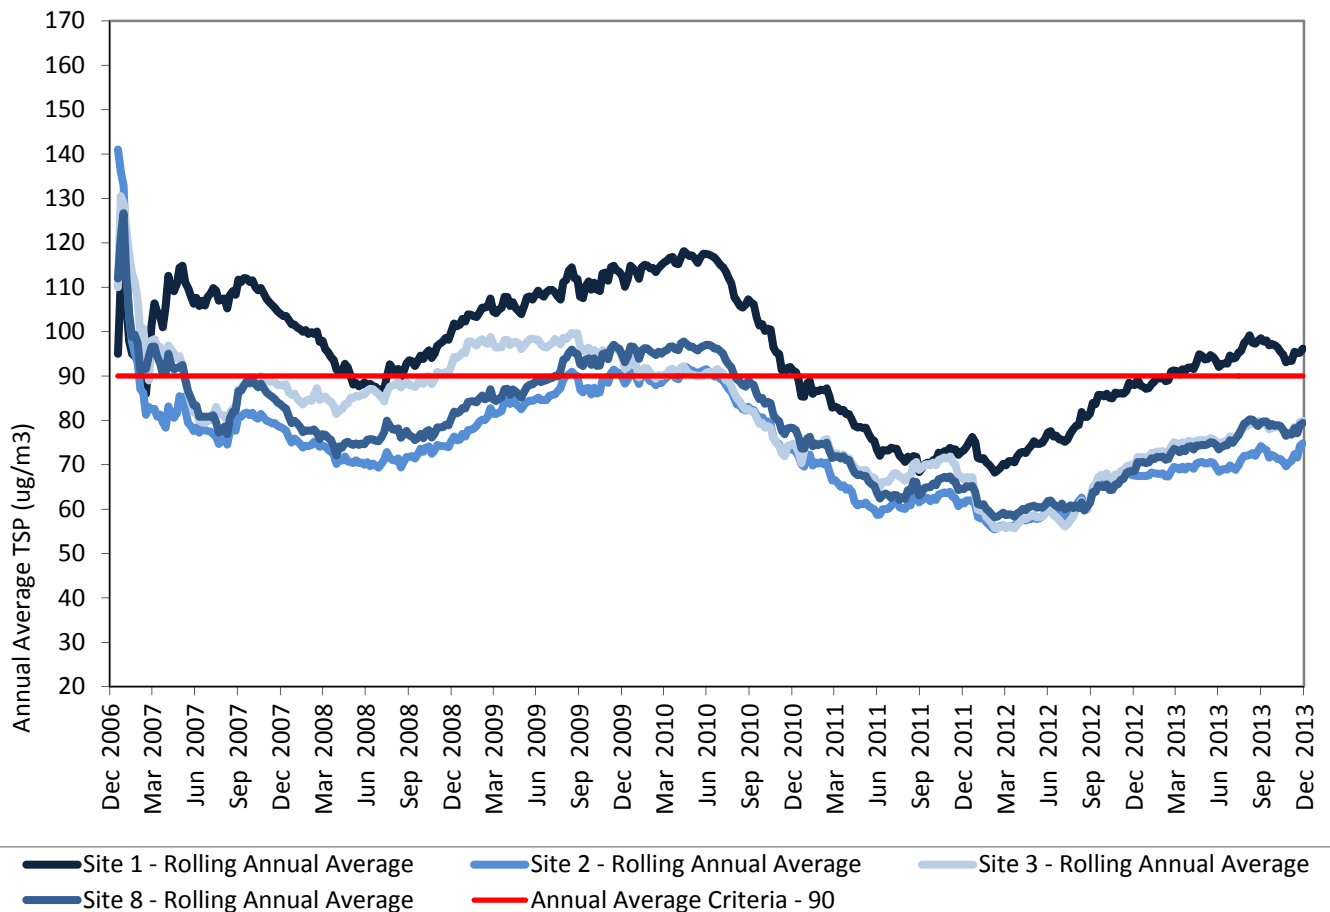
Figure 10: Long Term annual average TSP (HVAS) trends for all sites in the reporting period, 2013.

Site name	Site reference	Minimum 24-hour result µg/m ³	Maximum 24-hour result µg/m ³	Reporting period annual average µg/m ³	Long term (annual average) criteria µg/m ³
Camberwell village (north)	1	16	247	96	90
Camberwell village (south)	2	14	193	75	90
Property east of Camberwell village	3	13	196	80	90
Camberwell village (east)	8	11	209	79	90

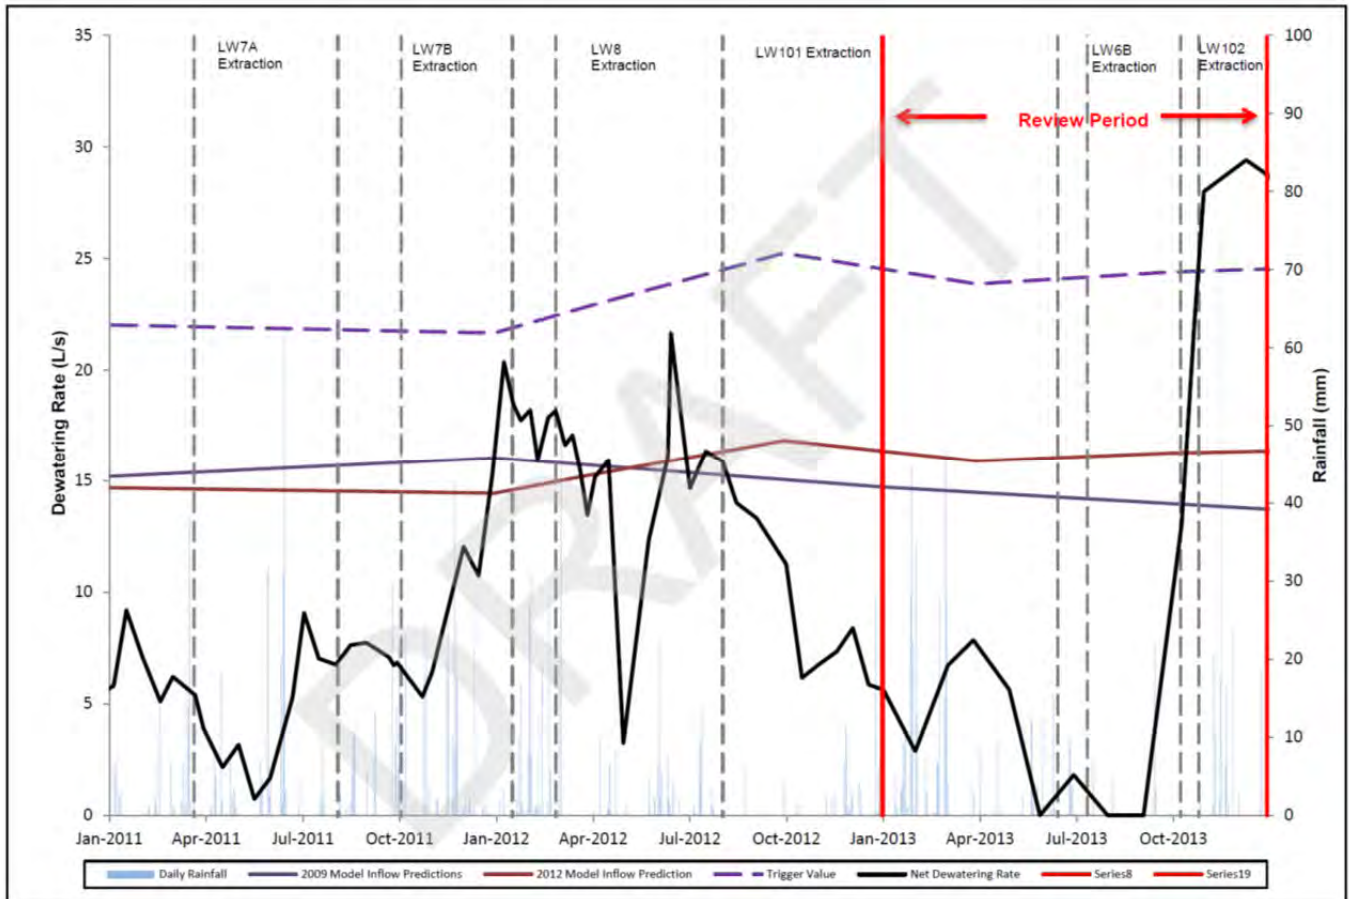
Figure 21: Mine dewatering and predicted inflows

Groundwater inflow and dewatering rates for the underground mine are calculated using metered pumping data and presented as a net dewatering rate in Figure 21. The groundwater model predictions for inflows are included on Figure 21 for comparison. Net dewatering volumes are calculated using a water balance method, i.e. total inflows are equal to the sum of the water pumped from the underground mine, minus the sum of the water supplied for operational purposes. Over the review period the elevated inflows exceed the trigger value by up to 50% and have been sustained above the trigger value for approximately 2 months. If inflows are sustained above 23.5L/sec for a period of 3 consecutive months then the reporting requirement will be triggered as described in the 2012 WMP Mine Inflows TARP.

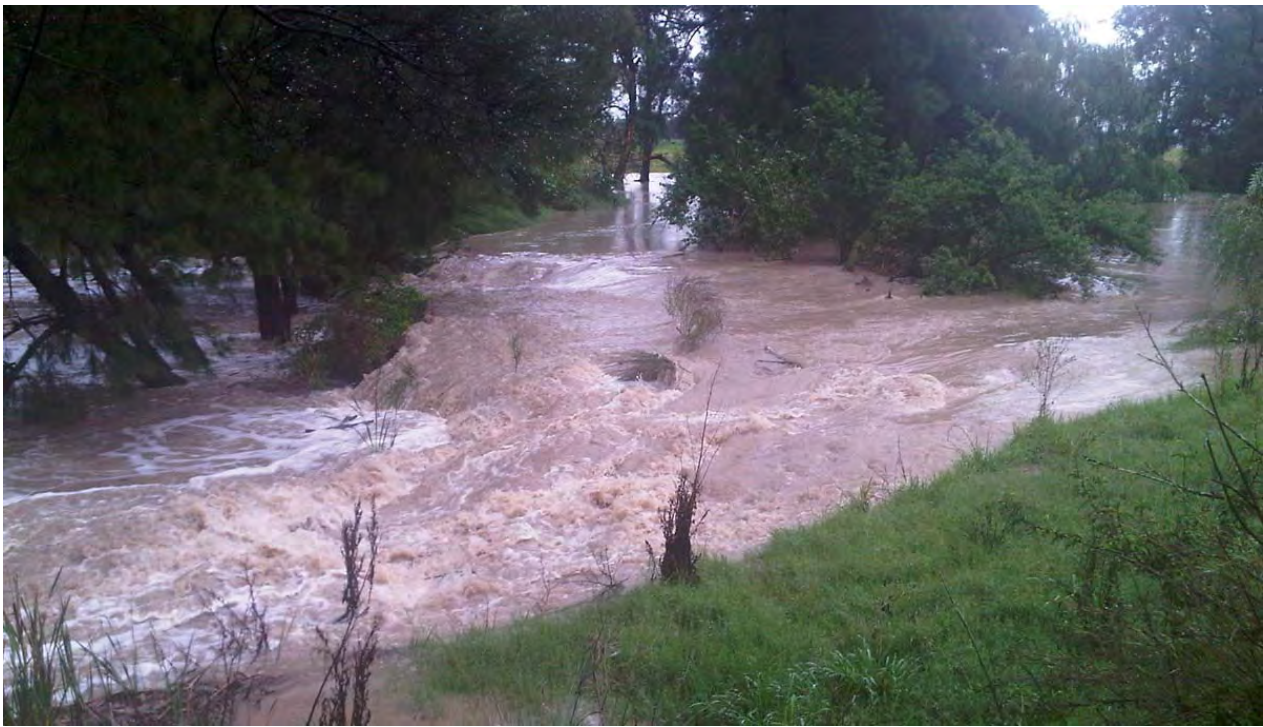
Figure 23: Connecting channel between EDC and Bowmans Creek in flood January 2013

Mean daily flow rates were very low (less than 1ML/day) for almost three months following the previous Bowmans Creek spring 2012 survey in early November, and then there were three distinct flood events in January to March, with the most significant event occurring between 28th February and 2nd March, where mean daily flow rates peaked at 6017 ML/day. This flood resulted in impacts to channel banks and drainage channels throughout the natural Bowmans Creek study area, including scouring, mobilisation and deposition of stream sediments, cobbles and organic matter, uprooting and deposition of large riparian trees and creation of new flow paths. The diversion channels were not adversely impacted by the high flow events and there were no indications of any significant scouring of the two engineered channels and no end channel scouring impacts, with only minor repairs works undertaken.

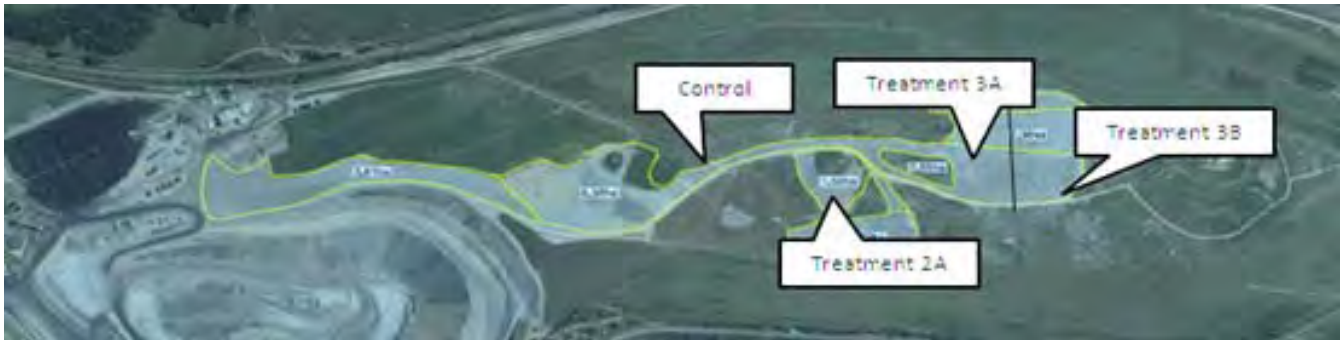
Figure 36: Location of SITA trial plots.

SITA in conjunction with Ashton started a trial with varying microbial sprays on compost to investigate possible improvements to soil health, pasture coverage and diversity. The trial was conducted on the autumn 2012 pasture rehabilitation and involved a variety of Petrik products (BDX, Digester & Green Manure Plus). The location of the trial plots is shown in Figure 36. The trial consists of the following plots:

- Control: A horizon top soil + 100t/ha Rehab-ARRT compost (1.0 ha)
- Treatment area A2: A horizon top soil + 100t/ha Rehab-ARRT compost + 1L/ha of green manure (2.1 ha)
- Treatment Area A3: A horizon top soil + 100t/ha Rehab-ARRT compost + 2L/ha digester + 1L/ha green manure (2.3 ha)
- Treatment area B3: A horizon top soil + 100t/ha of Rehab-ARRT compost + 750g/ha BDX + 1L/ha green manure (2.0 ha).

During 2013, pasture assessments were completed in January, March, July, October and December and reviewed groundcover coverage, plant biodiversity development, structure of the topsoil and biodiversity of the soil.

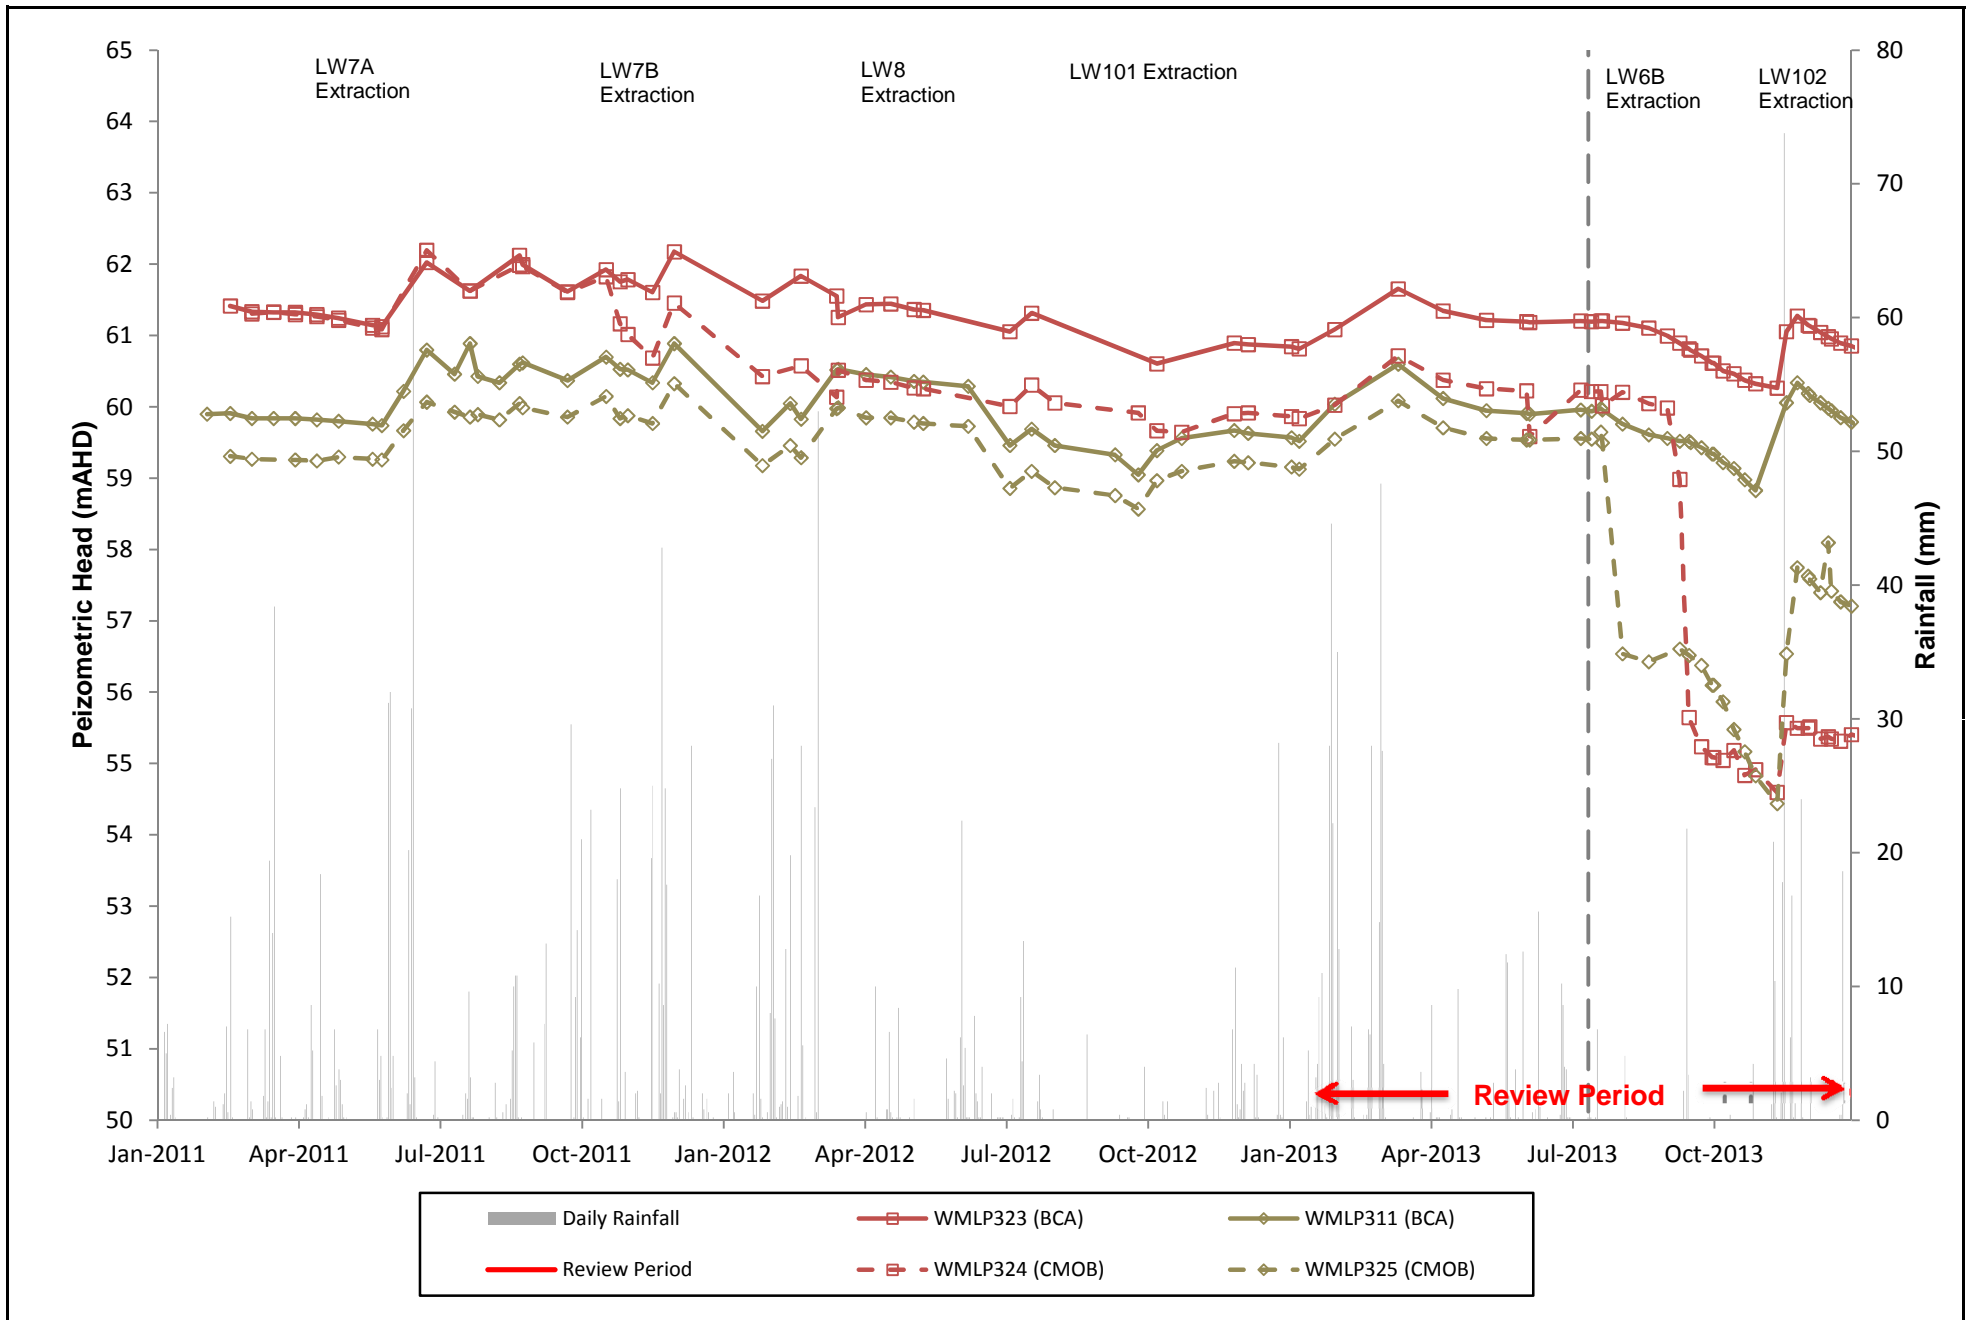
HYDROGRAPHS - PAIRED STANDPIPES (2) FIGURE 28

Note: BCA - Bowmans Creek Alluvium, CMOB - shallow coal measures overburden
