Bowmans Creek Geomorphology Review

Ashton Coal Project

Ashton Coal Operations Limited

Document No.: 60045376/DO-0002

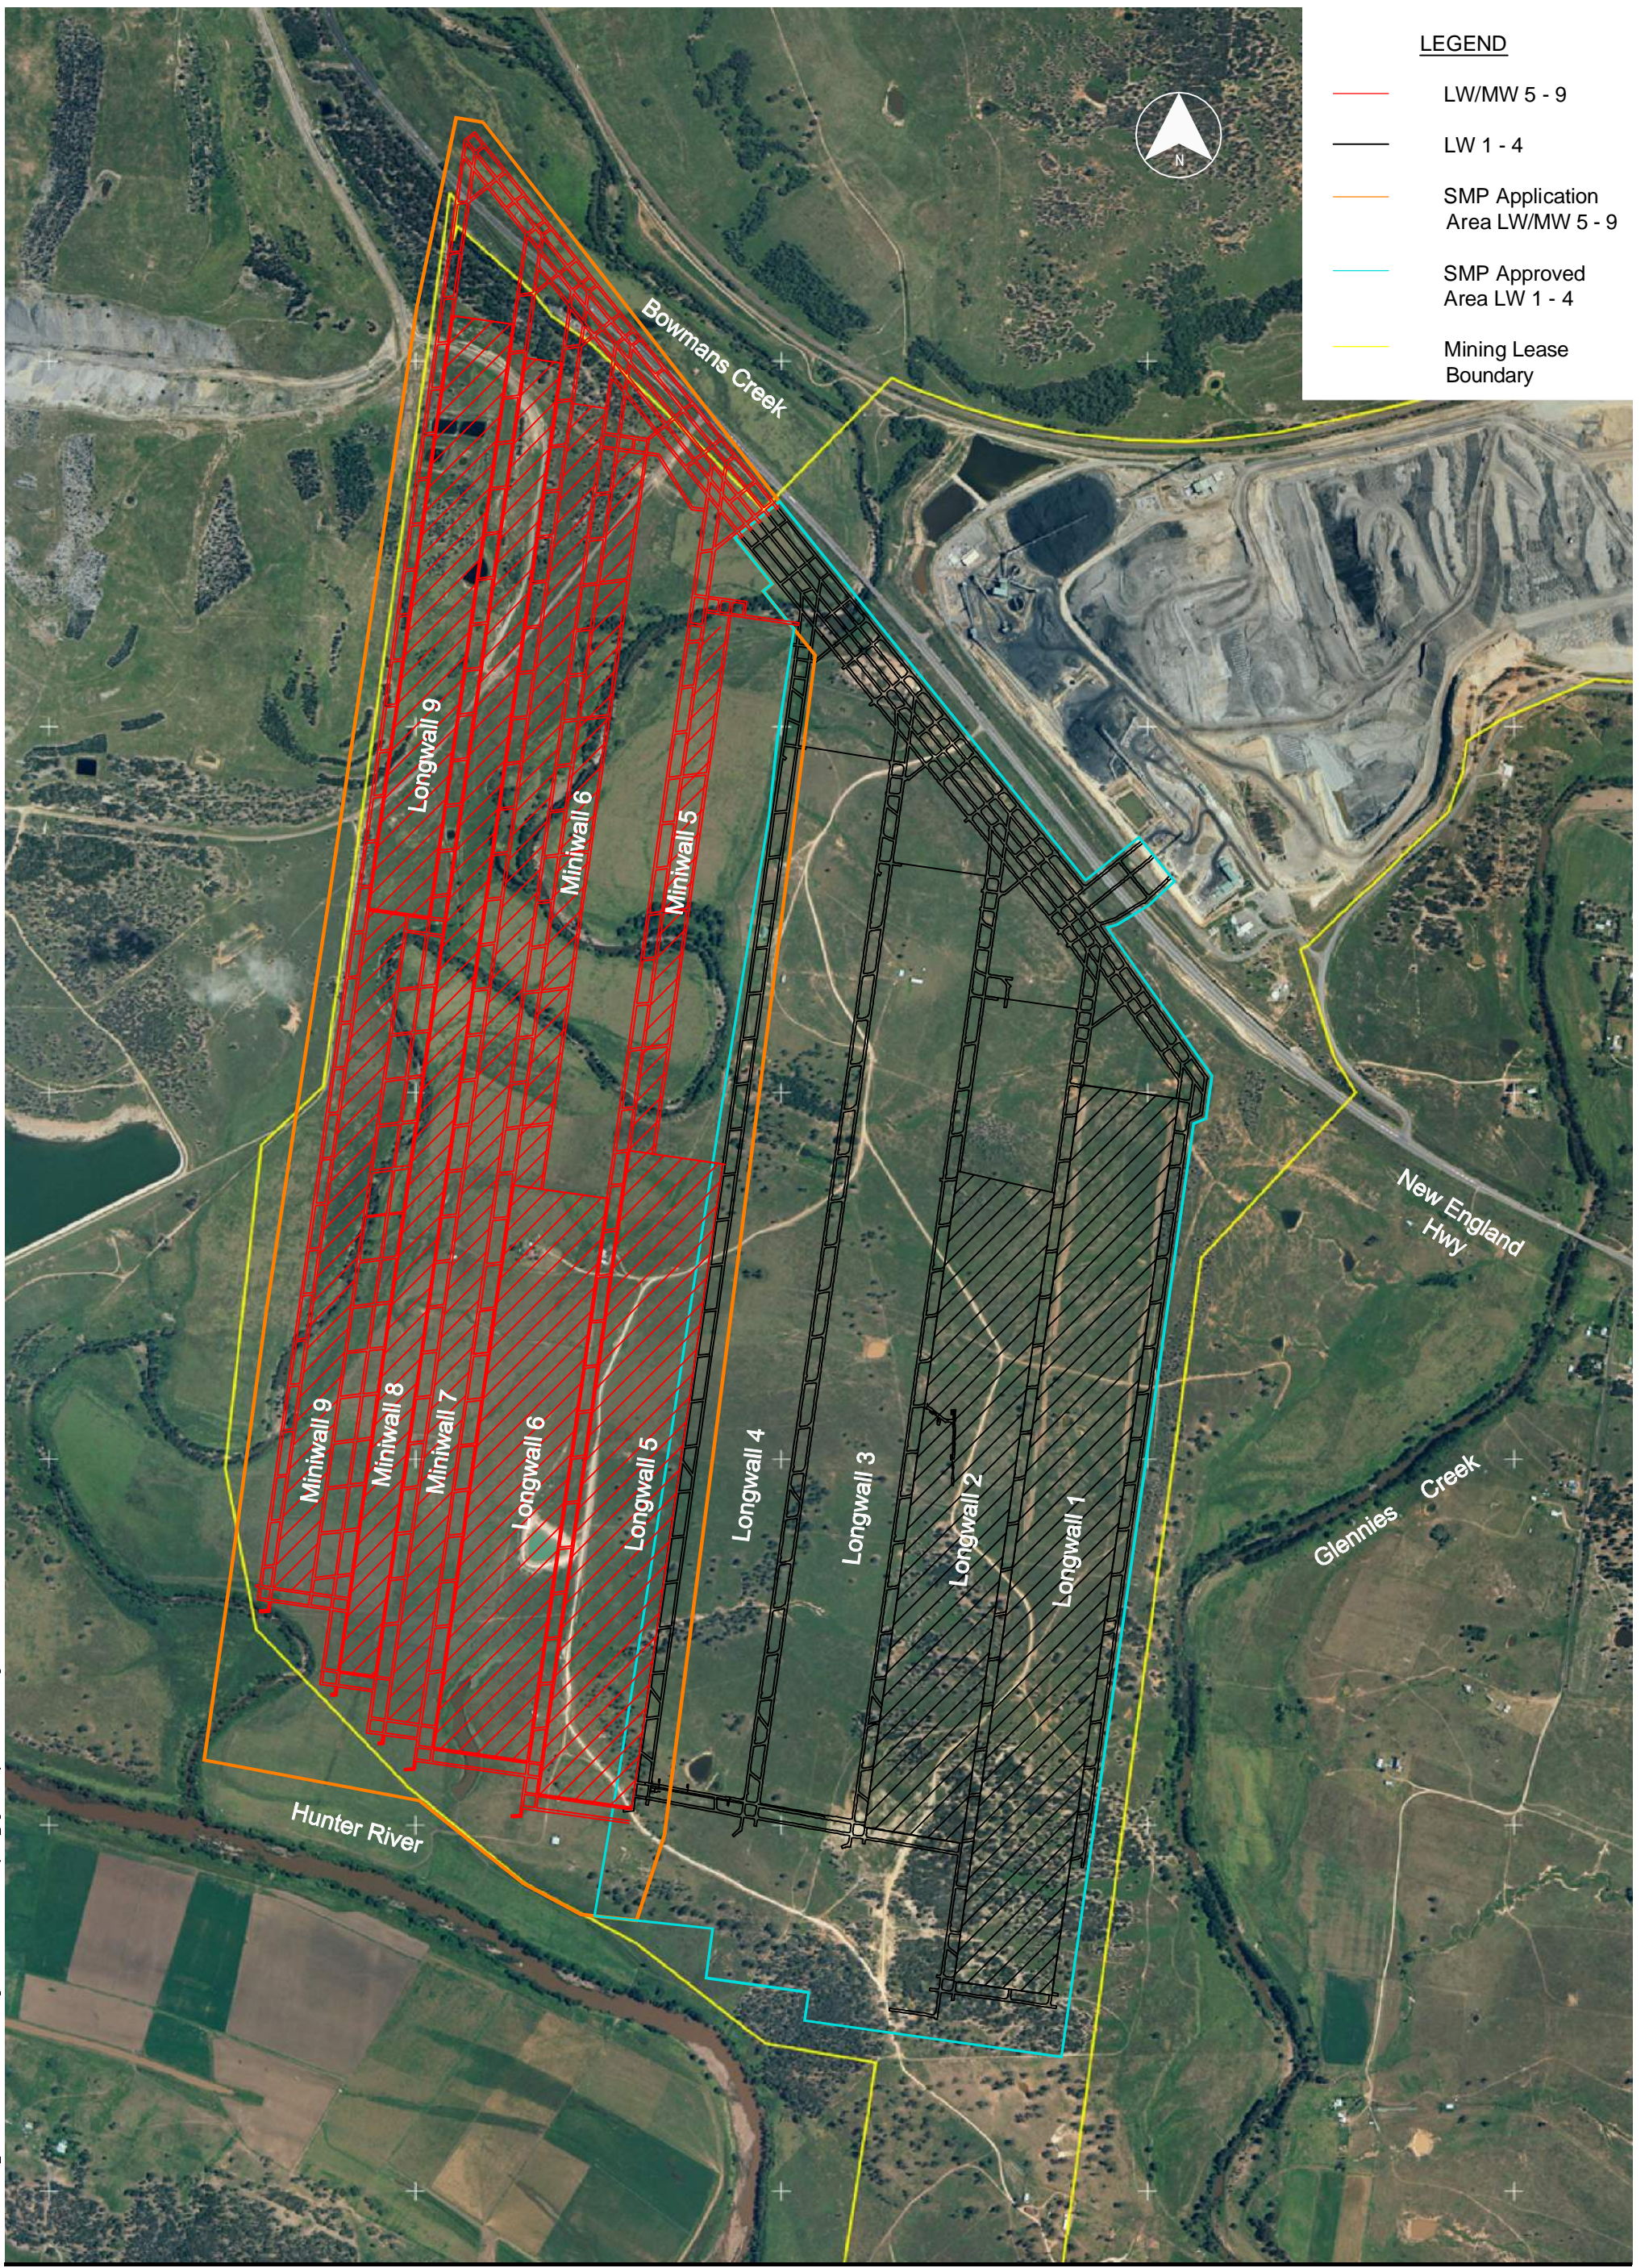
Figure 2 - Ashton Underground Mine Layout

The layout of the Ashton underground mine is shown in Figure 2. The mine plan has been revised since the original environmental impact assessment (HLA, 2001). Detailed monitoring and modelling of subsidence and impacts to groundwater has resulted in the mine plan being revised to incorporate a series of miniwalls below Bowmans Creek and its associated alluvial aquifer.
