groundtruth@optusnet.com.au**Geomorphology of the Ashton Coal Project site
in relation to archaeology.****Camberwell, Hunter Valley NSW.****Final Report: 3 June 2002.**

Dr P.B. Mitchell prepared this report for White Mining Pty Ltd. It covers additional work conducted under the National Parks and Wildlife Service (NPWS) Preliminary Research Permit (PRP) No 1328 issued on 23 April 2002. The work was undertaken to address issues listed in a letter from NPWS (ref 01/00608) to White Industries, dated 14/3/02 and matters discussed at a meeting held at NPWS Head Office on 21/3/02 between Ms M Koettig (NPWS), Mr A. Wells (HLA-Envirosciences), Mr I Callow (White Mining), Dr P.B. Mitchell (Groundtruth Consulting) and Dr D. Witter (Archaeologist).

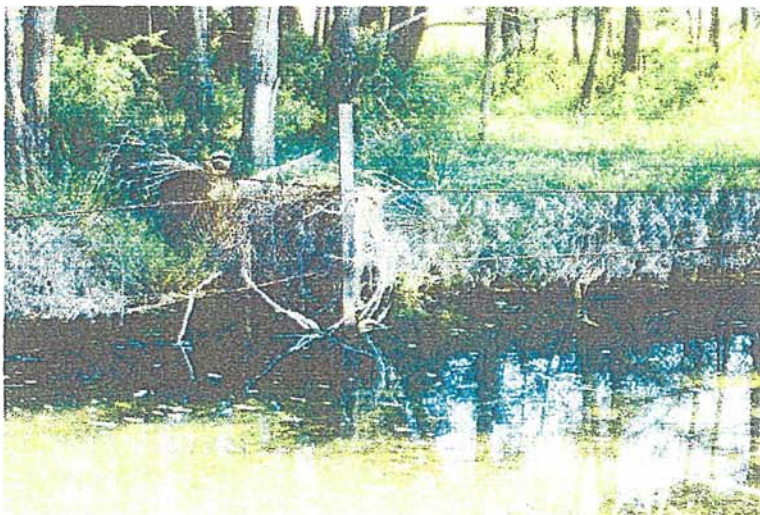
Figure 3. An intact section of engineered channel in Bowmans Creek showing the railway line piles, cables and mesh holding a constructed gravel bank. GR 317858E 6406286N

River 'improvement' works were confirmed on the ground and appear to have been constructed in the late 1970s at about the time that the New England Highway was relocated and new bridges constructed. They consist of channels and low floodplains that were reshaped by earthmoving equipment and stabilised with willow planting at fixed intervals. Cut bank sections were protected from erosion by the installation of heavy wire mesh supported on steel cables strung from driven railway line (Figure 3).

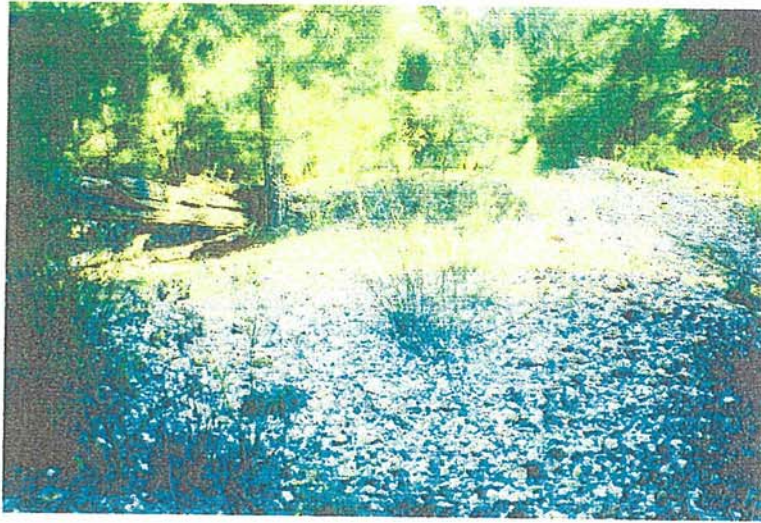
Figure 4. Large gravel bar advancing downstream in Bowmans Creek near the northwest edge of the lease. The bar is burying recent tree falls in its passage. The lobes at the front of the bar are 50cm high. GR 317997E 6407204N

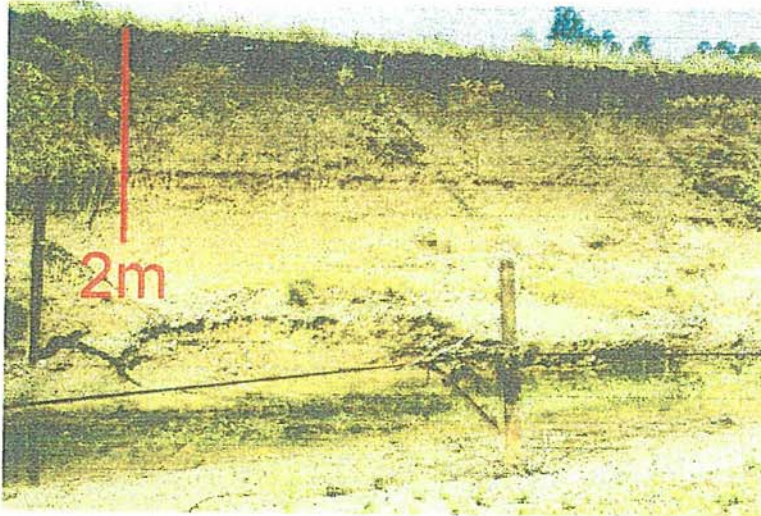
Figure 5. A section of engineering works that has failed where the face of the second terrace is being eroded. Bowmans Creek upstream of the highway bridge. The surface of the terrace has nearly 60cm of PE sediment over silty clay alluvium. GR 6406883N 318433E

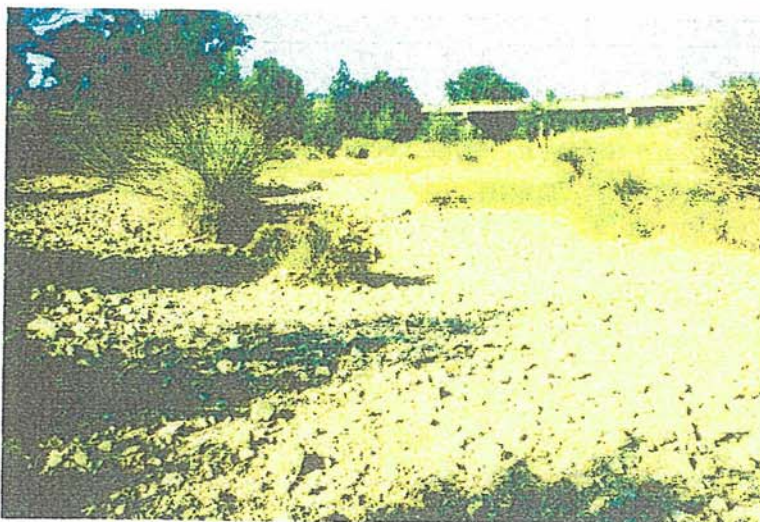
Figure 6. Bed and part of the low floodplain of Bowmans Creek upstream of the highway bridge showing the effects of recent scour. Even small floods are moving pebbles up to 25cm in diameter as bed load. GR 318455E 6406473N

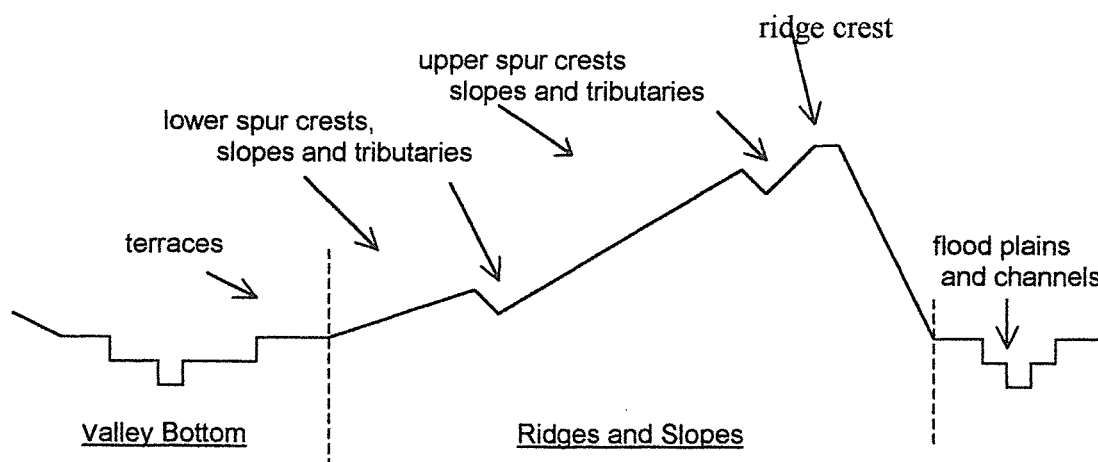
Fig. 7.2. Diagram showing the main landscape elements in the study area.

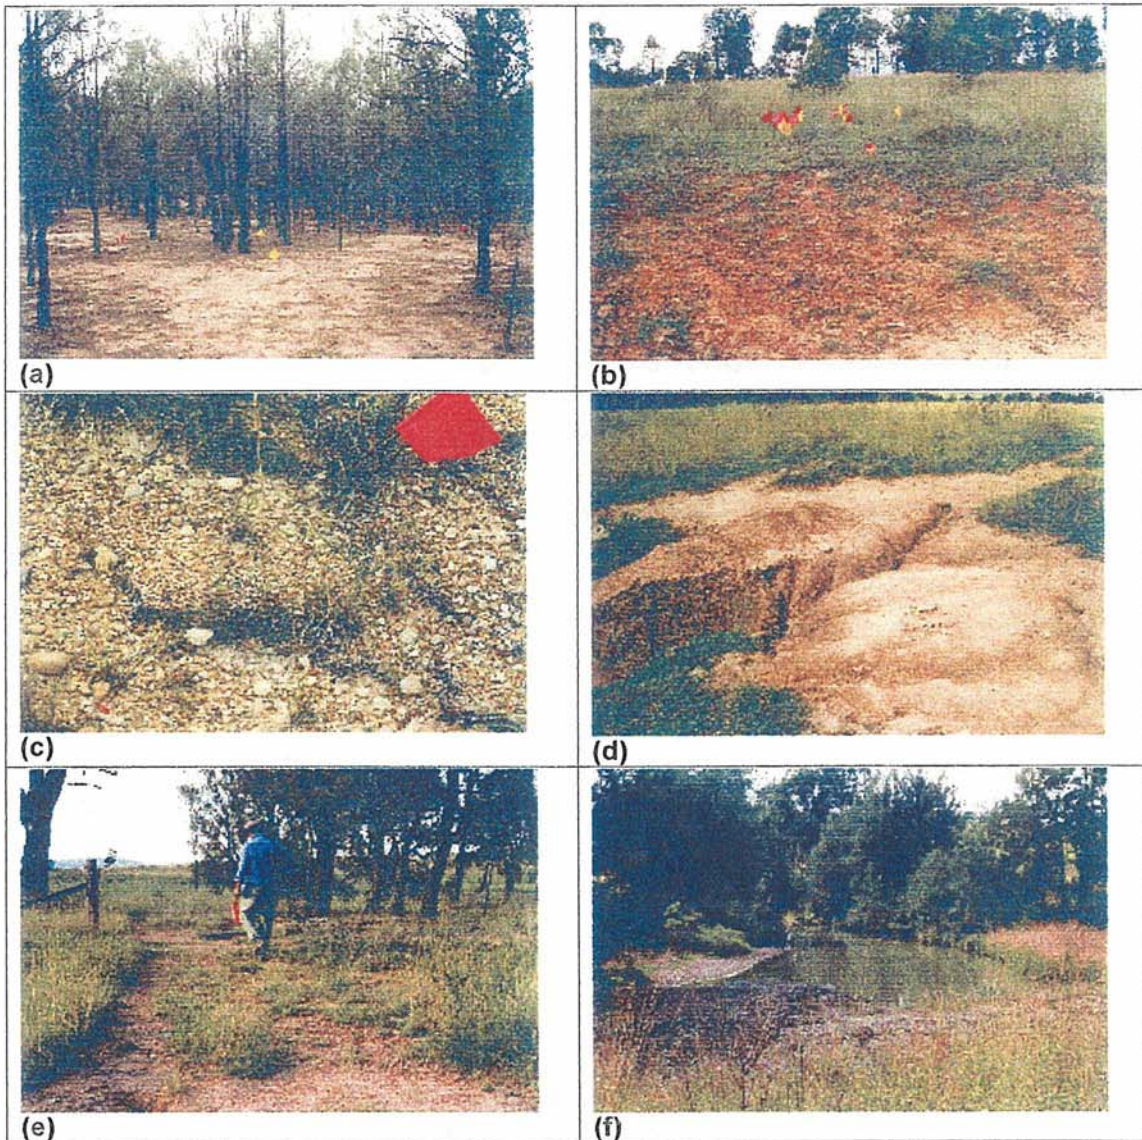
Plate 10.1. Exposures in the study area.

(a) Patchy A and B lag surface in a stand of casurina regrowth at the Glennies Creek Site EWA61.

The exposure data shown in Appendix 2 was analysed according to landscape type and the surface type of exposure by each of the geographical divisions. The exposure types are shown in Plate 10.1. The surface types were assessed as follows:

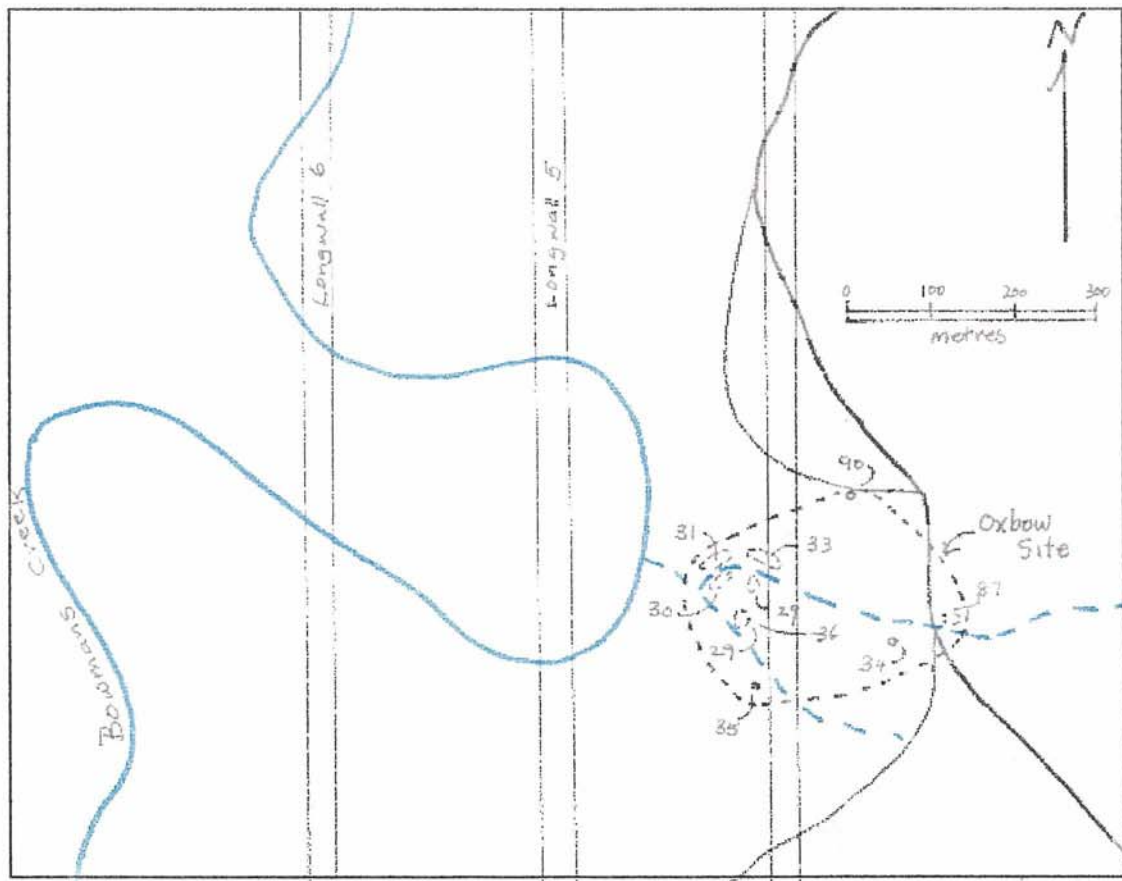
Map 12.5. Sketch map showing the Oxbow Site and distribution of EWAs.

The Oxbow Site implements below (Table 12.7) are from EWAS 29, 30, 31, 32, and 36 which are clustered together where the two tributaries join at the edge of the creek

bottom, as well as a microblade core from EWA 35 which is about 100 m up one of the tributary channels. The total implements are 27. The flake tools show a wide range of reduction, from usewear to cusped, suggesting relatively intense usage compared to the Waterhole Site. Microblade cores also are prominent, with both trial and reduced types. However, with a total of 13 blade cores, only 4 backed blades were found, and there were no identifiable microblade workshops. Although some of the exposure was from a vehicle track which may have had some smaller artefacts washed away, most of the exposure would have clearly indicated a workshop if it had been present.

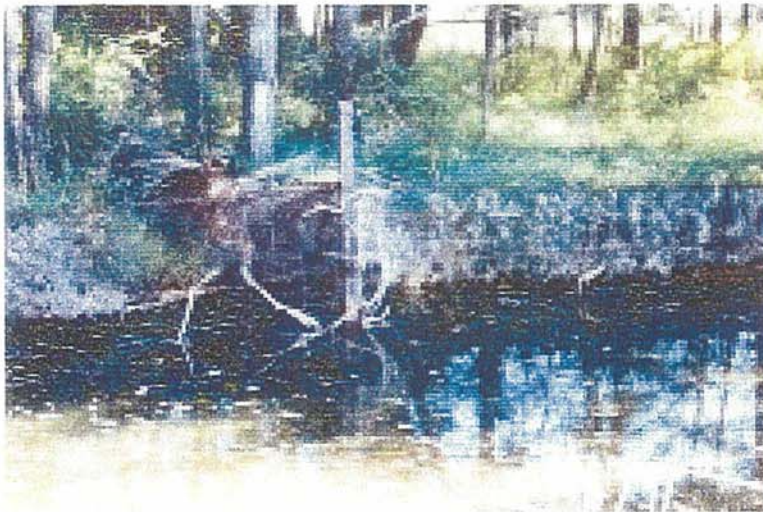
Figure 3. An intact section of engineered channel in Bowmans Creek showing the railway line piles, cables and mesh holding a constructed gravel bank.

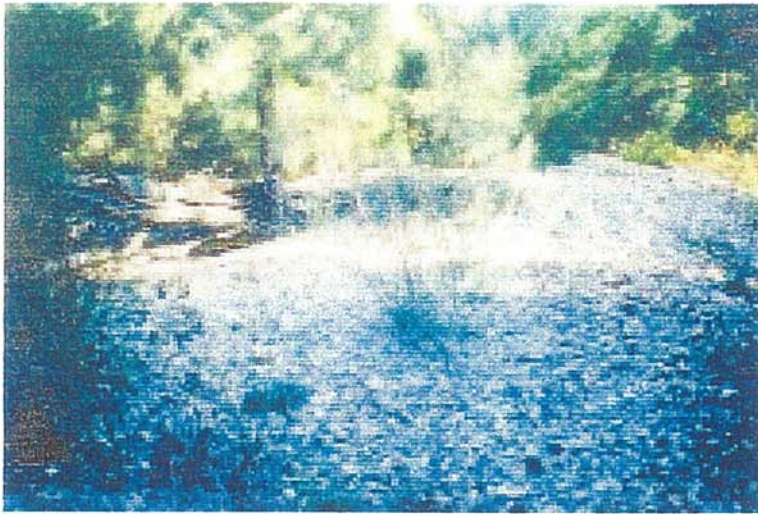
Figure 4. Large gravel bar advancing downstream in Bowmans Creek near the northwest edge of the lease. The bar is burying recent tree falls in its passage. The lobes at the front of the bar are 50cm high.

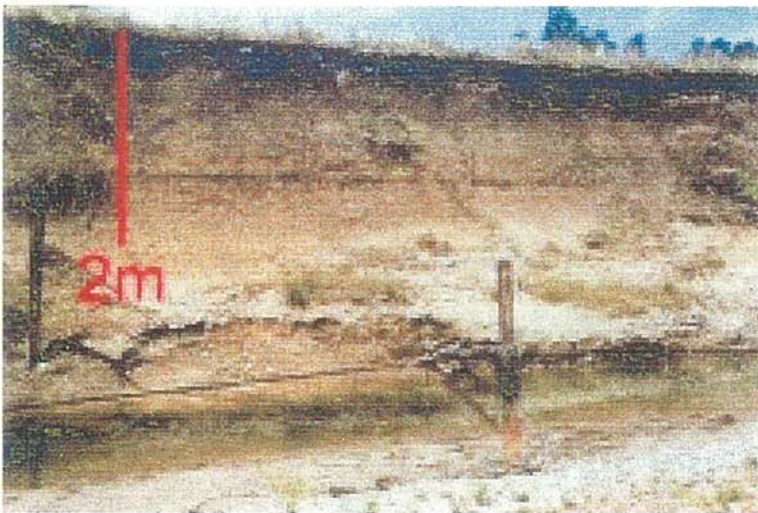
Figure 5. A section of engineering works that has failed where the face of second terrace is being eroded. Bowmans Creek upstream of the highway bridge. The surface of the terrace has nearly 60cm of PE sediment over silty clay alluvium.

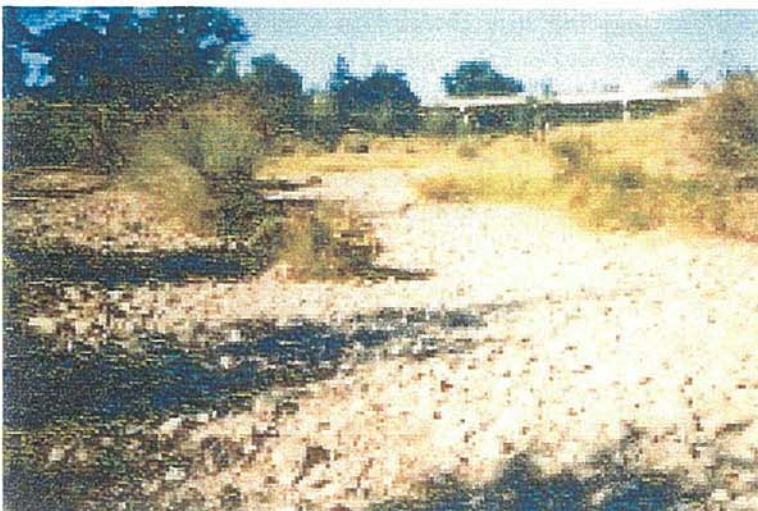
Figure 6. Bed and part of the low floodplain of Bowmans Creek upstream of the highway bridge showing the effects of recent scour. Even small floods are moving pebbles up to 25cm in diameter as bed load.

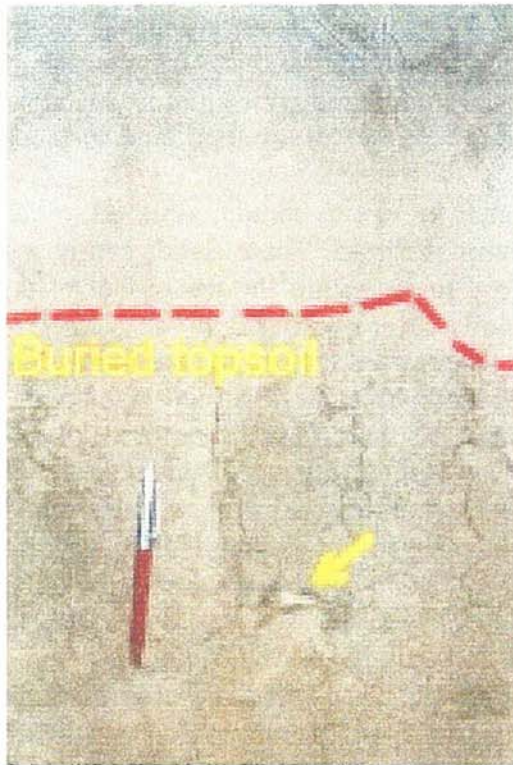
Figure 13. A single stone flake protruding from the exposed and slightly eroded face of Pit 15. The flake located some 15cm into the layer interpreted as a buried topsoil. The pen is 13cm long.
