***Aboriginal Archaeological Report
Proposed Goaf Gas Drainage Project
Ashton Coal Operations Ltd
Camberwell, NSW***

**Report to
Wells Environmental Services
on behalf of
ACOL**

July 2012

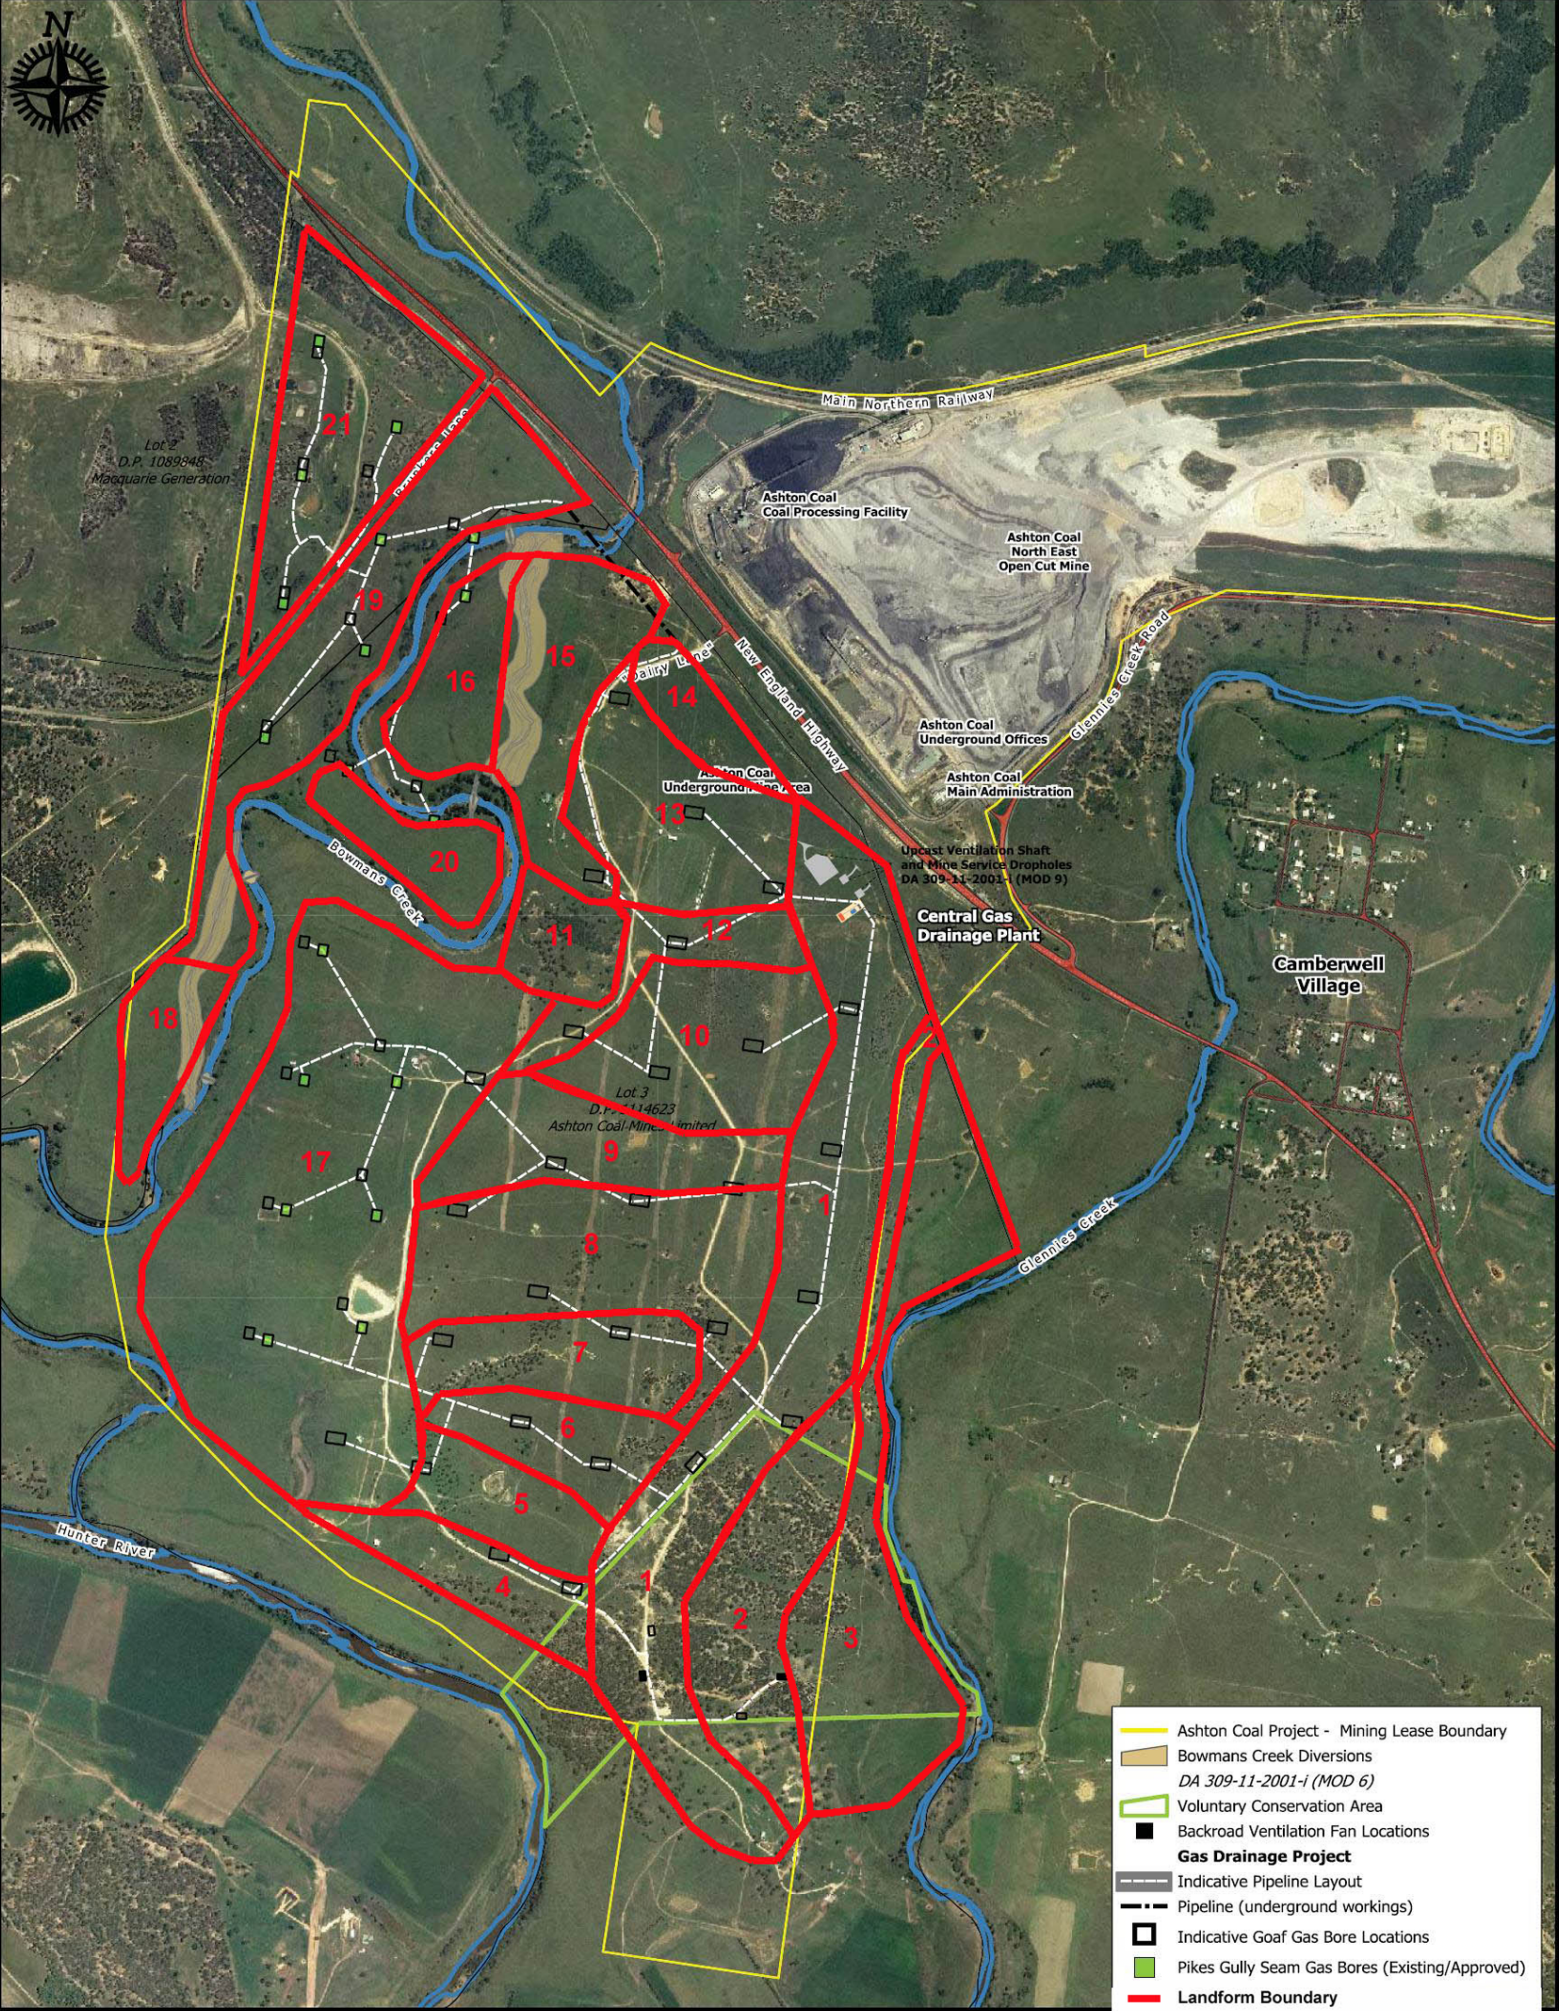
Figure 2
 Survey Landform Units

The stakeholder representatives were drawn from the continuous ACOL stakeholder roster. For the purposes of this survey the project area was divided into landform units, shown in **Figure 2**. Continuity of landform can be regarded as site continuity as surface visibility rarely allows a complete picture of material belonging within a particular site. An arbitrary figure of 50m between artefacts to define a site may result in the identification of a number of sites when in fact the sub-surface spread of artefacts may be continuous. The results of Bowman's Creek test excavations display such a situation. For the purpose of this report, previously recorded sites were collated and regarded as separate loci within each landform unit but, in certain instances, were incorporated as a larger, individual site.

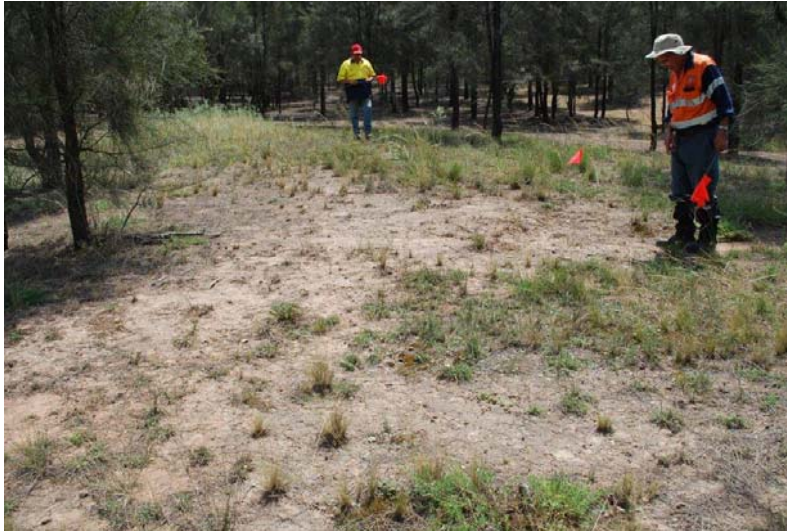
Plate 4 EWA 99

EWA099 was relocated. It lies within a gently sloping exposure measuring approximately 20m x 20m (80% surface visibility) beneath a stand of casuarinas. More than 30 artefacts were noted although no detailed records were taken. No artefacts were located within the area recorded as EWA098 although surface visibility was good (>50%) within this area.

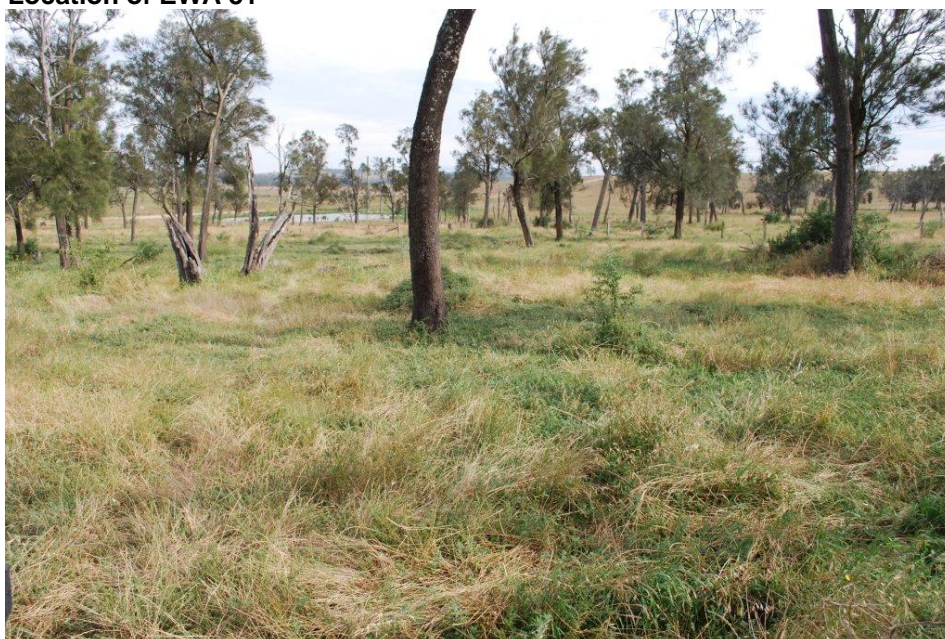
Plate 6 Location of EWA 51

The sites EWA050, EWA051 and LW5.3 were previously recorded within this unit, within the western limits close to its boundary with Unit 17. These sites were not able to be relocated due to very low surface visibility. Two artefacts (RS9) were located in the vicinity of these sites. RS9 was located within an exposure (20m x .5m) adjacent to a contour bank.

Sites EWA051 and RS9 are located in the proximity of proposed works. Test excavations as per AHIP methodology are recommended prior to any works commencing within 50m of these sites.

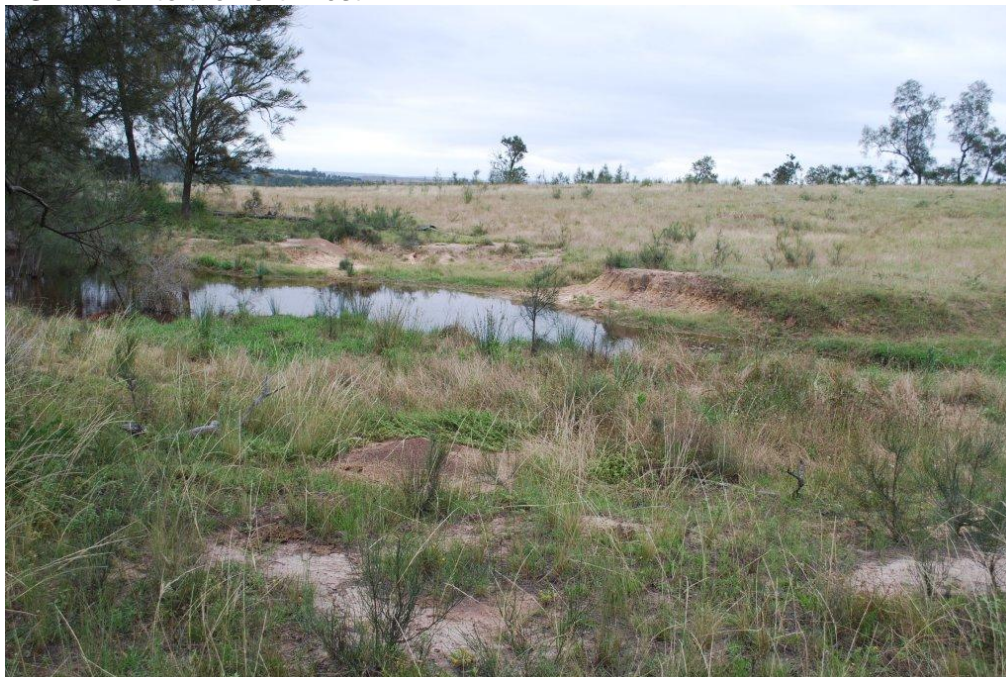
Plate 8 RS 11 view to the northwest

The site EWA057 was located in the vicinity of these ponds and the site consists of several loci each containing an isolated find. The previously identified loci were not located during this survey however eleven artefacts (RS11-15) were located in exposures adjacent to the banks along 125m of this watercourse. An isolated artefact (RS27) was located further upstream close the bank. Surface visibility within this unit was generally very low due to grass cover. Artefacts were located spread across a broad area of exposures adjacent to the lower sections of the watercourse. Plate 8 shows the landform within Unit 7 at RS11.

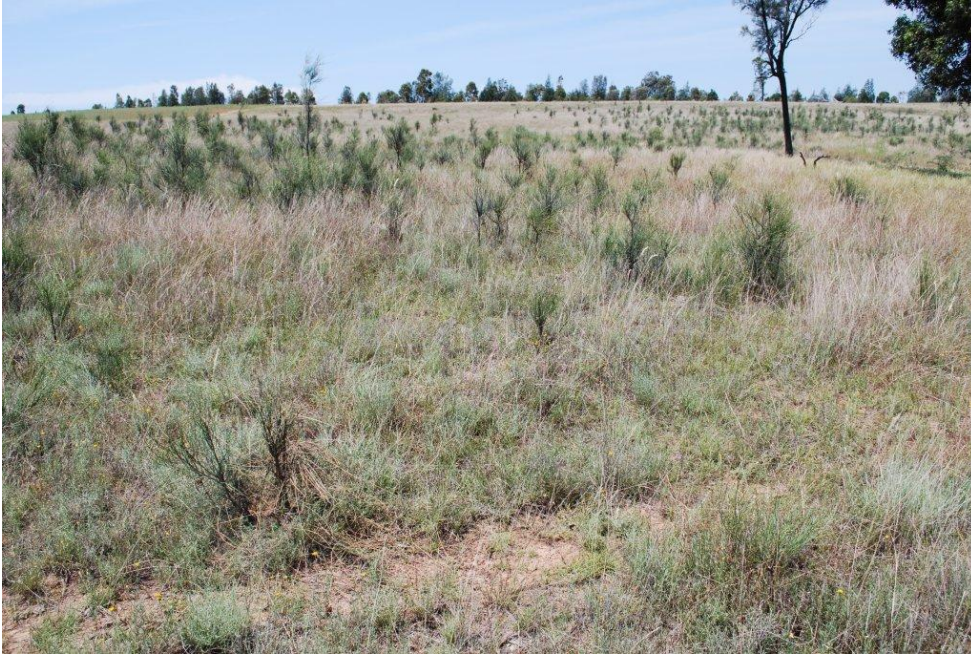
This unit contains a gently sloping drainage depression covering an area of approximately 18 hectares. A farm dam has been constructed in the upper sector and another in the central sector of the unit, prior to ACOL's ownership of the land. Surface visibility is generally very low with some limited exposures around the dams and along the watercourse channels. Plate 9 show the landform within Unit 9. One site (SA13.1) was previously recorded in a gravelly exposure to the north of a dam in the upper part of this unit. An artefact scatter (RS17) was located in this area during this survey. While the GPS coordinates differ, it is likely that these two loci are from the same site.

Plate 9 Vicinity of SA13.1 note natural *Casuarina* regeneration, facilitated by ACOL's land use practices implemented to enhance natural ecosystem regeneration.

The proposed pipeline will pass through the site SA13.1/RS17. Salvage as per AHIP methodology is recommended.
