**Ashton Coal  
Longwall Panels 1 - 4**

Subsidence Management Plan  
Written Report

# Slope Stability Assessment for Ashton Coal SMP

July, 2006

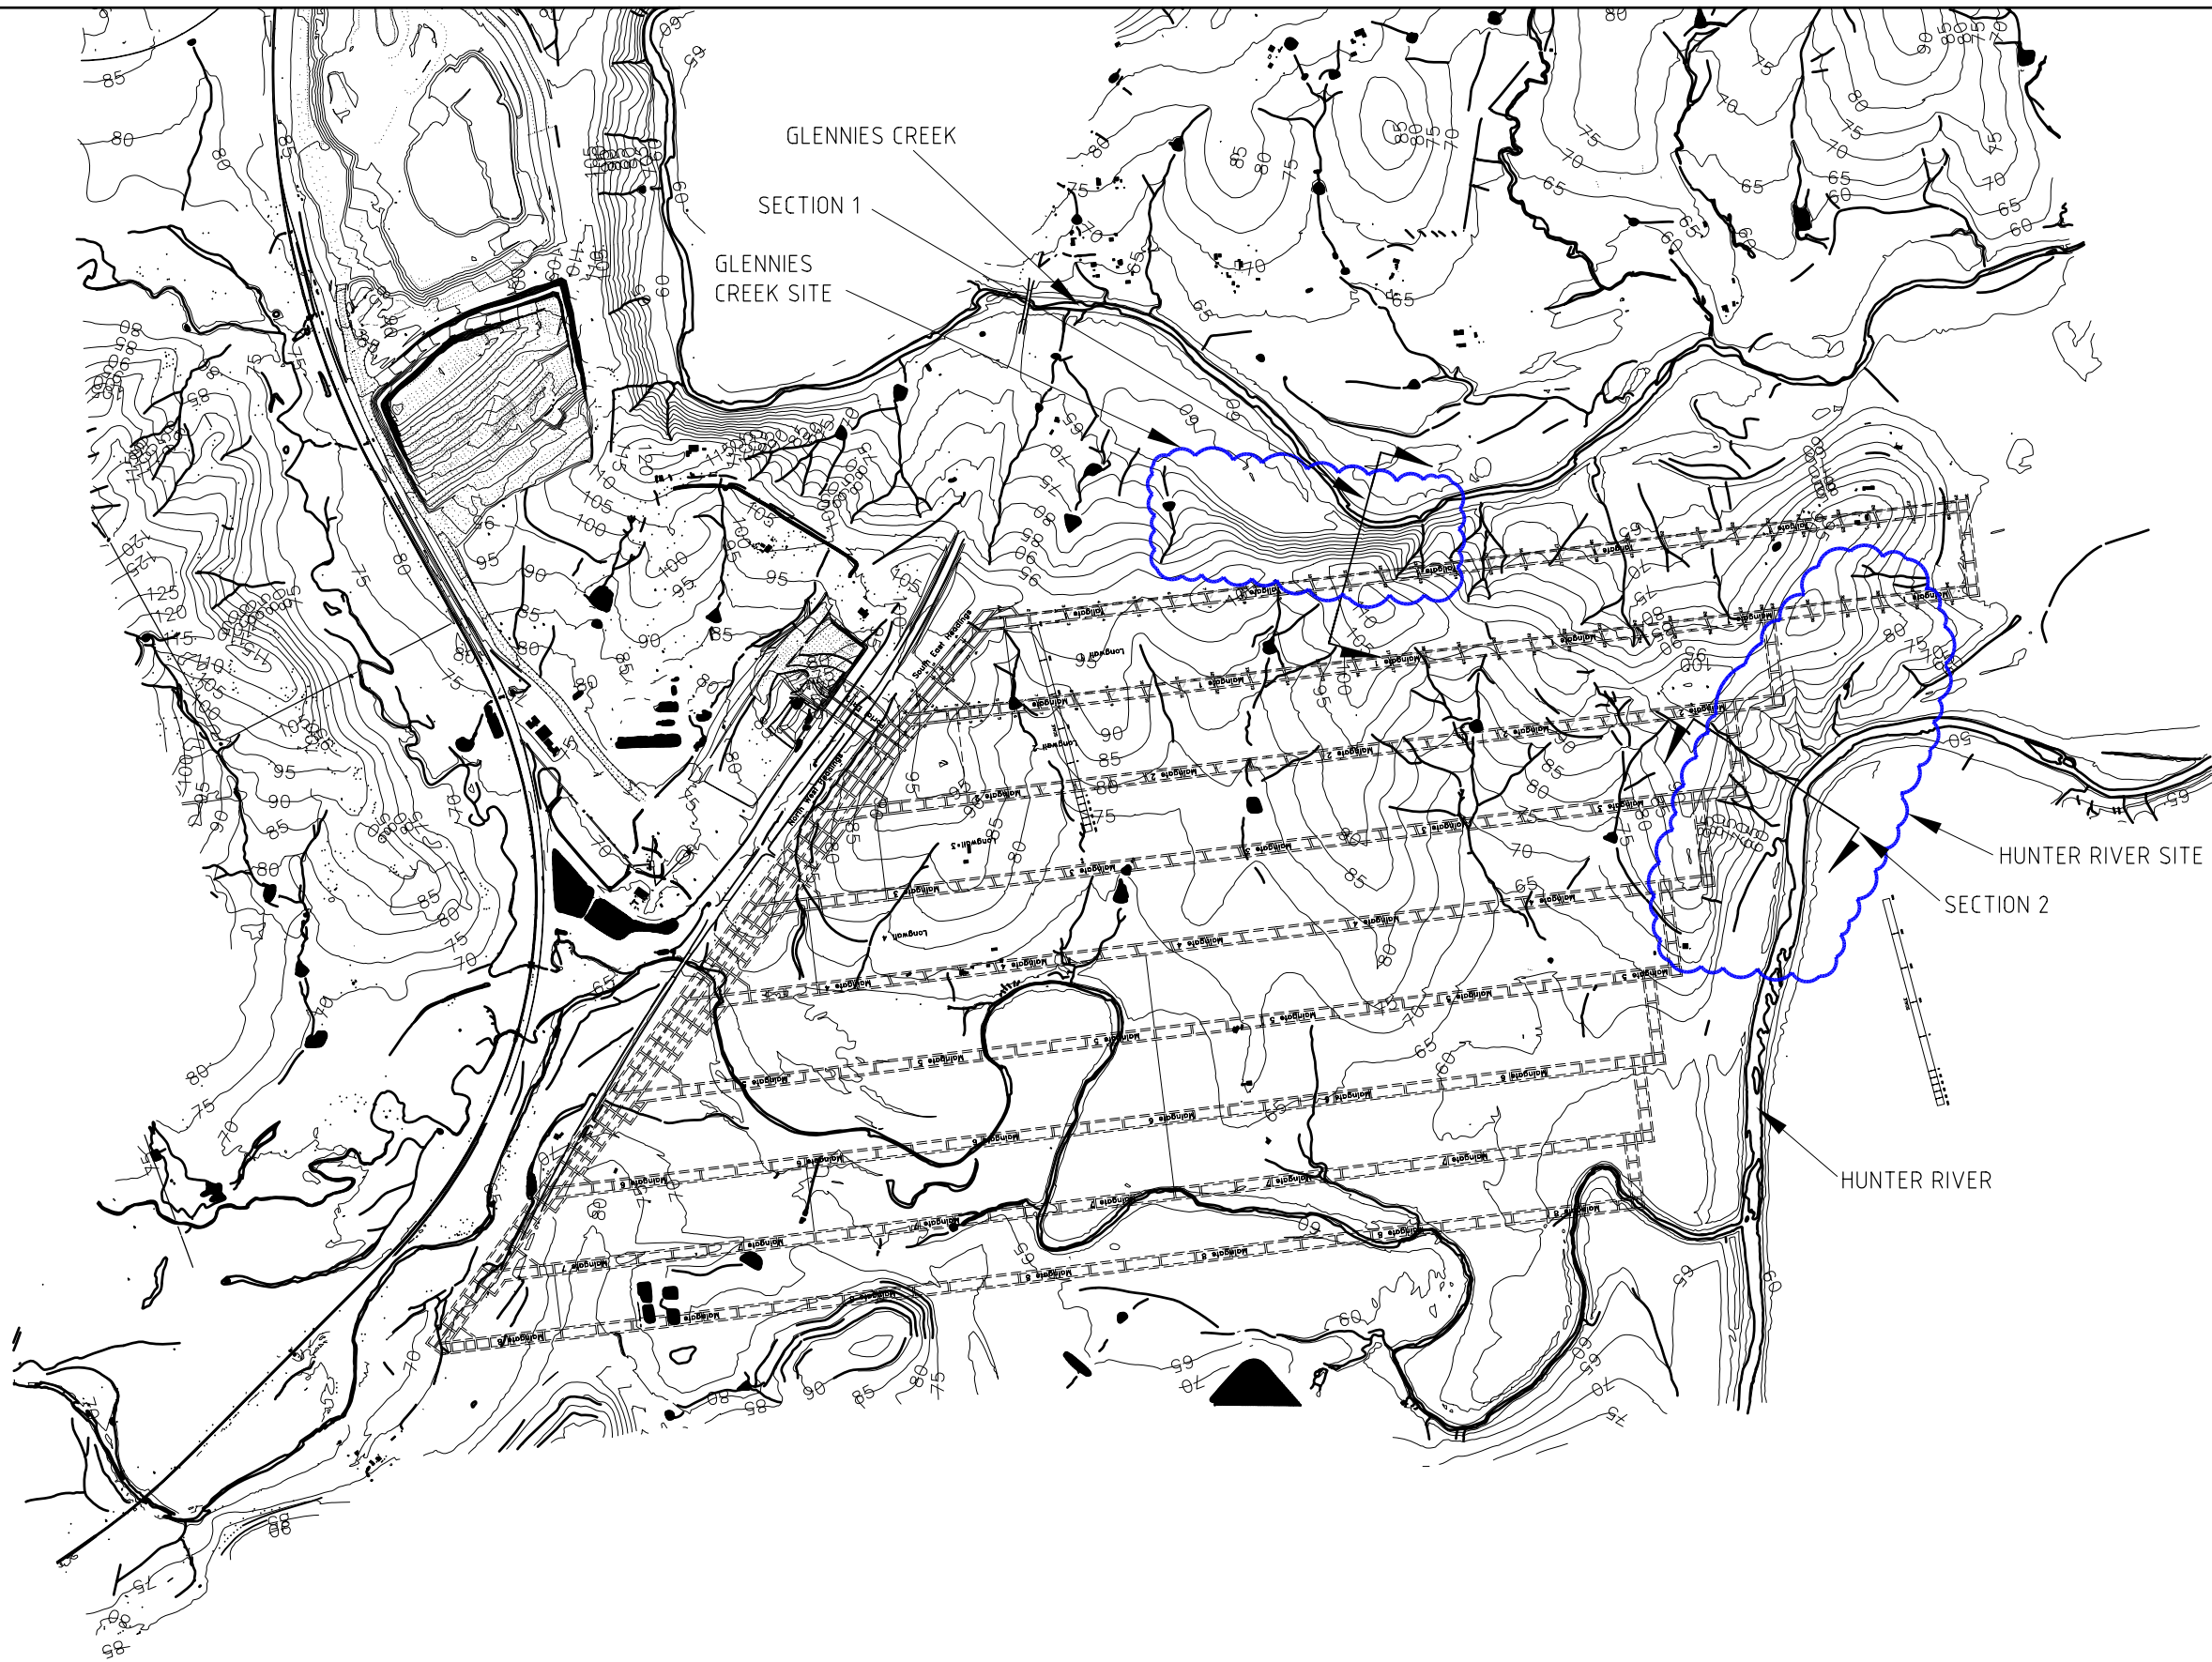
Site Plan  
Section 1  
Section 2

The failure mechanisms are illustrated on the attached Section 1.

Mechanism 1 generally involves the reduction of the colluvium/slopewash strength due to increased pore water pressures leading to a slump. The likelihood of slump failure increases with slope angle. Debris from the slump may move down slope and with sufficient moisture content may form a debris flow.

Mechanism 2 comprises a circular type failure through the rock mass similar in shape to a slump in soil. The failures result from a large number of fractures in the rock mass with some shearing through intact rock 'bridges'. Such failures are generally only possible where there are steep high slopes as relatively high stresses are required to shear through the intact rock.
