ASHTON COAL PROJECT

PIKES GULLY SEAM

LONGWALLS 6B, 7B (SHORT) & 8

BUILT FEATURES MANAGEMENT PLAN

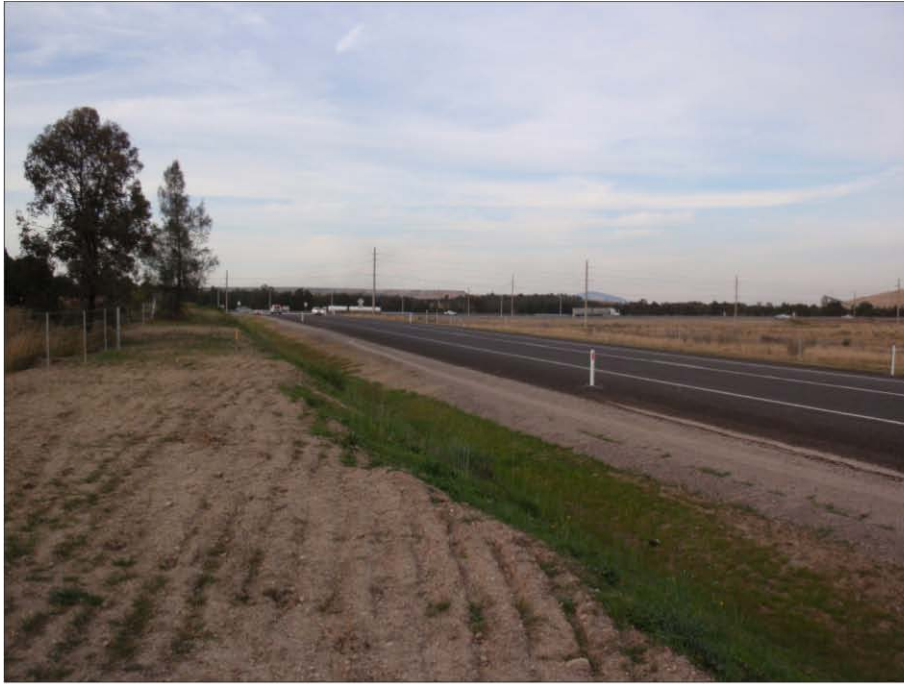
a) Lemington Road looking north east.

Figure 2 shows two photographs of Lemington Road looking northeast toward the intersection with the New England Highway and in the opposite direction.

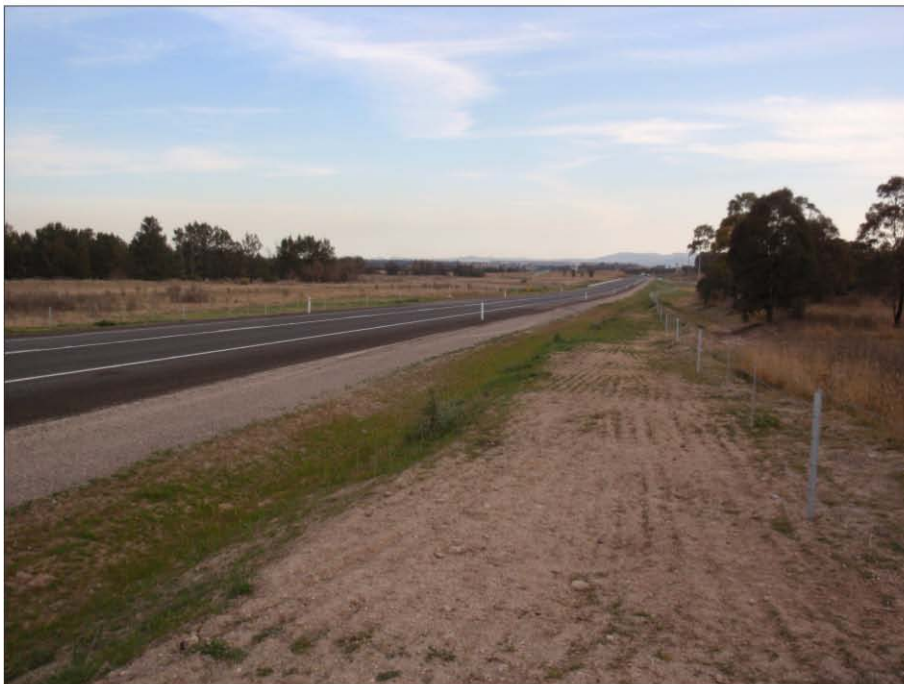
b) Lemington Road looking south west.

Figure 2: Photographs looking north east and south west along Lemington Road.
