ANNUAL ENVIRONMENTAL
MANAGEMENT REPORT
2005 / 2006

Name of mine Ashton Coal Mine

Titles/Mining Leases ML1526 and ML1533

AEMR Commencement Date 2/09/2005 **AEMR Completion Date** 1/09/2006

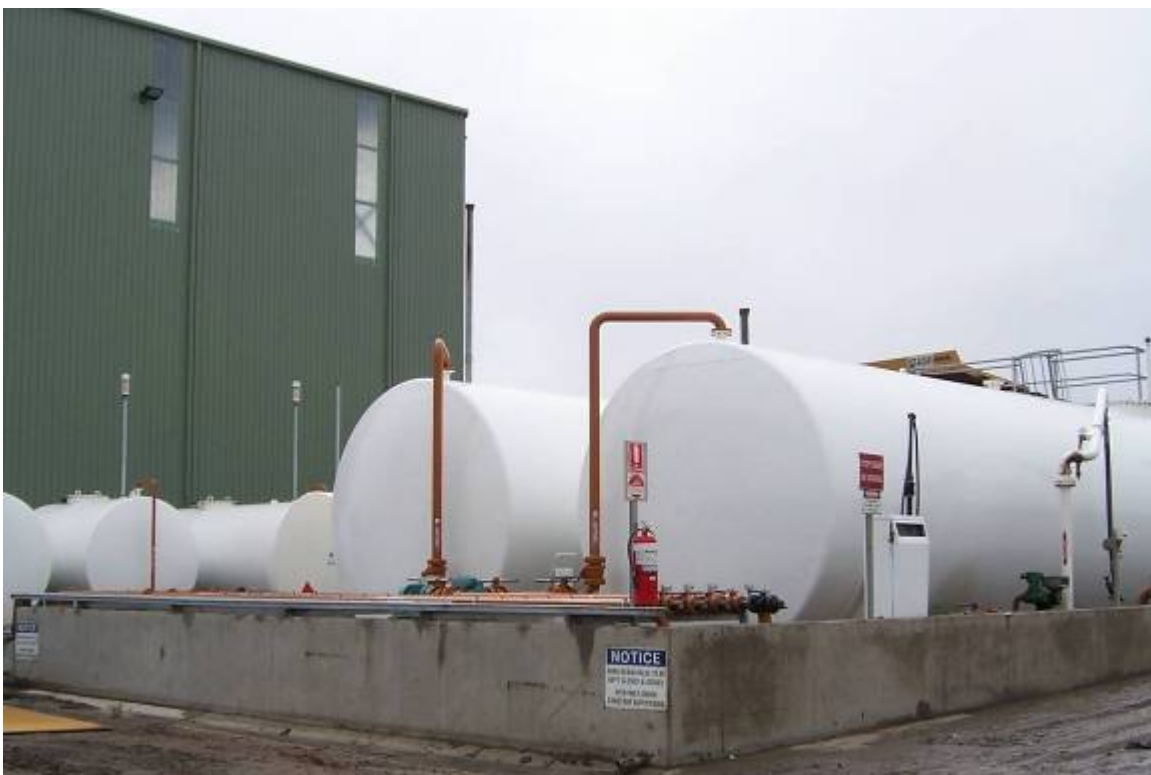
ACOL Hydrocarbon storage area

The open cut workshop and fuel storage facilities have a dedicated bunded area for both fuel and oil storage.

It was identified during a site audit that the oil water separator at the Open Cut Workshop did not have enough capacity to cater for the flow rates generated from the wash down bay and catchment area it was servicing. The best solution to this problem is to create a larger storage area before the water enters the dam. In this larger area will be another oil water separator which will treat the water for a second time, resulting in cleaner discharge water. At this stage the second separation pond has been constructed and we are waiting for the oil water separator to be completed.

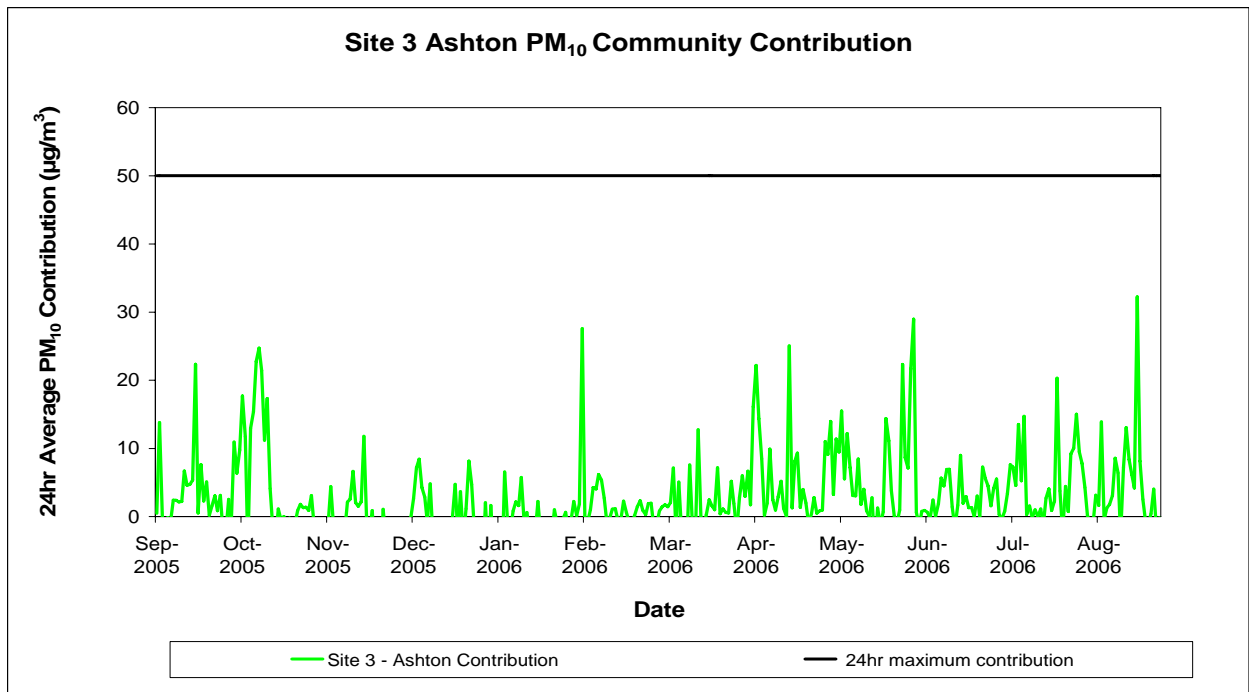
Site 3 TEOM

Site 3 is located on a farming property to the east of the Eastern Emplacement Area. 100% of data was recovered at Site 3 for the reporting period. Results of PM₁₀ monitoring at this location were as follows:

The rolling average PM₁₀ results for Site 3 demonstrates compliance with the annual goal of 30µg/m³.

Site 3 remained in compliance with the community contribution criteria of 50 µg/m³ at all times.

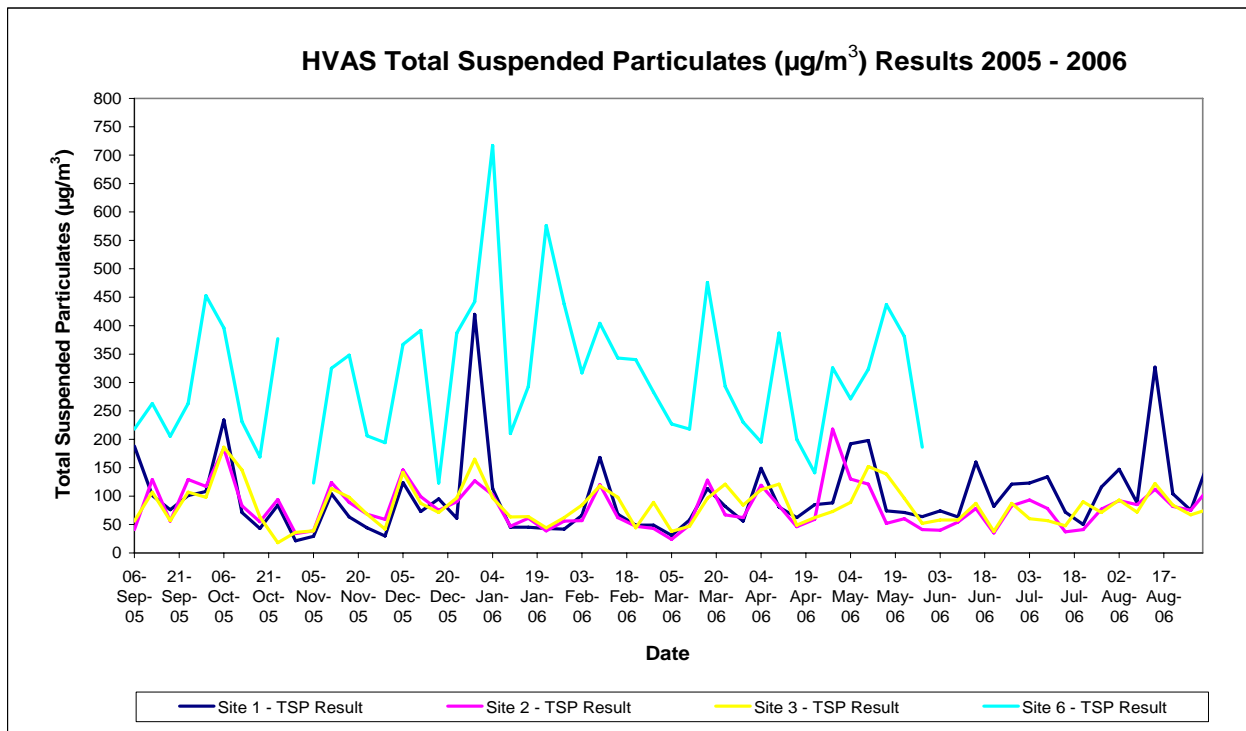
100% of data was recovered at sites 1, 2 and 3 for the reporting period. Site 6 recovered 98.1% of data while operating however as it was decommissioned in May 2006 making the total percentage recovery 72.1%. Data from all TSP monitors was as follows:

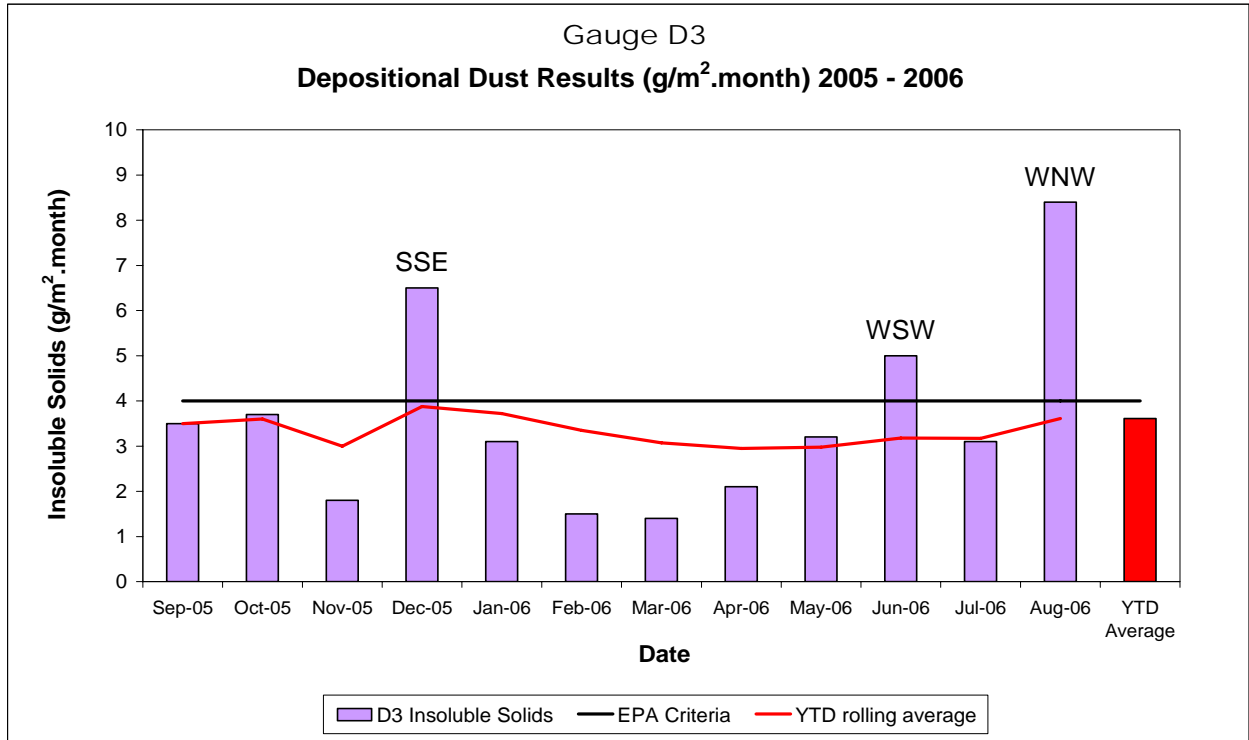
Depositional dust gauge D3 is located to the south of the Ravensworth Mine near the Hunter River. Year-to-date annual average results are below the EPA criteria of 4g/m²/month. Ashton is only likely to effect dust results at this site when winds are emanating from the north east sector. The elevated results seen December 2005 and June and August 2006 have not been significantly impacted by Ashton Operations.

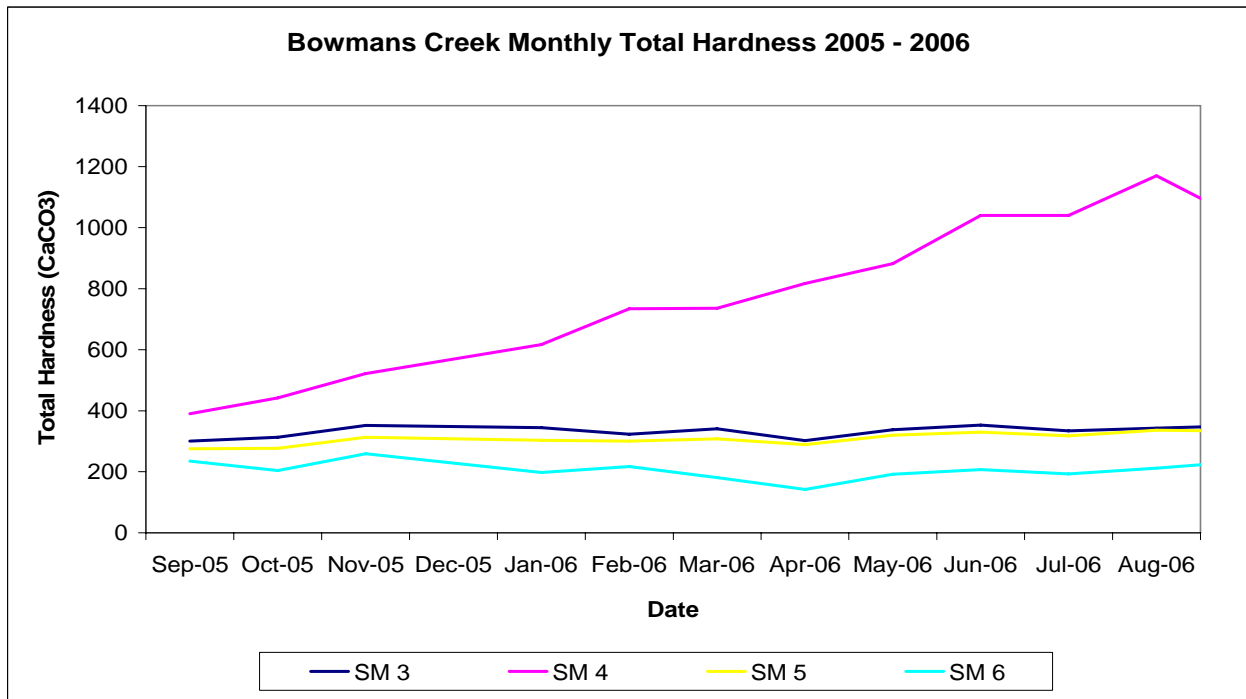
With the increase in pH, EC and TDS between SM3 and SM4, an increase in hardness of the magnitude observed would be expected.
