# Ashton Coal Mine Longwalls 201 to 204 Extraction Plan

November 2016

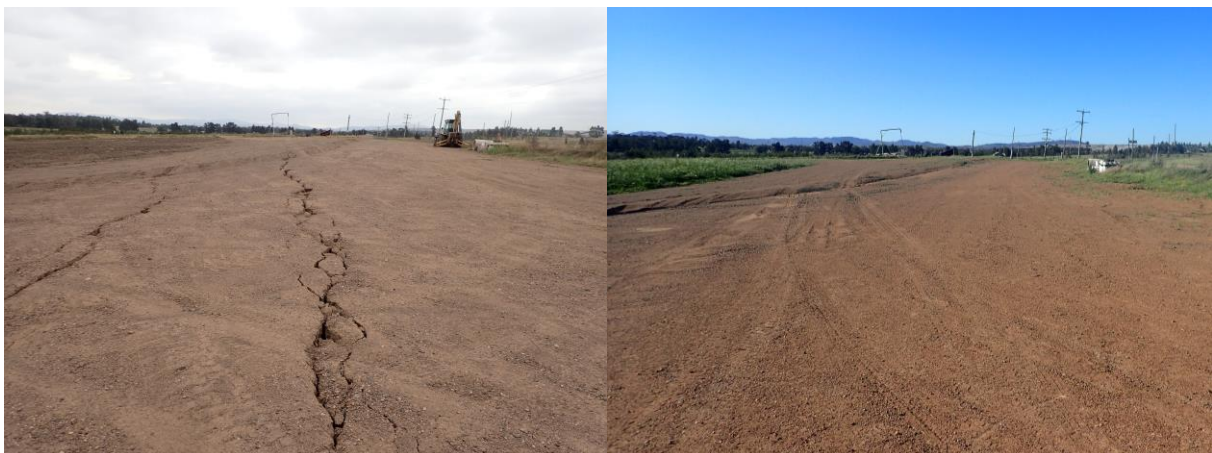
**Photo 1:** Example of subsidence cracking along stacked goaf edge and after crack remediation

Significant cracking occurring around stacked edges has been successfully remediated using a variety of techniques including ripping, excavation and backfilling. The most significant stacked edge cracking to date has occurred along LW104B. Photographs of the impacts of subsidence along the stacked goaf edge as well as impacts after remediation is shown in **Photo 1** and **Photo 2**.

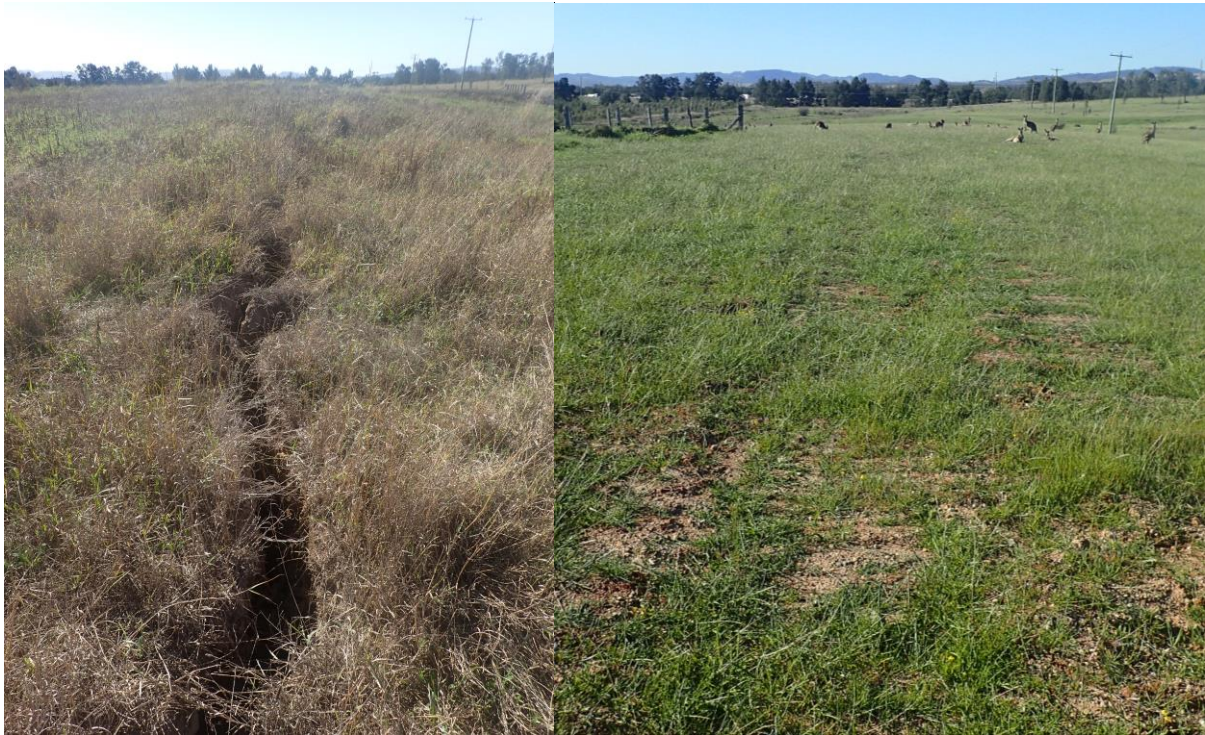
**Photo 2:** Example of subsidence cracking along stacked goaf edge and after crack remediation
