Longwalls 205 to 208

Built Features Management Plan

October 2020

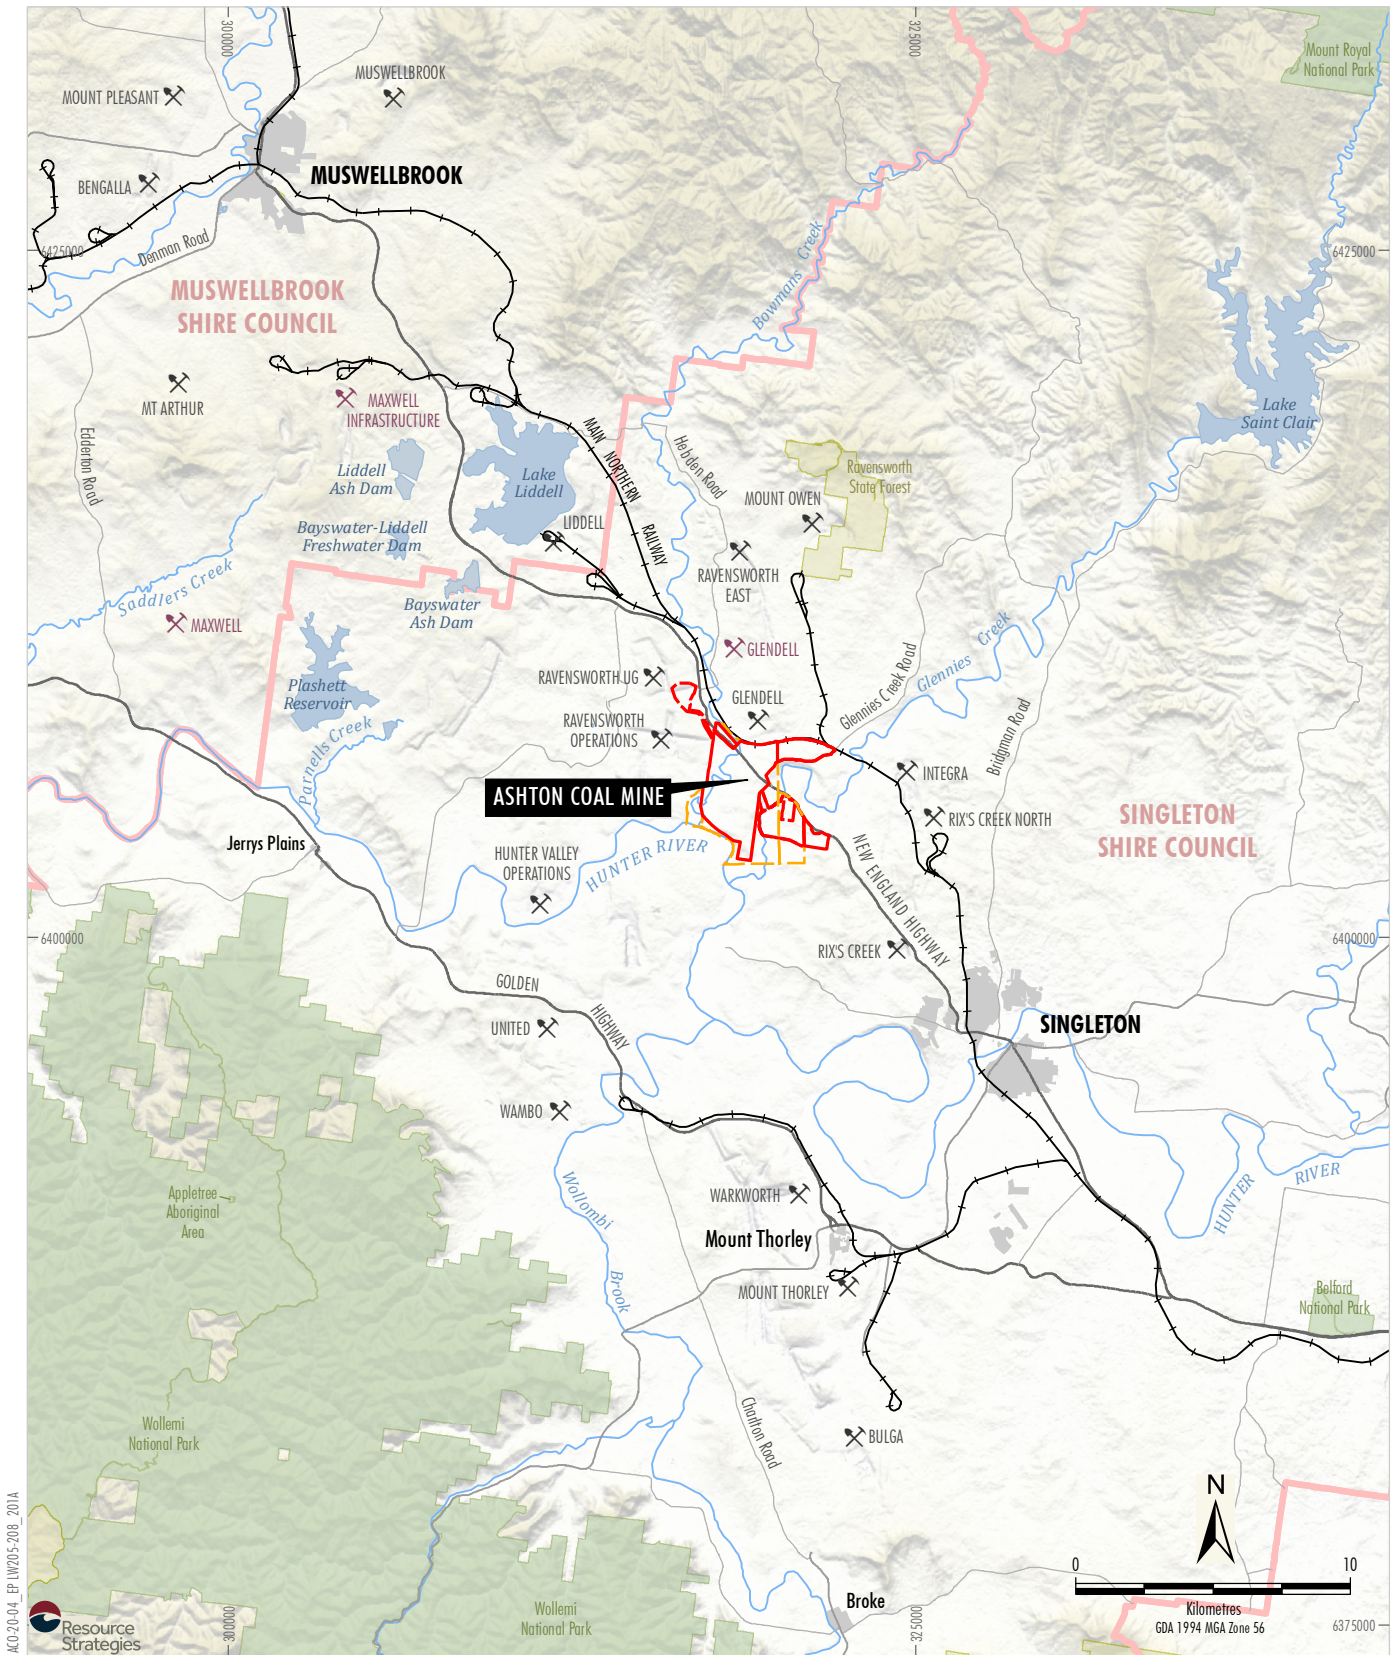
Figure 1

YANCOAL
 宏业澳洲大矿业有限公司
ASHTON COAL MINE
 Regional Location

Ashton Coal Operations Pty Ltd (ACOL), a subsidiary of Yancoal Australia Limited (Yancoal), owns the Ashton Coal Project (ACP), an underground coal mine located approximately 14 kilometres north-west of Singleton in the Hunter Valley in New South Wales (NSW) (**Figure 1**).

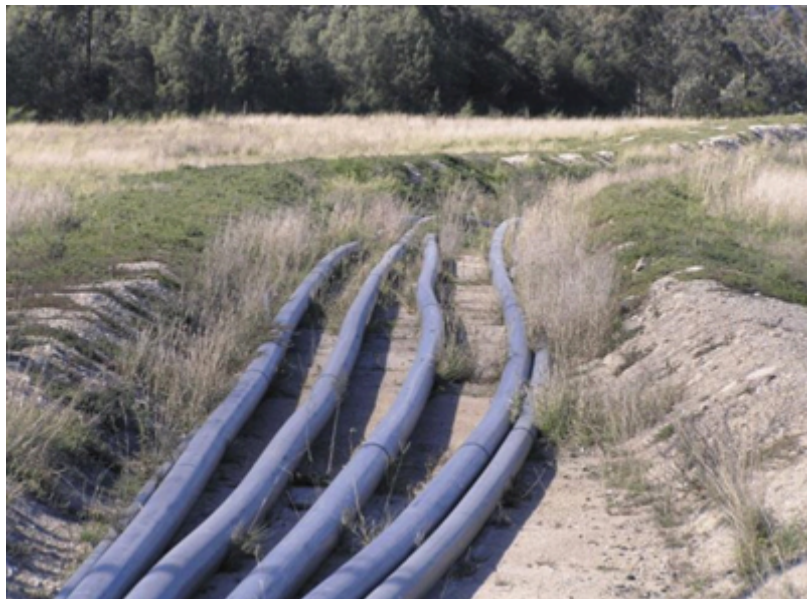
Plate 1: ACOL Tailings Disposal Pipelines in Open Trench

Figure 4 shows the route of several polylines delivering tailings from the Ashton CHPP to the ACP Tailings Dam and the decant return back to Ashton CHPP. These pipelines are laid in open trenches where they cross double stacked goaf edges along the northern end of Longwalls 208 and the corner of Longwall 207B and they are buried on ACOL land near the end of Longwall 206B. Plate 1 shows the pipelines in the open trench above the north eastern corner of Longwall 207B. No significant impacts are expected to these pipelines as they are located on the surface and are free to move independently of subsidence movements.

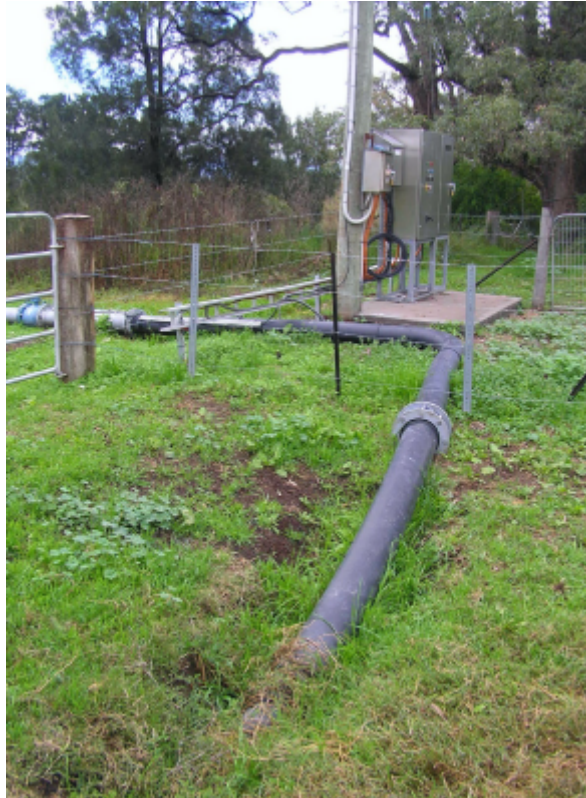
Plate 2. ACOL Water Supply Pipeline

Plate 2 shows a photograph of the pipeline where it is exposed near the pump.

The water supply for the ACP CHPP is pumped via a buried 200 mm diameter polyline from an intake at the Hunter River. **Figure 4** shows the pipeline route from the intake in the southwest corner of the Longwalls 205-208 Extraction Plan area, above Longwalls 206A and 205 and north across Longwall 4. There is potential for subsidence movements localised at pre-existing fractures and at compression overrides to cause damage to the pipeline with possible loss of water supply and minor environmental impacts. Potential impacts can be managed if they are found to be a recurring problem by exposing the pipeline.
