Longwalls 205 to 208

TransGrid

Asset Management Plan

October 2020

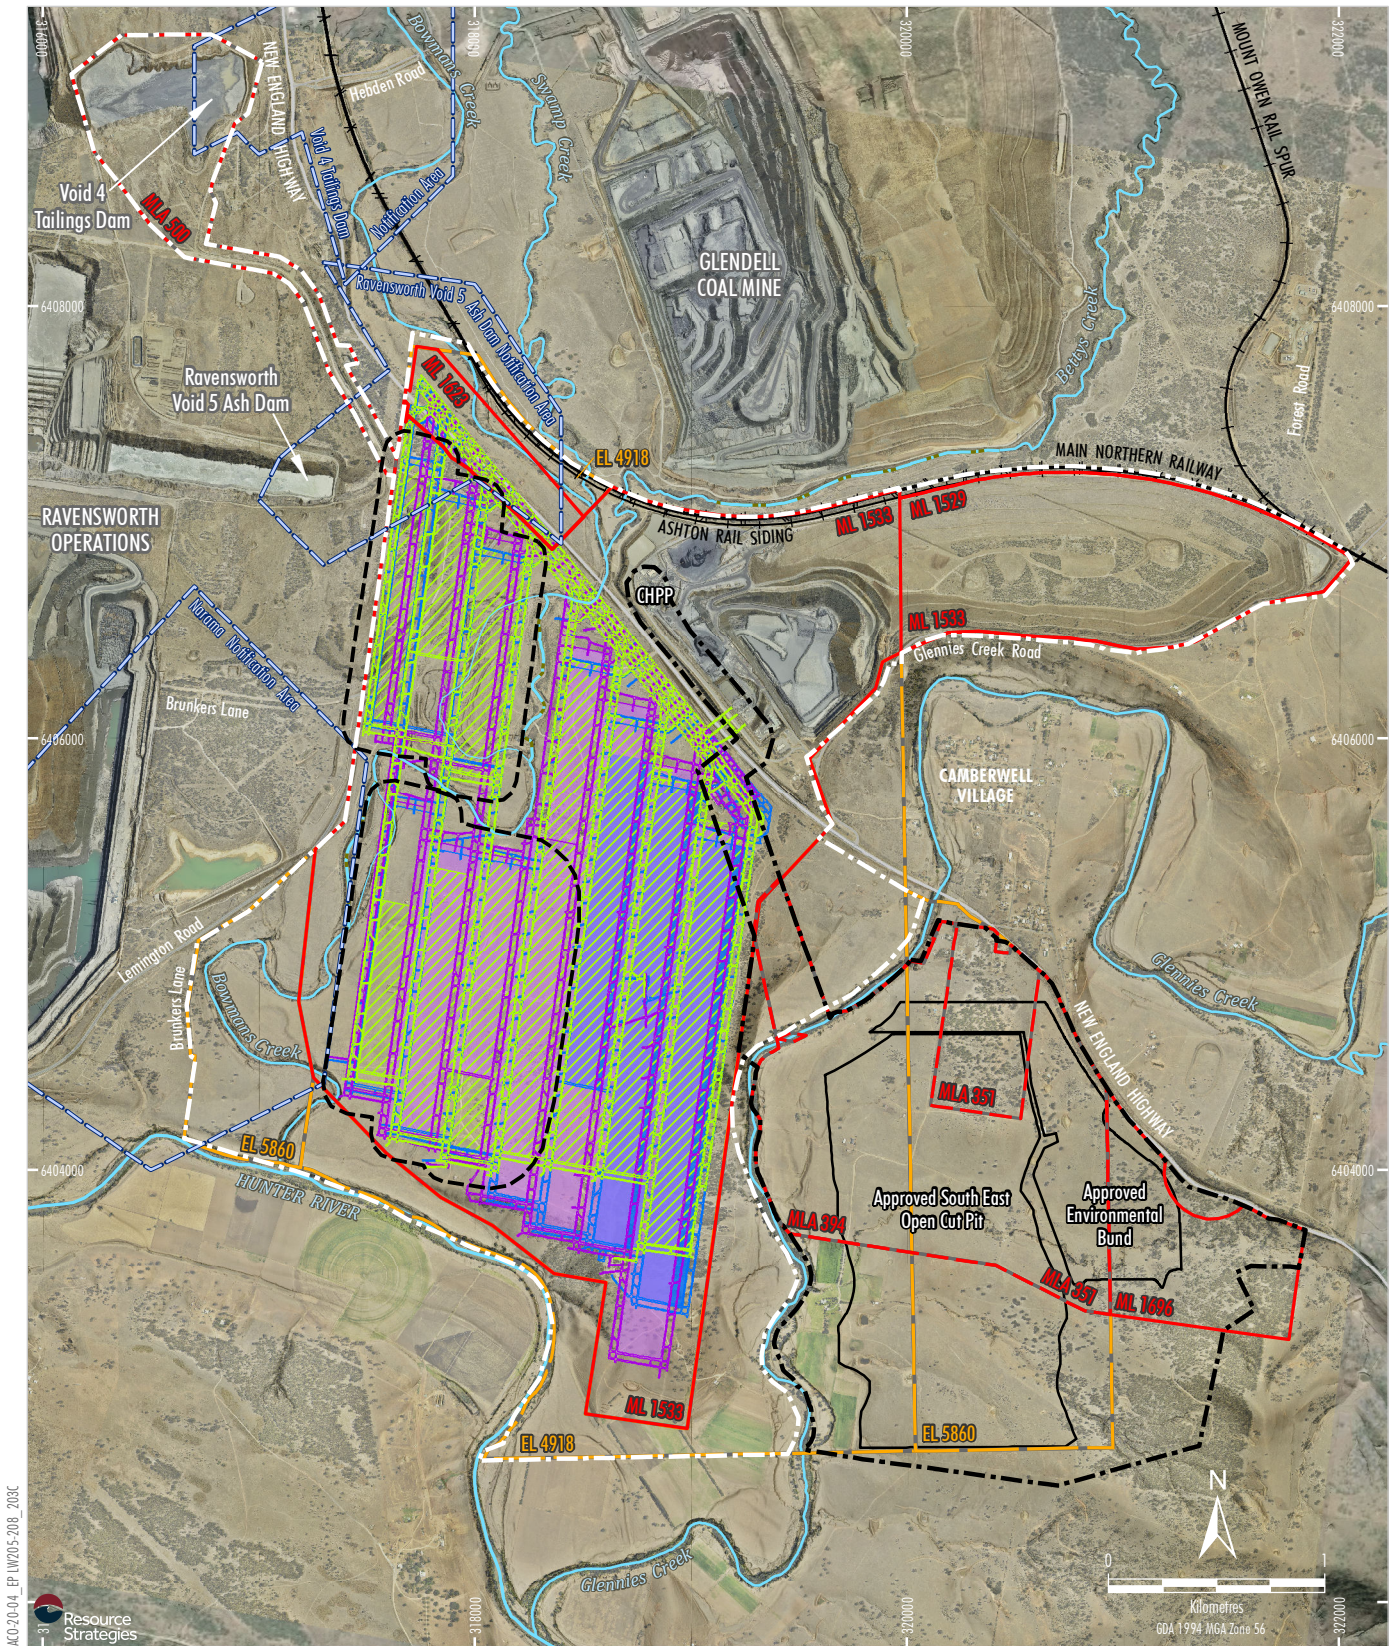
Figure 2

ASHTON COAL MINE
 General Arrangement

The underground mine is approved for multi-seam longwall extraction, targeting four coal seams in descending order (Pikes Gully (PG), Upper Liddell (ULD), Upper Lower Liddell (ULLD) and Lower Barrett (LB)) (**Figure 2**). Development of the underground mine commenced in December 2005 and is accessed through the southern wall of the Arties Pit under the New England Highway.

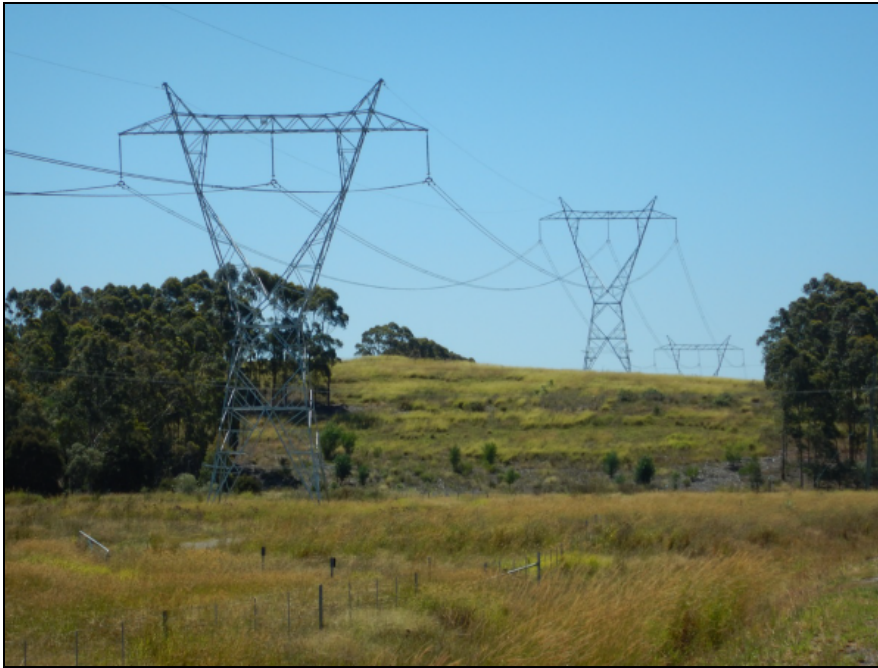
Plate 1: TransGrid 330 kV Transmission Line along western boundary of Extraction Plan Area

The TransGrid 330 kV transmission line is located west of Lemington Road and traverses along the western boundary of the Extraction Plan Area parallel to Longwall 208. Five steel truss pylons that support the conductors are within the Extraction Plan Area (**Plate 1**).

The transmission line was previously relocated into the corridor along the lease boundary between the Ashton Underground Coal Mine and Ravensworth Underground Mine (RUM) as part of the Ravensworth North Open Cut expansion to minimise the impacts from future mining. Three of the five towers located within the Extraction Plan area are positioned over solid coal beyond the RUM workings in the PG Seam. The remaining towers are located on the fill and capping material approximately 40 m from the edge of the Ravensworth No 2 Bayswater Pit.

Towers are approximately 90-100 m from the edge of Longwall 208 in the ULLD Seam. Tower foundations are designed and built to accommodate the combined subsidence movements associated with both the Ashton Underground Coal Mine and RUM.
