# Longwalls 205 to 208

## Glencore Asset Management Plan

October 2020

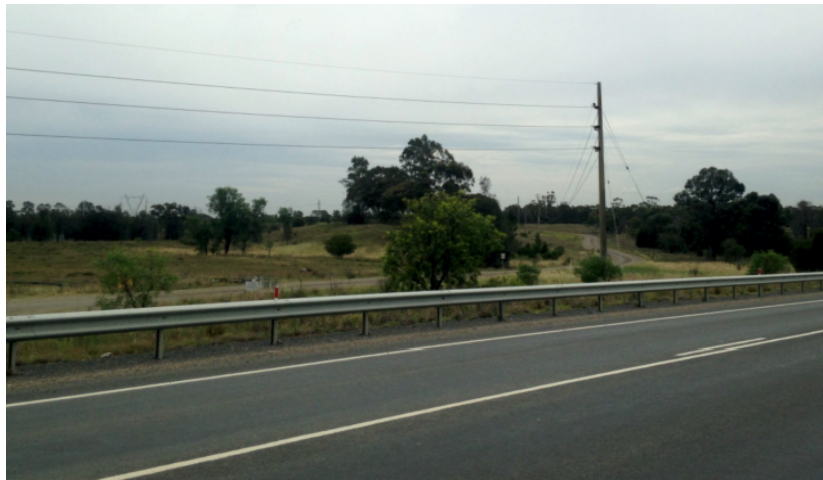
**Plate 1: 33kV Transmission Line Adjacent to AGLM South Access Road**

The 33 kV transmission line is located within or immediately adjacent to the Extraction Plan area. Seven transmission poles are located above or between Longwalls 207B and 208. The transmission line was constructed prior to mining Longwall 8 in the PG Seam. The line traverses the surface immediately to the west of Lemington Road before changing direction to follow the AGL Macquarie (AGLM) south access road to the north west (**Figure 3**) (**Plate 1**).
