Longwalls 205 to 208

AGL Macquarie Asset Management Plan

October 2020

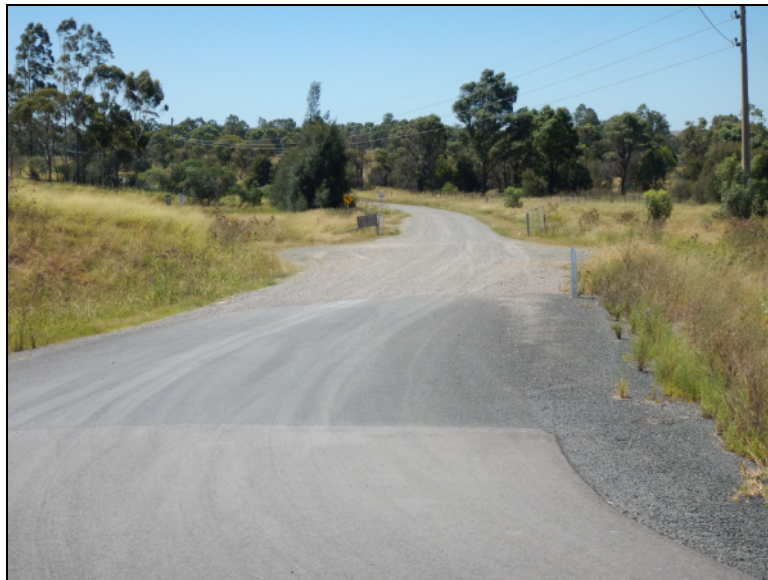
Plate 1: AGL Macquarie South Access Road Looking North from Lemington Road Intersection

The AGL Macquarie South Access Road extends from the intersection with Lemington Road (overlying Longwall 207B) to the north-western boundary of the Extraction Plan area (with a small section overlying Longwall 208) (**Figure 4**). The road is sealed in the vicinity of the Lemington Road intersection and unsealed for the remainder of its length (**Plate 1**).

These strains and tilts are expected to cause surface cracking up to 200-300 mm wide and compression humps greater than 100 mm high as well as localised steep gradients along and across the road. Most of the surface cracks and compression humps are expected to occur at the same locations as those that formed when Longwalls 7B and 8 were mined.

Impacts to the sealed section of the South Access Road can be managed using temporary filling and regular regrading during the period of active mining. Resealing is likely to be required once the road formation has been regraded and cracks have been filled.

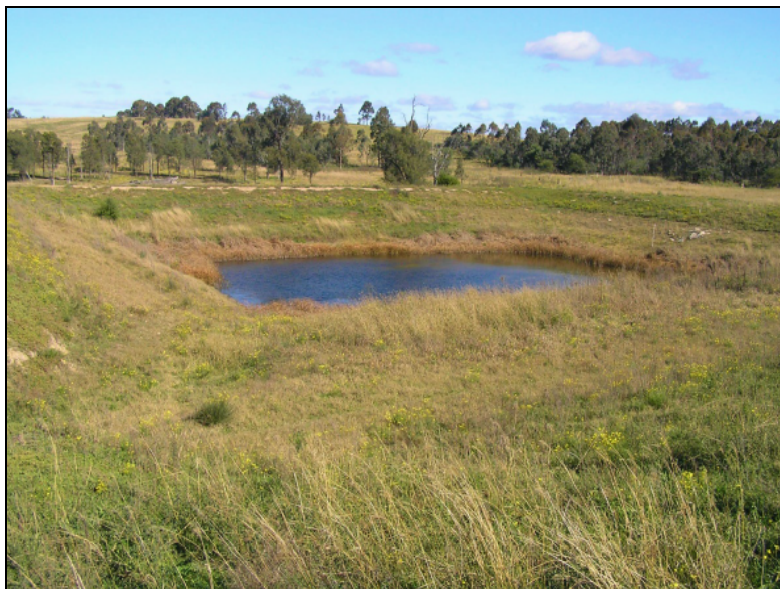
Plate 2: AGL Macquarie Disused Sediment Ponds

Four disused sedimentation ponds are located over and on the edge of Longwall 208 (**Plate 2**). SCT understands that AGL Macquarie do not intend to use these ponds again.

Impacts are expected to include cracking of the dam walls and tilting with potential loss of water from the ponds. The sedimentation ponds are positioned where incremental subsidence of up to 2.2 m is expected with maximum cumulative subsidence of up to 3.1 m. Maximum incremental strains of 37 mm/m and maximum tilts of 73 mm/m are expected over the stacked edge of Longwall 208. Large permanent cracks and significant changes in grade are expected, particularly along the eastern side of the ponds.

The impacts are likely to be repairable to a state in keeping with their current and planned usage with some relatively significant earthworks. Loss of water from these ponds is not expected to pose an operational risk to mining underground and is not considered to be an inrush hazard.
