Longwalls 205 to 208

Telstra Asset Management Plan

October 2020

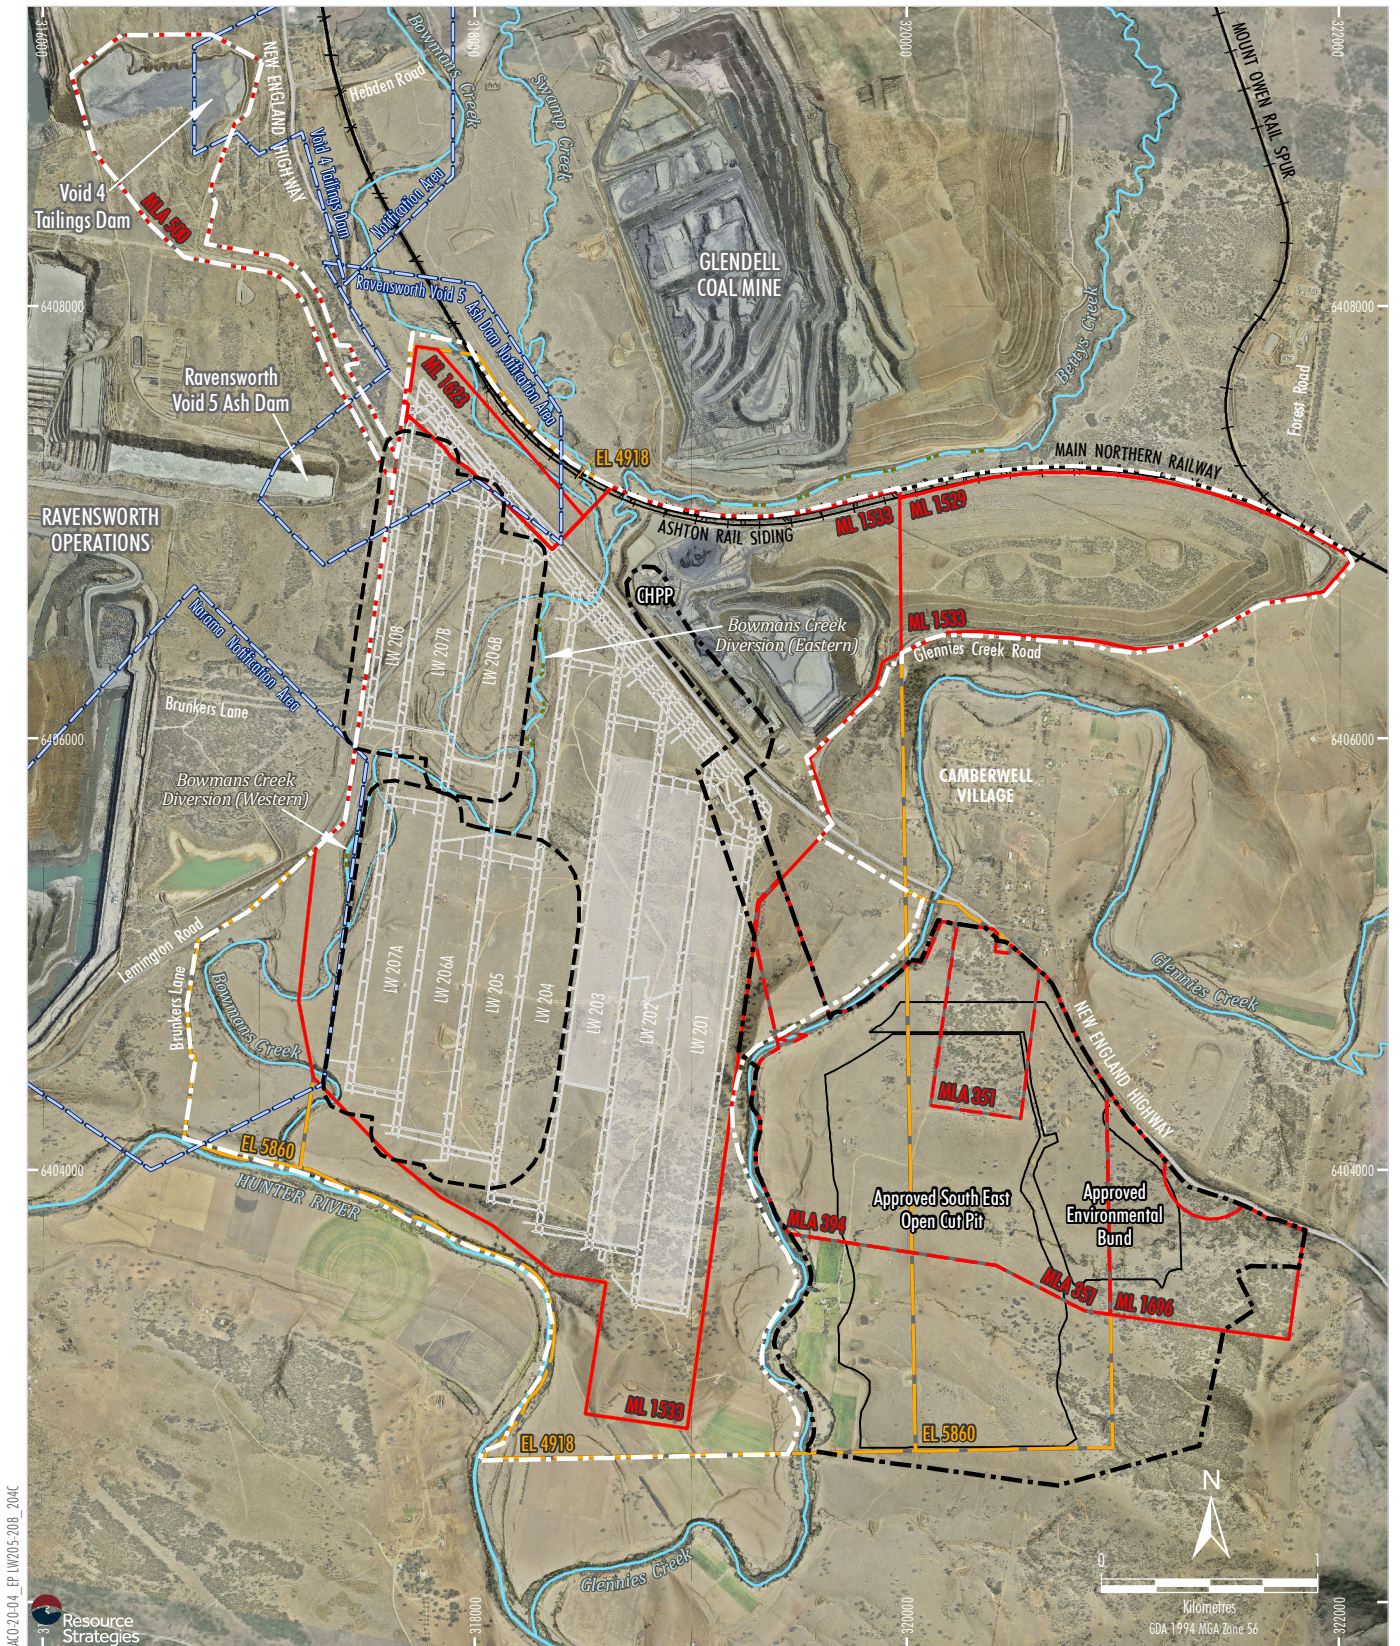
Figure 3

Figure 3: General Arrangement of Upper Lower Liddell Seam Longwalls

ACOL has subsequently prepared an Extraction Plan for mining of Longwalls 205 to 208 in the ULLD Seam of the Ashton Underground Coal Mine, varying between 185 metres and 255 metres below the surface. Proposed mining of Longwalls 205 to 208 (the **Extraction Plan Area** – refer **Figure 3**) is due to commence in March 2021 and is planned to take place over a three-year period.
