Longwall 206B

Lemington Road

Monitoring and Maintenance Plan

January 2023

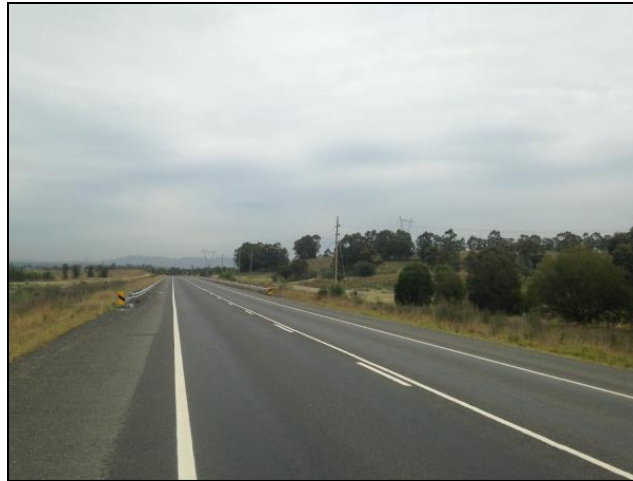
Figure 5 Lemington Road looking South

Lemington Road was diverted and reconstructed during and following mining of Longwalls 7B and 8 in the PG Seam as part of the Ravensworth North Open cut Mine Project. **Figure 5** shows the road looking south from a position above Longwall 207B. Longwall 6B in the PG Seam subsequently mined below a small section of the new road causing low level subsidence above the corner of the panel and minor cracking along the edge of the road.

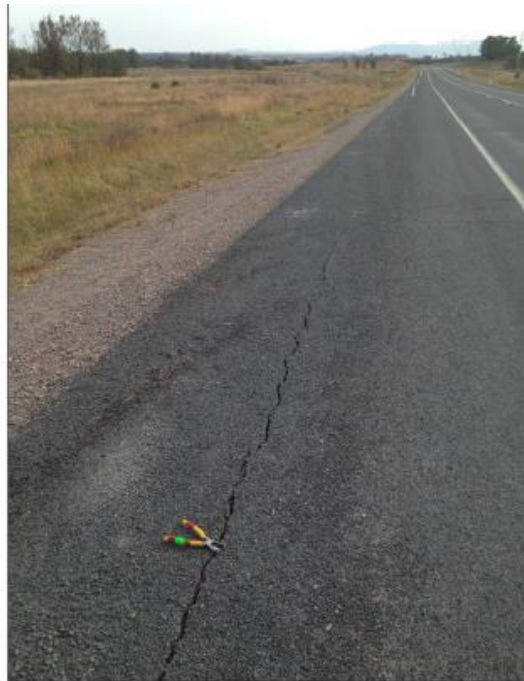
Figure 6 Lemington Road cracking FROM LW6B panel

Based on past experience at Ashton with stacked Longwall panel edges, the cracking on the Lemington Road pavement is likely to be about 2-3 times the width of previous cracking experienced from the mining of LW6B and be concentrated at or near the existing crack locations on the Lemington Road pavement. Previous cracks up to 20 mm wide were observed along the edge of the southbound lane (Refer **Figure 6**). Fresh cracks from LW206B of up to around 60 mm wide are therefore expected. Cracks of about 5-10mm were previously observed in the southbound lane so cracks up to about 30mm wide are also expected in the southbound lane. Both sets of cracks are expected to be limited to within a zone 290-350 m from New England Highway.

The cracking on the Lemington Road pavement from LW206B Longwall extraction is likely to be about 2-3 times the width of previous cracking experienced from the mining of LW6B and be concentrated at or near the existing crack locations on the Lemington Road pavement.

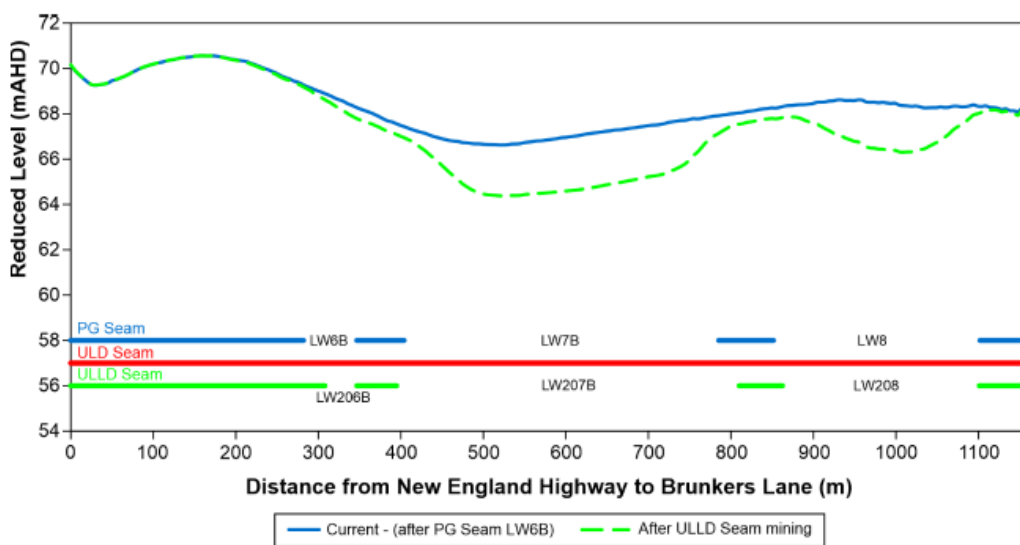
Figure 7 Lemington Road – estimated profiles after subsidence

Figure 7 shows the estimated road surface profiles along the centre of Lemington Road from current, after subsidence from ULLD Seam longwalls.

The subsidence movements are expected to occur gradually as mining progresses and are expected to move along the road affecting a section up to 100-150 m long at any given time. Impacts are expected to occur incrementally in response to mining geometry rather than suddenly. However, with normal longwall retreat rates of 70-100 m per week, the impacts at any one location may develop to their maximum over a few days and be substantially complete within one to two weeks.
